Typical moisture failures of the slab-on-ground structures in Finland

Abstract: This paper includes a summary of several case studies on moisture damaged slab-on-ground structures. The object of the paper is to suggest a classification of the causes for moisture damages and introduce the typical moisture failure of the slab-on-ground structures in Finland. The common causes for moisture damages in the slab-on-ground structure can be classified into four categories: design, construction, repair and maintenance. According to the studied moisture damage cases the most common cause is design fault. Usually the slab-on-ground structure is unfit in the light of present knowledge. The most common design faults are lack of capillary breaking drainage layer under the slab, lack of thermal insulation and incorrect placement of the vapor barrier.

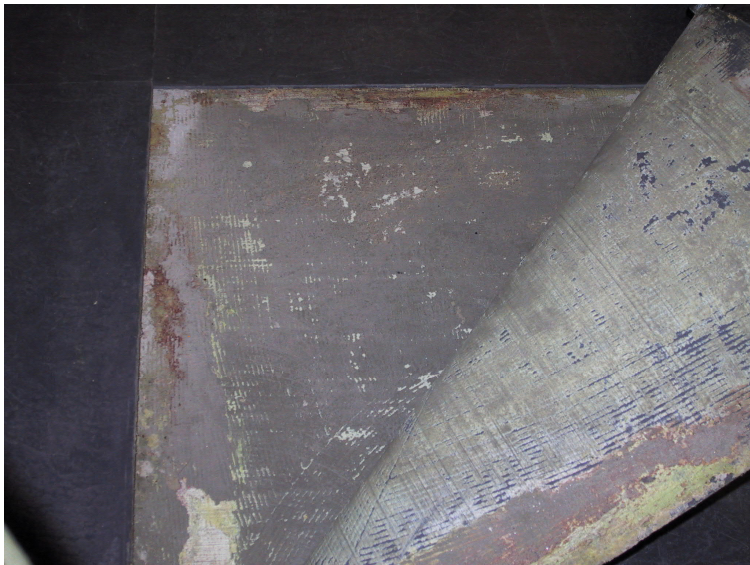
Figure 2.

Figure 2 Loss of adhesion of the floor covering in restaurant building caused by the excess moisture flow from the soil. The slab-on-ground structure: 100 x 100 mm glued natural rubber plates, 100 mm concrete floor slab, 800 mm expanded clay aggregate drainage layer.
