11th Nordic Symposium on Building Physics, NSB2017, 11-14 June 2017, Trondheim, Norway

Long term monitoring of repaired external wall assembly

Susanna Ahola^{a*}, Jukka Lahdensivu^b

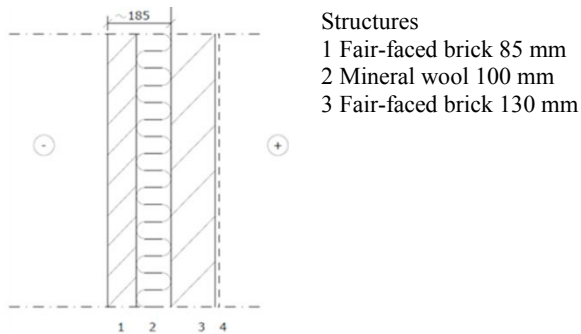
Fig. 1 The original external wall assembly

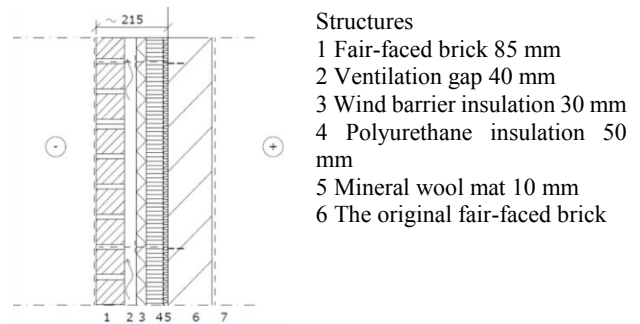
Fig. 2 The repaired external wall assembly

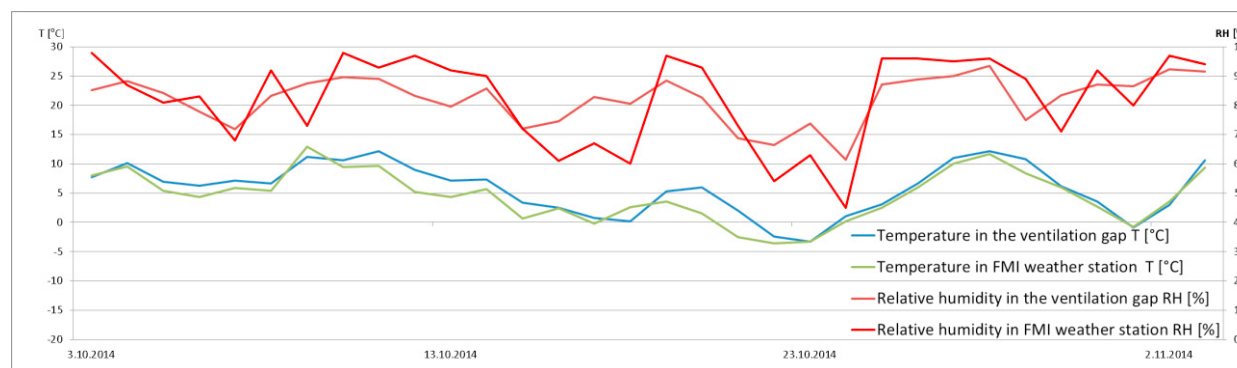
Fig. 8 The results from the sensor group 90, sensor #4 compared to outside air temperature and relative humidity [10]
