## THE AIR FLOWS AND MICROBIAL CONTAMINATION TO INDOOR AIR FROM SANDWICH FACADE – CASE STUDY

### ABSTRACT

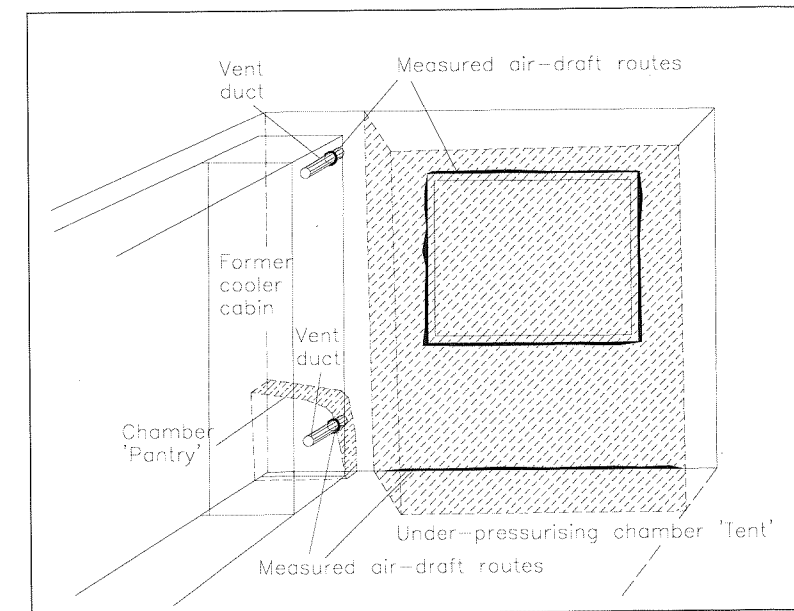
Figure 1. Test chambers and detected air-draft routes

Flat number 9 (kitchen) was chosen to be a subject of closer examination because it has the highest contamination. Formerly, the outermost kitchen cupboard had been used as cooler (pantry), and there were ventilation ducts through the exterior wall (Figure 1). Used steel ducts have been sealed from inside of the duct, as the cupboard was not used anymore as a cooler.

Foot ledges and covering lists around window opening were removed in the test room (*kitchen*) and the covering board between outermost cupboard and exterior wall was removed. The air-drafts in normal pressure conditions was measured (Figure 1).

Two chambers with PE-plastic and timber frame were build. Chamber *Pantry* covered the area around lower ventilation duct between outermost dresser and exterior wall. It was loose plastic hood and it's purpose was to examine air-drafts around air duct hole. Chamber *Tent* covered rest of the exterior wall as shown in Figure 1. It was made air tight and its purpose was to examine air-drafts from normal joints of sandwich panel during under-pressurising.

The pressure difference between insulation layer and outdoors was about two thirds of total pressure difference over exterior wall. So the sealed joints of outer concrete slab were tighter than joints in inner concrete slab. Also during the under-pressurising the under-pressure in insulation layer was more than half of pressure difference through whole wall. The air velocity around bushings of steel ducts was as high as 5 m/s, but were not able to determine the volume of air flows inside chamber *Pantry*. The exhaust air volume from under-pressurised chamber *Tent* was 20 m<sup>3</sup>/h and measured air velocities near joints varied from 0.15 to 0.5 m/s.

After first under-pressurising the joints in exterior wall inside of chamber *Tent* were sealed with elastic sealing compound and the under-pressurising and air-draft measurements were

redone. No significant air flows were detected after the sealing reparations.

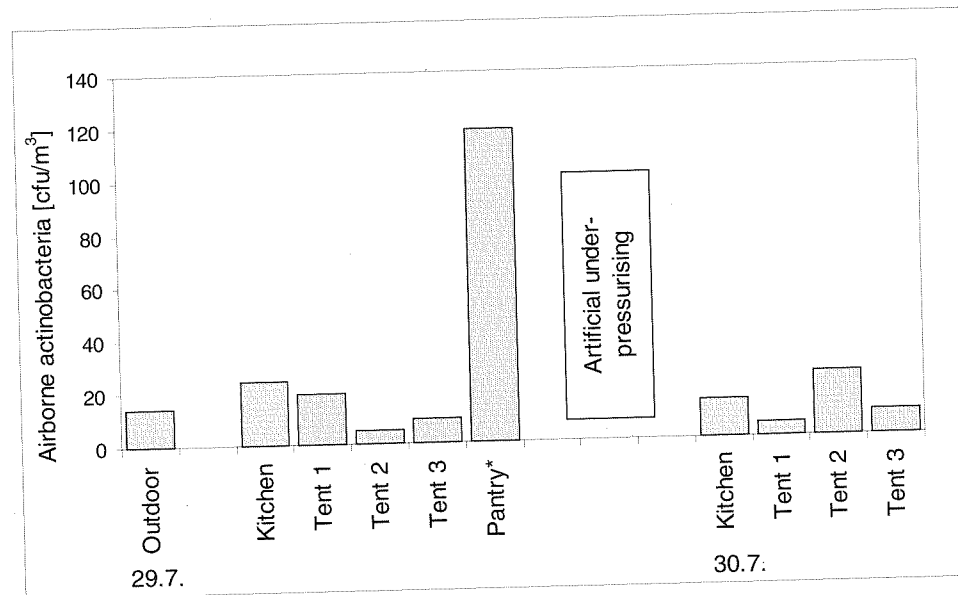
Figure 2. Actinobacterial concentrations during the test

Concentrations of both actinobacteria and *Penicillium-Aspergillus* -group were highest in the former cooler cabin (*Pantry*) and explained well the high counts of the flat 9. Actinobacterial counts were similar to *kitchen* in the *Tent* -chamber before the artificial under-pressurising, but fungal counts much lower. During the under-pressurising, the actinobacterial counts in *Tent* -chamber did not change, but the fungal species changed similar to outdoor source: the main genera were basidiomycetes and *Cladosporium* and other outdoor moulds. The main source of actinobacterial and *Aspergillus-Penicillium* -group spores of indoor air was found to be connected to inaccurate structural details in the bushings of the exterior wall. Furthermore, there were obvious air flows in elastic joints around window frames, and in bottom- and side-edges of interior slab of sandwich panel. *The microbial flora that came through them was mostly outdoor orientated.*

First of all, in this case the main sources of actinobacteria was clearly the loose bushings of steel ducts of former cooler cupboards.
