**Relevance of Laboratory Wear Experiments for the
Evaluation of In-Service Performance of Materials**

Julkaisu 1587 • Publication 1587

Thesis for the degree of Doctor of Science in Technology to be presented with due permission for public examination and criticism in Konetalo Building, Auditorium K1702, at Tampere University of Technology, on the 2nd of November 2018, at 12 noon.

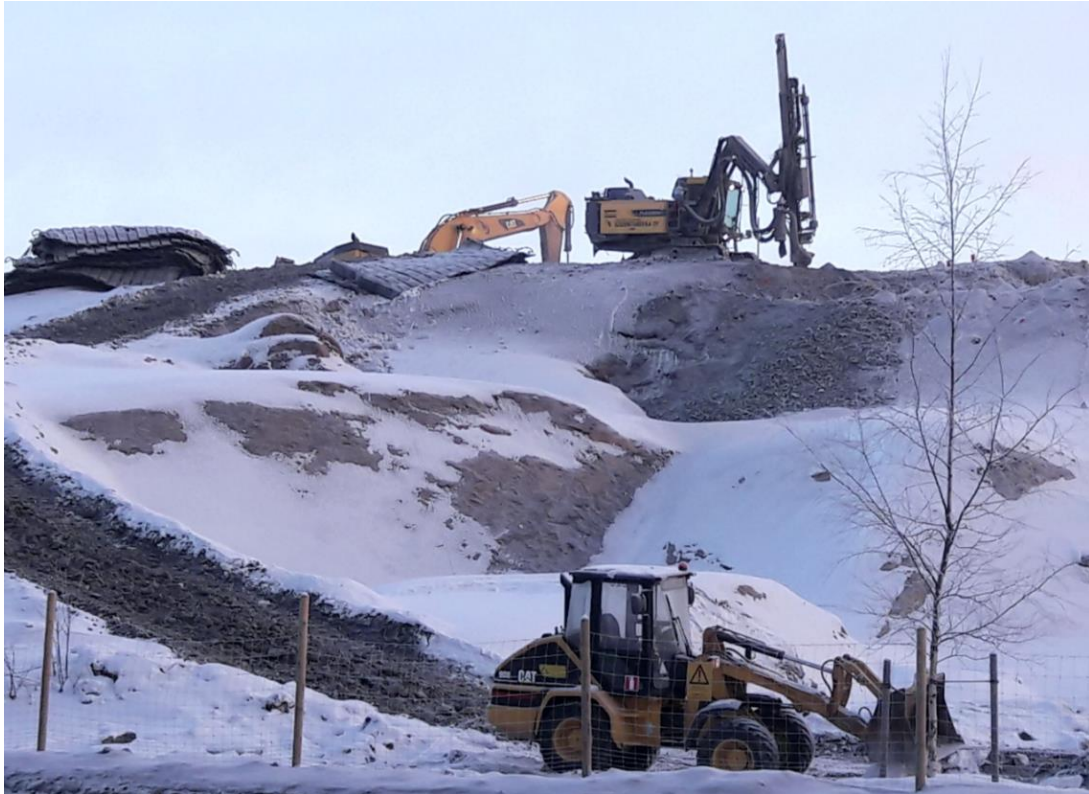
Figure 4.3. Tram line construction worksite in Tampere, in operation at -20 °C in Winter 2018.

The exploitation of the Arctic area is getting more intensive, when the current mines are impoverished and the price of the raw materials is increasing. Moreover, in the countries around the Arctic Circle, the temperatures are typically below 0°C during the winter months (Fig. 4.3). The working conditions at subzero temperatures set demands also to the materials. The ductile-to-brittle transition (DBT) at low temperatures is typical for metals with a body-centered cubic microstructure [106]. Therefore, also the wear behavior of the steels can change markedly at subzero temperatures, when their ability for plastic deformation becomes limited.

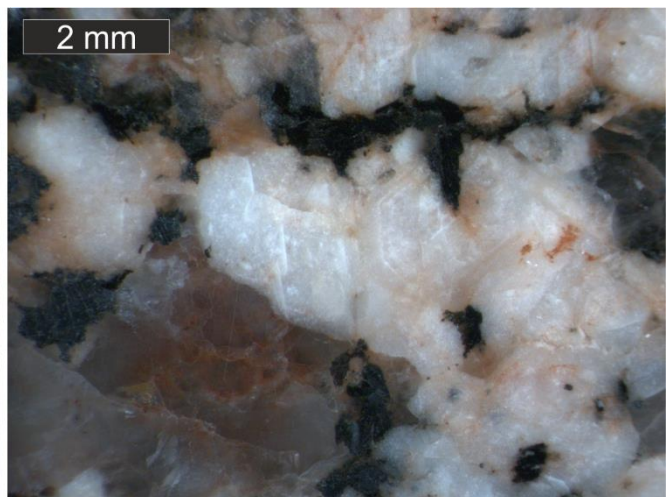
Figure 5.2. Stereomicroscope images of the cross-sections of the abrasives used in this study [Publication III].

Mineral abrasives have a marked role in the high-stress abrasive wear in mining and rock handling. In this study, four crushed rock materials were used as abrasives: chromite, quartzite, and two slightly different granites. The Sorila granite was earlier an 'in-house standard' rock material, but the properties of different batches were found to vary markedly. Thus, it was changed to Kuru granite, which has a finer and more homogenous microstructure. For simulating the conditions in a chromite mine, also chromite ore was used as an abrasive. Quartzite, in turn, was selected because of its high abrasivity and common use in wear testing. Fig 5.2 shows an example of the microstructure of the minerals, and Table 5.2 lists their composition and typical mechanical properties. The abrasivity and crushability values of the minerals were determined by the LCPC test at Metso Ltd [70]. In the LCPC tests, the reference steel was SSAB Laser 250C with a minimum yield strength of 250 MPa. Chromite is easily crushed, because the hard chromite particles are surrounded by silicates, as seen in Fig. 5.2. Therefore, the abrasivity value of chromite is relatively low despite its high hardness.

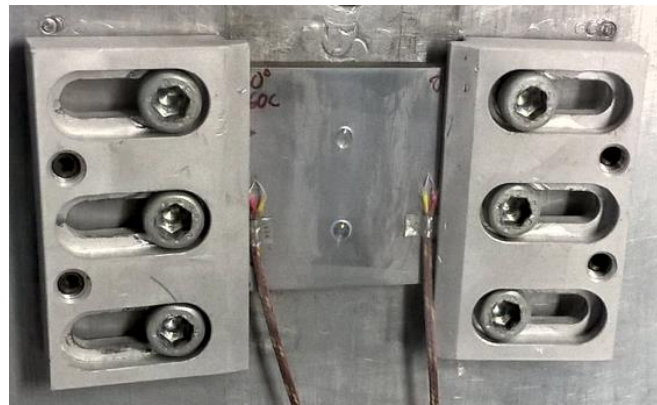
Figure 5.12. Two impact marks on the steel plate sample attached to the sample holder.

Fig. 5.12 shows how the polished $40 \times 40 \times 4$ mm samples were attached to the sample holder with steel clamps. The final polishing of the samples was made with $1 \mu\text{m}$ diamond paste. Two K-type thermocouples were spot-welded on them to measure the temperature of the sample surfaces. The attached samples were cooled inside an insulating box by nitrogen gas flowing through a heat exchanger immersed in liquid nitrogen. Two impacts were made on each specimen, as seen in Fig. 5.12. The samples were cooled a few degrees below the target temperature and kept there for a few minutes to even out the temperature before the actual test. The first cooling cycle from room

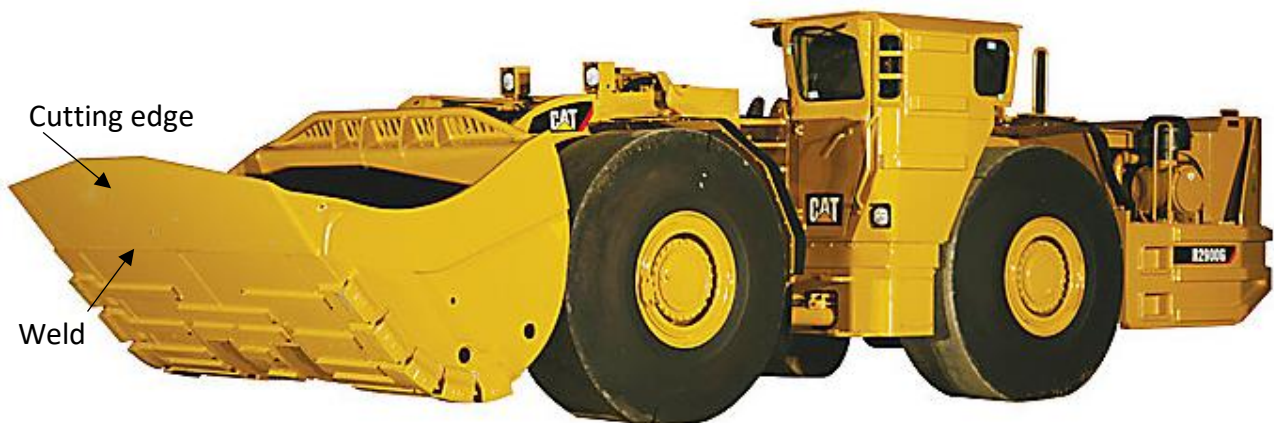
Figure 5.15. CAT R2900G underground mining load-haul-dump loader [119].

In the bucket of an underground mining load-haul-dumper (LHD), the cutting edge is exposed to very harsh conditions. In this thesis, two in-service cases were characterized and compared to the results of several different laboratory tests [Publications II & III]. Lapland University of Applied Sciences was responsible for the field testing in the Outokumpu Kemi chromite mine. In both cases, the cutting edge was welded to the bucket of the CAT R2900G LHD loader (Fig. 5.15.). The LHD loaders were used in a normal operation, and the cutting edges were measured with the ATOS 3D scanner when they were replaced. In recent years, the average changing interval of the cutting edges in the Kemi chromite mine has been 1014 hours. The loaders haul quarry gravel, including granite, chromite, barren rock, and slurry paste.

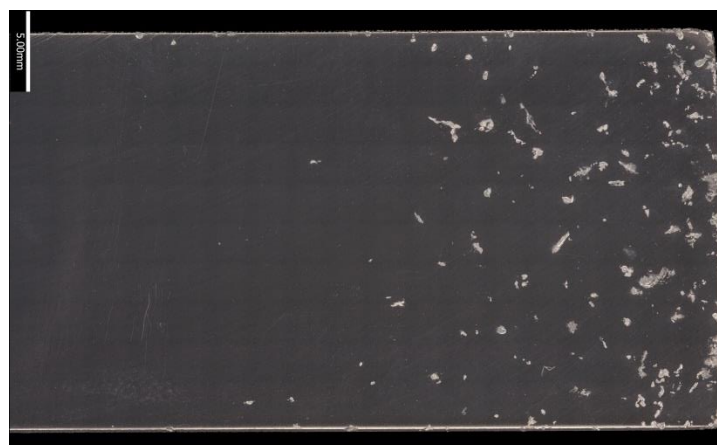
Figure 6.2. Optical profilometer image of a polished 400HB steel sample tested for two seconds with the impeller-tumbler. Scale bar is 5 mm.

In the impeller-tumbler tests, the samples are not in a uniform contact with the abrasive as in the other test methods. However, the true contact area in the impeller-tumbler tests is quite similar to that in the crushing pin-on-disc tests. The impact area in the impeller-tumbler tests was determined from the polished 400HB sample surface, which was tested for two seconds. In that time, about 2.2 % of the sample surface was subjected to impacts. When Fig. 6.2 is compared with Fig. 5.5, which gives a 2.1 % true contact area for a crushing pin-on-disc sample, it can be concluded that the contact conditions are similar enough to justify the comparison of the wear rates as mm/h. However, it should be noted that the impacts are concentrated on the tip of the impeller sample and not on the whole wear area as in the other methods used in this study.

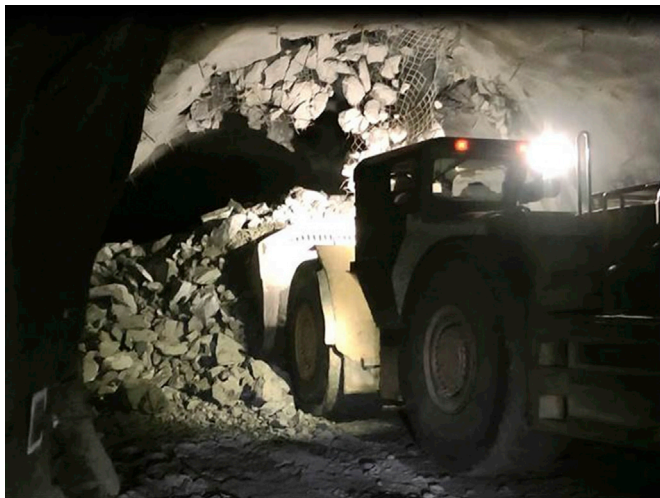
Fig. 4. CAT R2900G LHD working on typical size of rocks. For reference, the diameter of the LHD tires is about 2 m.

For the in-service testing, the cutting edge was constructed from R500HB and 550HB steels by submerged arc welding. The cutting edge was tested in CAT R2900G Underground Mining Load-Haul-Dumper (LHD), which is seen in operation in Fig. 4. For this dumper, the typical change interval of the cutting edge was about 1000 h.

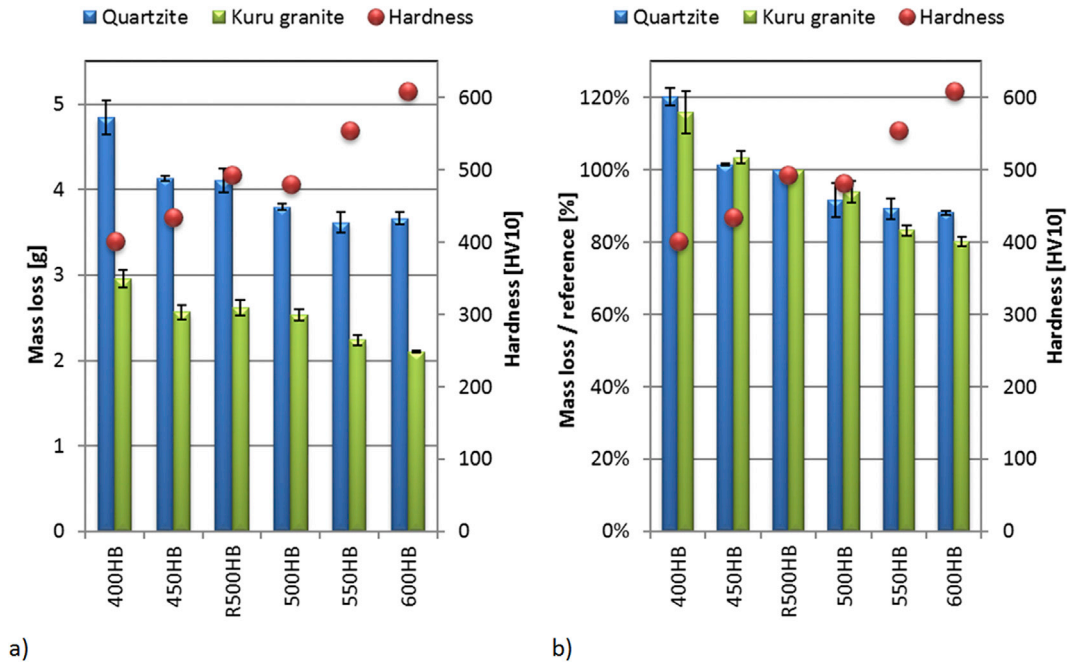
Fig. 8. Test results with quartzite and Kuru granite for 60 min at 500 rpm showing a) absolute average mass loss and b) mass loss relative to the wear of the R500HB reference sample. The error bars represent the standard deviation.
