**Durability Properties and Actual Deterioration of
Finnish Concrete Facades and Balconies**

Durability Properties and Actual Deterioration of Finnish Concrete Facades and Balconies

Thesis for the degree of Doctor of Science in Technology to be presented with due permission for public examination and criticism in Rakennustalo Building, Auditorium RG202, at Tampere University of Technology, on the 23rd of March 2012, at 12 noon.

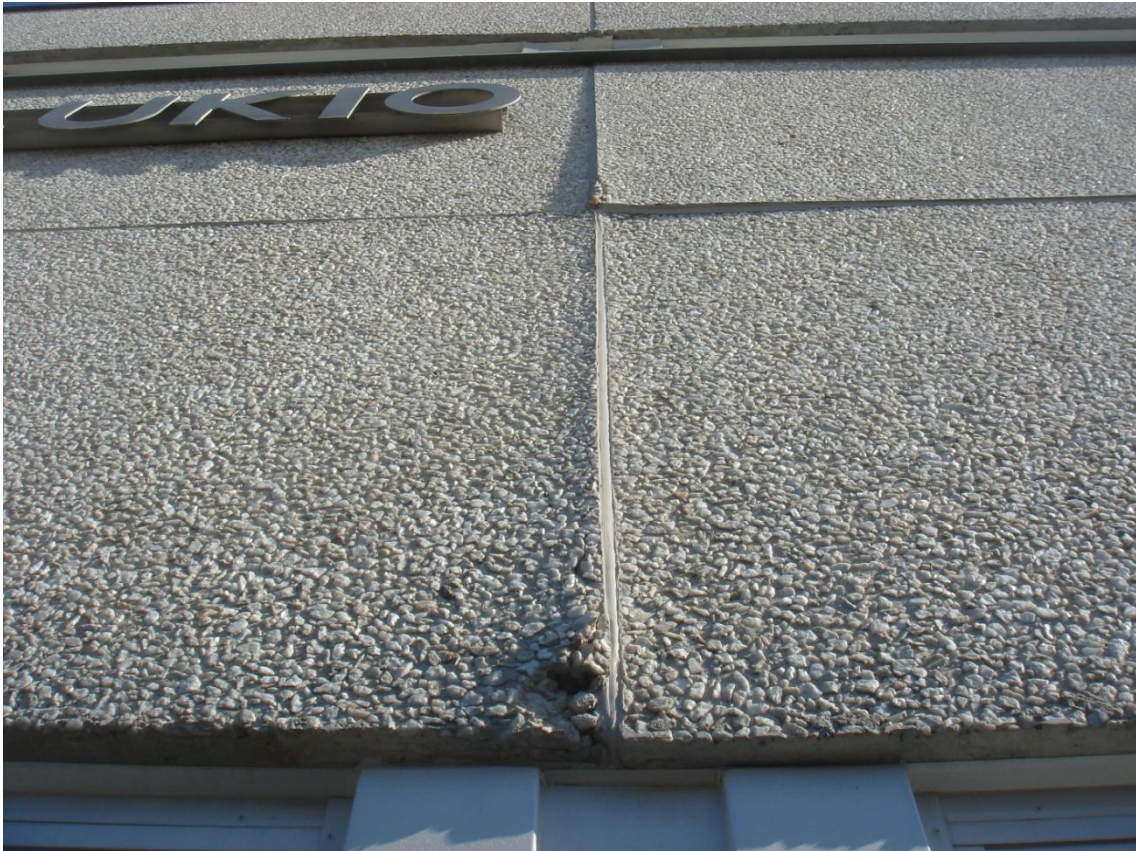
Fig. 2.2 Far advanced frost attack curls the edge of a facade panel.

Far advanced frost damage is manifested as reduced strength of concrete, loss of bonding, or crazing or chipping off of the surface. Disintegration of concrete also accelerates carbonation of concrete due to cracking and thereby also steel corrosion.

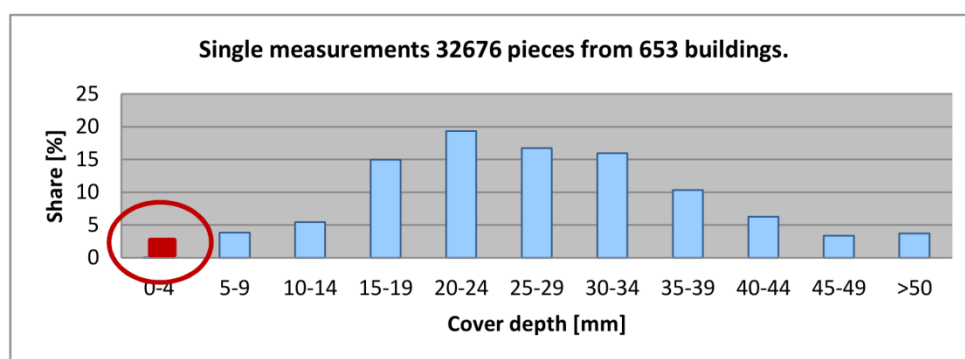
Fig. 4.3 Cover depth distribution of balcony side panel reinforcements of entire database. The red column depicts the estimated share of the smallest cover depths based on visible corrosion damage.

The reinforcement cover depth distribution is inaccurate in the 0-4 mm range since the depths are not measured for practical reasons. The red column in Figure 4.3 is an estimation of the share of the smallest cover depths of balcony side panels. The share of the smallest cover depths in the case of different panel types has been studied based on a total of 56 condition investigations conducted by TUT since an abundance of photo material related to them is available. Based on the study, the share of the smallest 0-4 mm cover depths is typically smaller in facade panels than that of 5-9 mm cover depths. The smallest cover depths of facade elements, according to the photos taken during condition investigations, occurred mostly at the edge bars. The share of the smallest 0-4 mm cover depths is greater in balcony structures than facade panels, but never larger than the share of 5-9 mm cover depths.

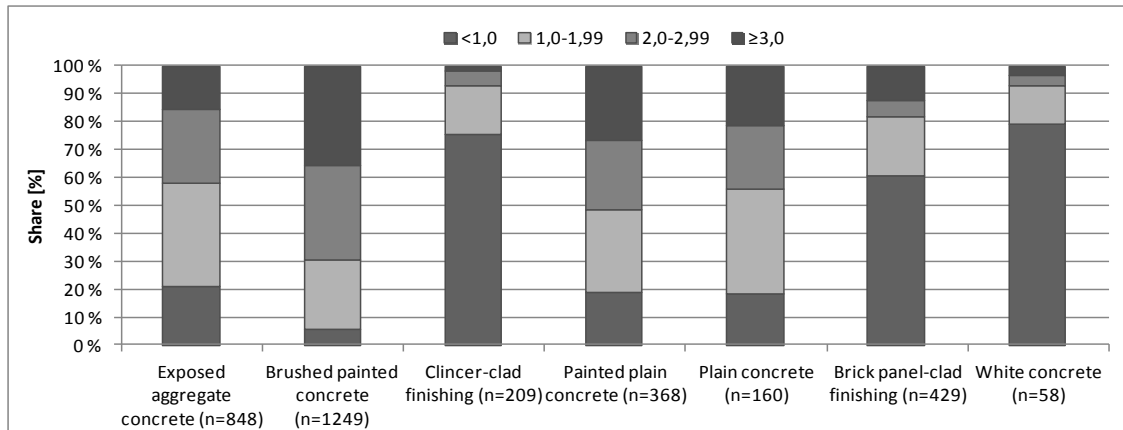
Fig. 5.3 Carbonation coefficients, k , of outer surfaces of facades by facade surface types.

Carbonation is clearly fastest in brushed and floated panels. Their facade surfaces have been treated while fresh. The carbonation rates of other facade surface types fall fairly evenly between the rate of the above-mentioned facade surface types.

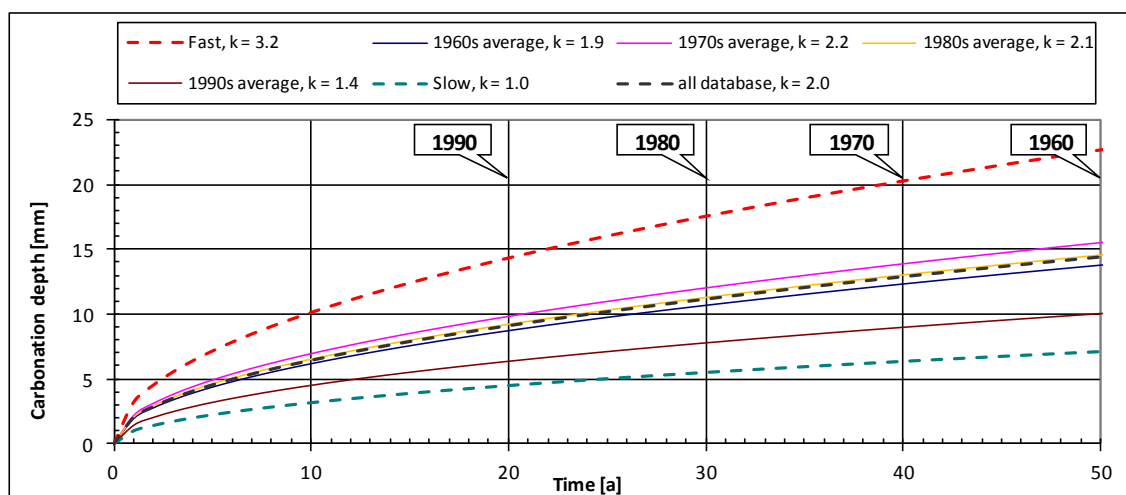
Fig. 5.7 Average carbonation of all balcony panels in various decades.

The average carbonation rate of the concrete of the panels of all balconies built in the 1980's is only slightly slower than that of balconies built in the 1960's and 1970's. The carbonation rate of 1990's balconies is clearly lower than in previous decades. The reason is the general raising of the compression grade of concrete for all panel types, which has made concretes denser and increased the content of cement, the carbonating ingredient. Another significant factor is the lower water-cement ratio of concrete as the workability of concrete has been improved by air-entraining agents and plasticisers contrary to the 1960's and 1970's when workability was normally improved by adding water.

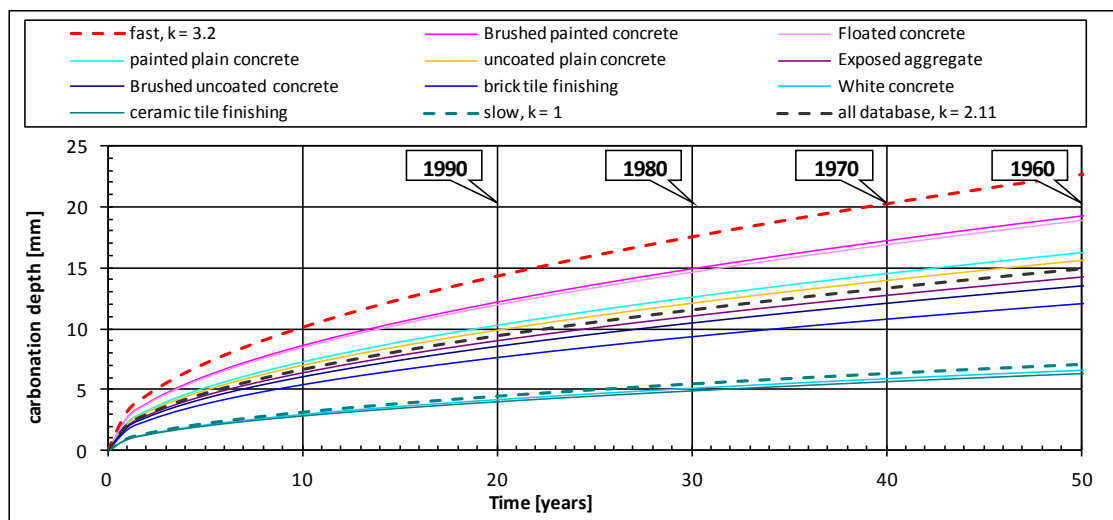
Fig. 5.8 Average carbonation depth of concrete according to surface finishing.

With the exception of white concrete and clinker-clad facades, carbonation has reached a depth of 5 mm in less than 10 years on average, and 10 mm in 20-30 years. The present average carbonation depth of a precast multi-storey residential building completed in 1970 is 11-20 mm depending on the facade surface type, see Fig. 5.8. In white concrete surfaced and clinker-clad panels carbonation has progressed only to a depth of about 7 mm. Thus, corrosion of steels closest to the surface has been possible in facades completed before 1980 for 20 years or longer.

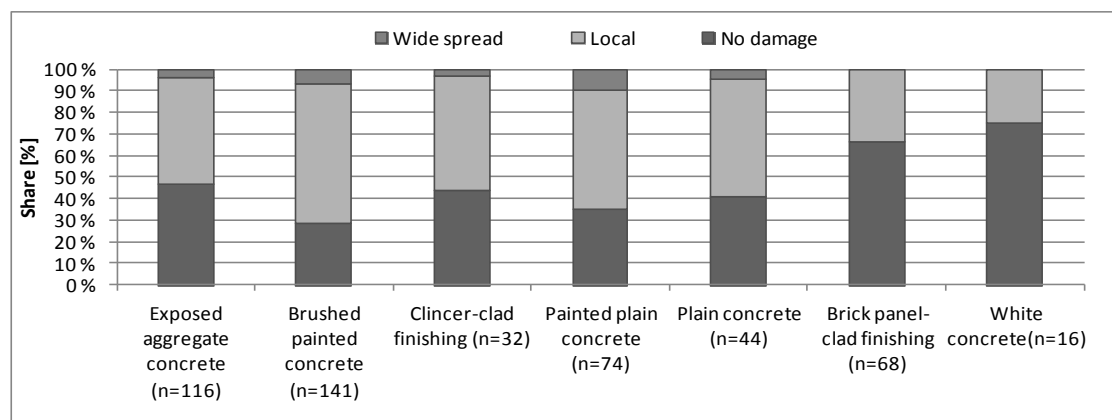
Fig. 5.9 Shares of visible corrosion damage by facade surface types, n= 491 buildings.

Most extensive corrosion damage to exposed aggregate and brushed painted panels occurs in the southern coastal areas. Similar correlation between damage in southern coastal areas and inland has not been observed with other facade surface types.

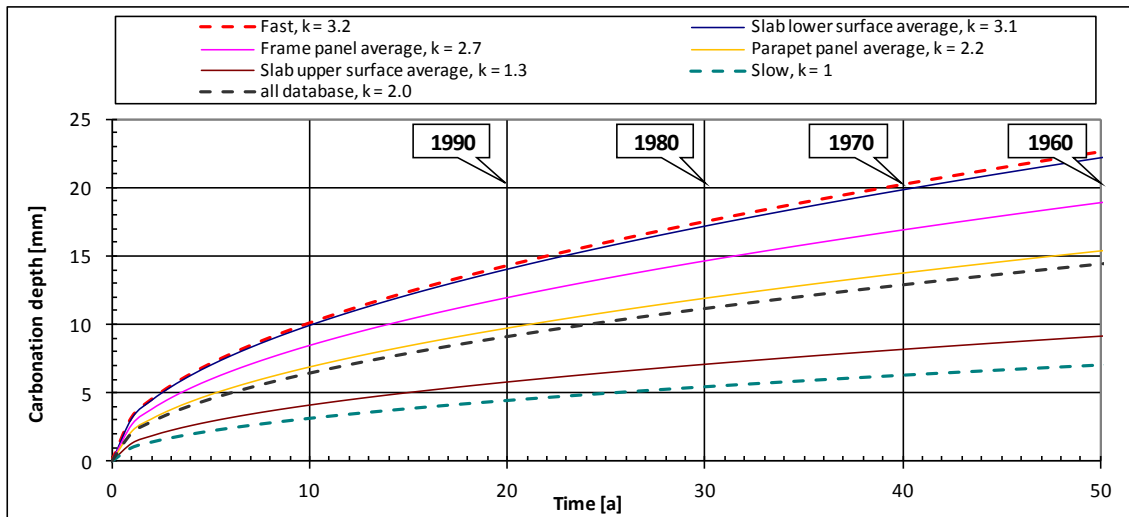
Fig. 5.10 Average carbonation depth of concrete of balcony panels.

The average carbonation rate of balcony elements is faster than that of facades. Carbonation has propagated to a depth of 5 mm in less than six years on average, and to 10 mm in about 15-22 years. Carbonation advances significantly faster in the soffit of balcony slabs than its side and parapet panels. Presently, the carbonation of the soffit of a balcony slab manufactured in 1970 has progressed on average to a depth of about 20 mm, and that of a slab manufactured in 1980 to a depth of about 15 mm, see Fig. 5.10. Reinforcement corrosion has thus been possible in a quite significant portion of the soffit reinforcements of balcony slabs manufactured before 1980. Carbonation of side panels and parapets of the same age has also propagated quite deep subjecting a significant portion of the reinforcements to corrosion.

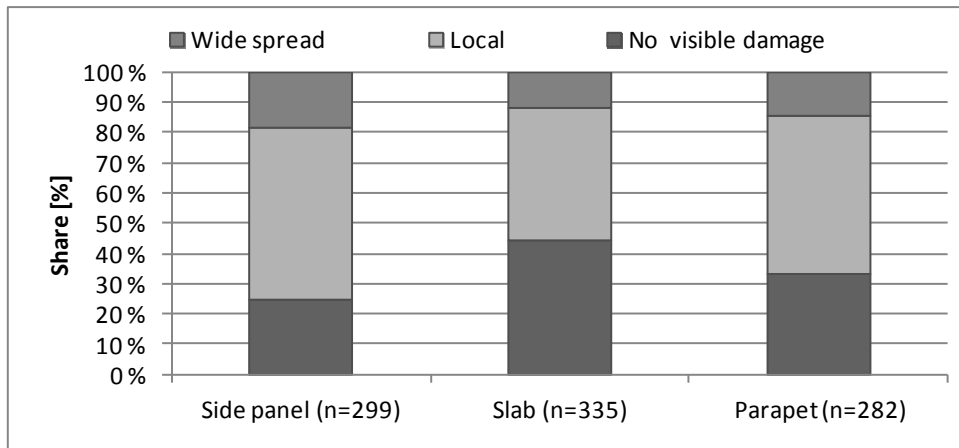
Fig. 5.11 Share of visible corrosion damage in different balcony elements.

Extensive and local visible corrosion damage occurs mostly in balcony side panels, 76% of whose edge bars generally show some degree of corrosion damage. The share of reinforcements at under 5 mm depth in parapet panels is 1.5% on the outer surface, which is nearly three times the reinforcements of side panels at corresponding depth. Yet, no visible corrosion damage has been detected in 33% of the buildings, and the share of extensive corrosion damage in parapet panels is smaller than in side panels. The concrete of balcony parapets appears to be of a higher grade: the average carbonation rate of parapet panels is lower and the share of capillary pores smaller than in side panels.

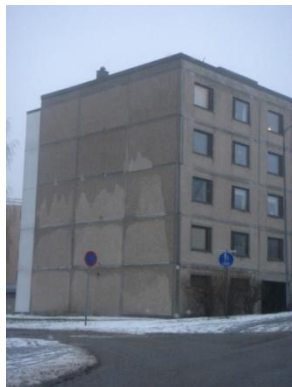
Fig. 5.15 End of a concrete building at the beginning of a rain event. The upper sections receive more rain than the lower ones.

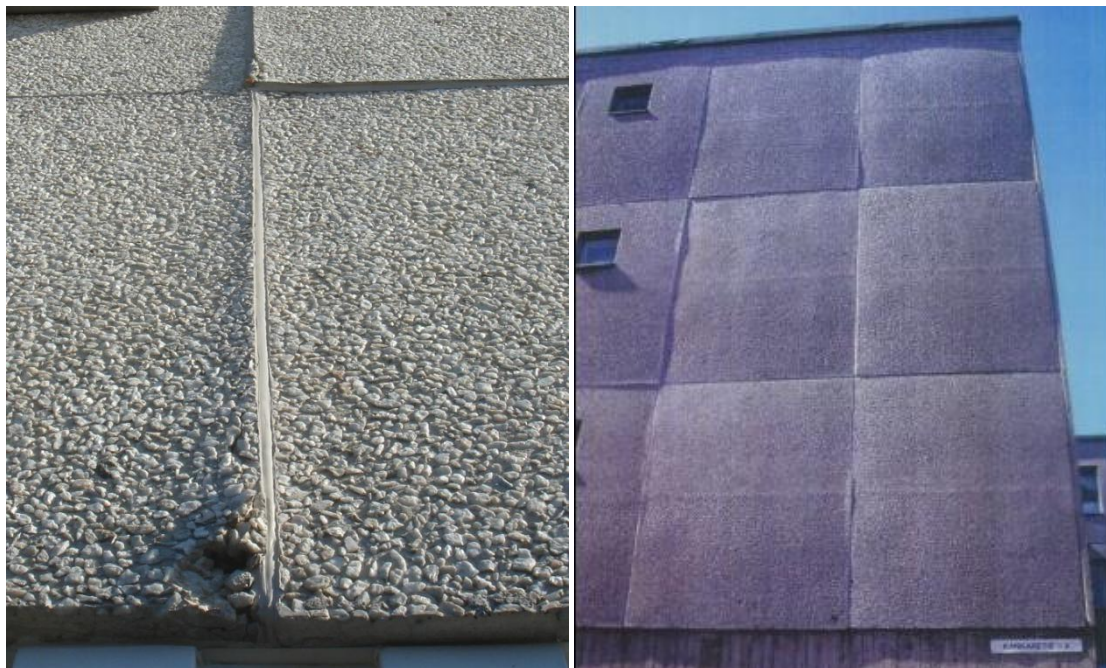
Fig. 5.24 On the left, local frost damage at the edge of an exposed aggregate concrete panel. On the right, far advanced and wide spread frost damage to exposed aggregate concrete panels.

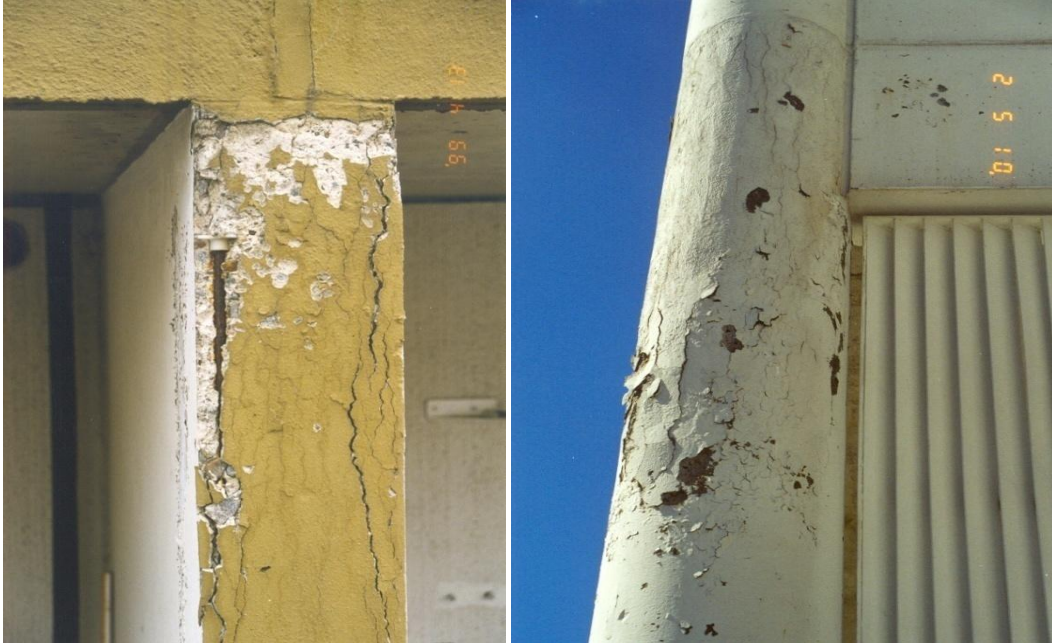
Fig. 5.26 On the left, local frost damage in the front edge of a balcony side panel. On the right, far advanced and extensive frost damage in balcony column. Both are load-bearing structures.

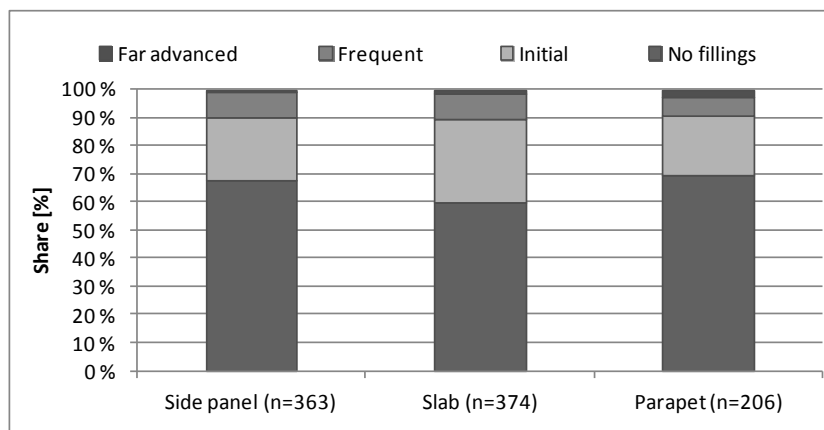
Fig. 5.37 Degree of pore filling of different balcony panel types.
