**Propagation of Carbonation Induced Reinforcement
Corrosion in Existing Concrete Facades Exposed to the
Finnish Climate**

Tampereen teknillinen yliopisto. Julkaisu 1399
Tampere University of Technology. Publication 1399

Thesis for the degree of Doctor of Science in Technology to be presented with due permission for public examination and criticism in Rakennustalo Building, Auditorium RG202, at Tampere University of Technology, on the 16th of September 2016, at 12 noon.

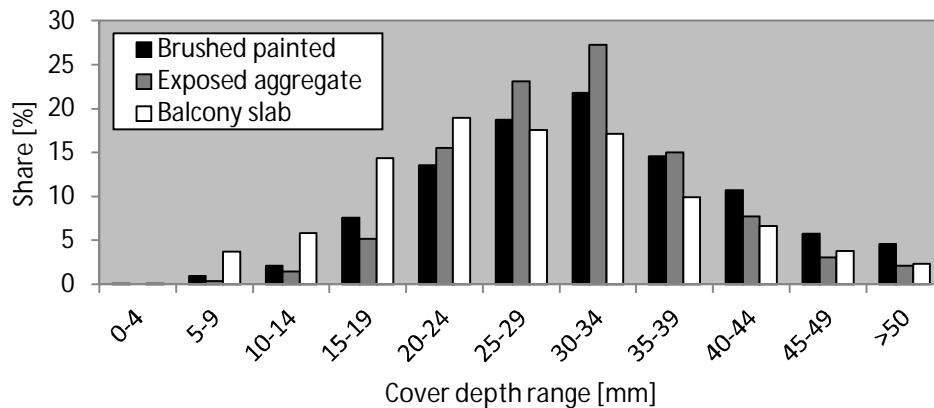
Figure 1.1 The realized scatter of reinforcement cover depths in different concrete surfaces manufactured in 1965–1989. Number of measurements is for brushed painted facade 60 640, Exposed aggregate concrete 104 958 and for the balcony slab 12 957.

However, there is significant variation in the scatter of the actual cover depths (Fig. 1.1) in existing concrete facade panels and balcony structures (Lahdensivu 2012), and this poses a risk for the durability of the buildings, as other reinforced concrete structures have shown similar problems (Lollini et al. 2012). The scatter in facade and balcony panels has mainly been caused by the poor manufacturing techniques used for these panels, e.g. lack of spacers or workers walking on top of the panels during the casting of concrete (Hytönen and Seppänen 2009). Differences between different facade surfaces have also arisen from the casting direction, which can vary from face-up (brushed surface, good cover) to face-down (exposed aggregate and form surface, bad cover) (Pentti et al 1998).

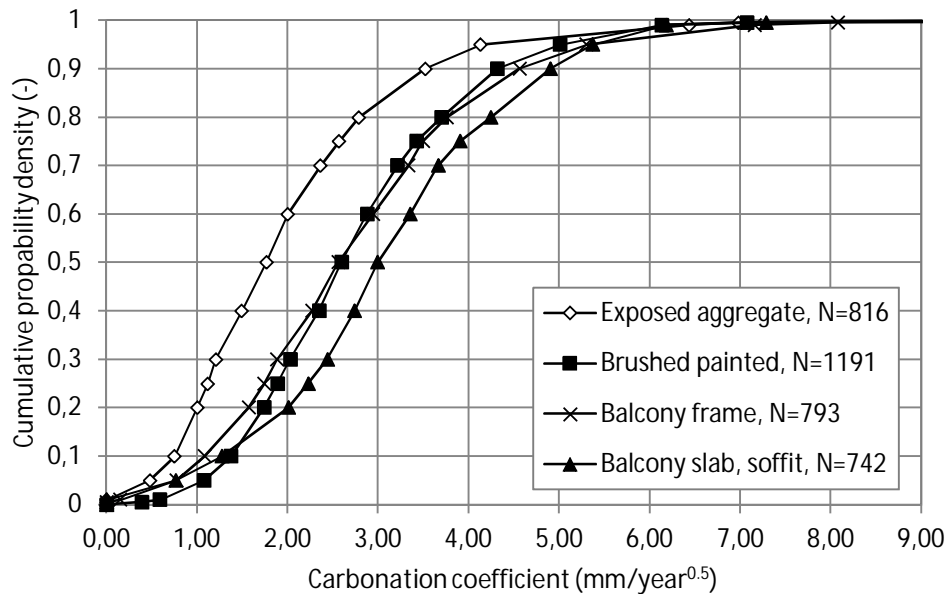
Figure 1.2 The carbonation resistance presented as the carbonation coefficient of different existing concrete facades and balcony structures manufactured in 1965–1989

exceed this value (average level of approx. $2.0 \text{ mm/year}^{0.5}$) which indicates that fast carbonation can be expected in these structures (Fig. 1.2).

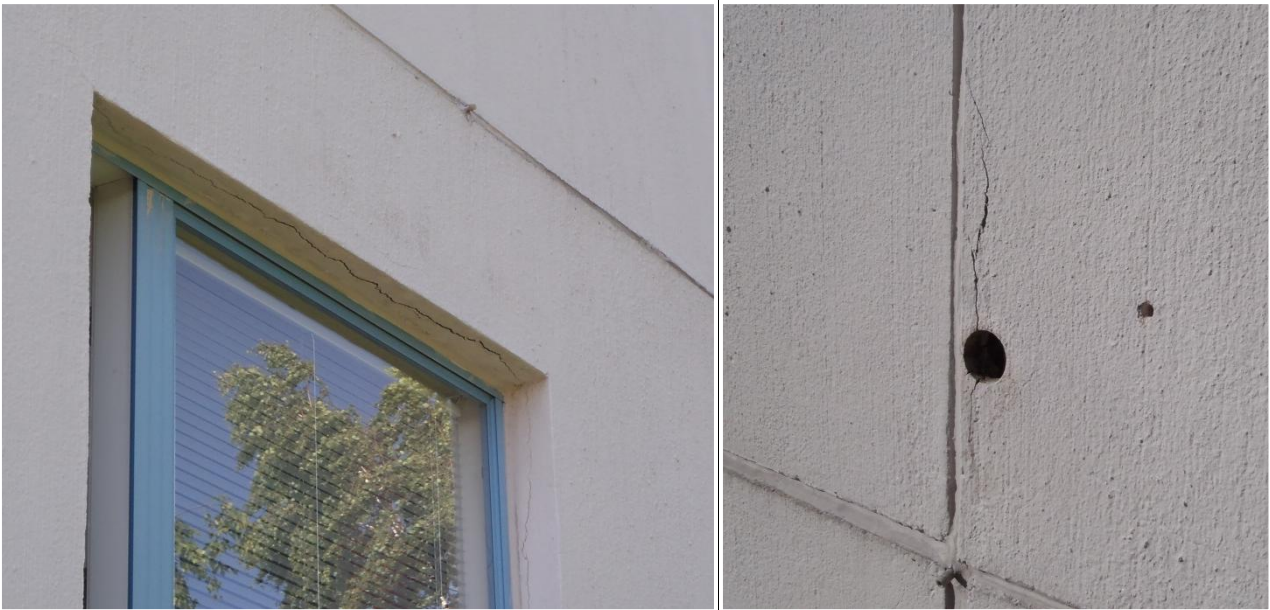
Figure 1.3 Typical corrosion damage on concrete facades

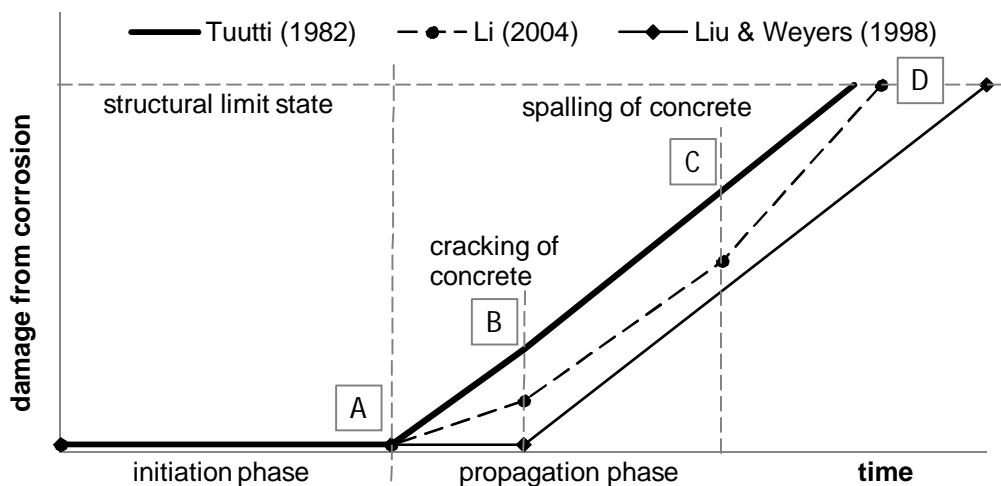
Figure 1.4 The model of reinforcement corrosion usually utilizes the principle of initiation and propagation phases.

other factors can be used to determine the end of the structure's service life, such as concrete cracking and/or spalling (points B and C in Fig. 1.4), critical deflection or collapse (point D in Fig. 1.4) (Li 2004).

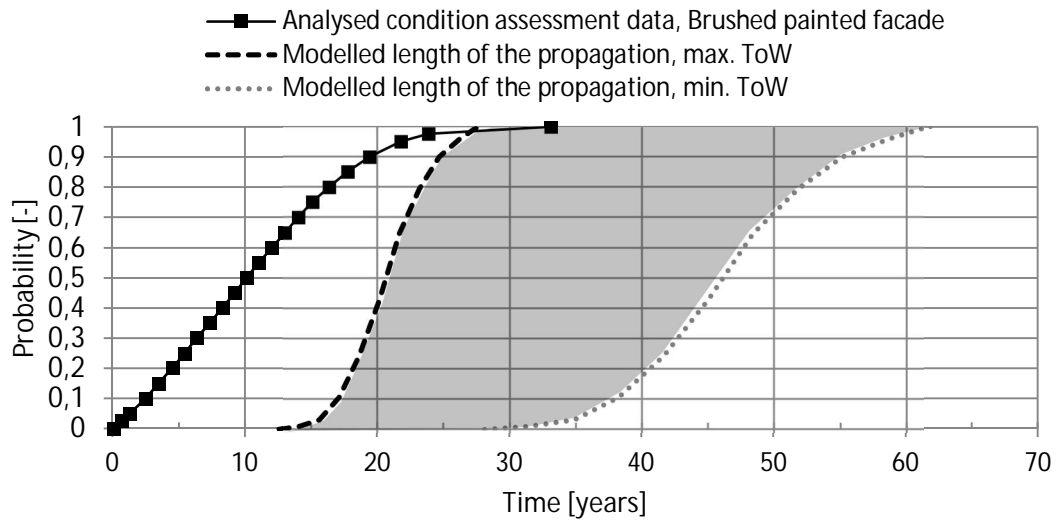
Figure 1.5 The sensitivity of the predicted corrosion propagation phase to time of wetness (ToW) of 0.17-0.43 by the DuraCrete model

A parametric analysis was conducted (Article II) on the time of wetness and concrete resistivity which describe the environment and material quality in the DuraCrete model. Values for the parameters were varied in a range expected in the Finnish climate, and a significant influence of these parameters on the model was revealed (Figs. 1.5 and 1.6). Climate data was used to determine the time of wetness (between 0.17 and 0.43) and the concrete's resistivity was varied between 50 Ωm and 200 Ωm . The influence of time of wetness and the resistivity of the concrete can multiply the service life prediction 2 and 4 times, respectively. The climate-related temperature and time of wetness can easily be induced from statistical parameters, so their scatter can be quantified with meteorological data. In this analysis, the choice of the concrete resistivity parameter had a very substantial influence on the model's results.

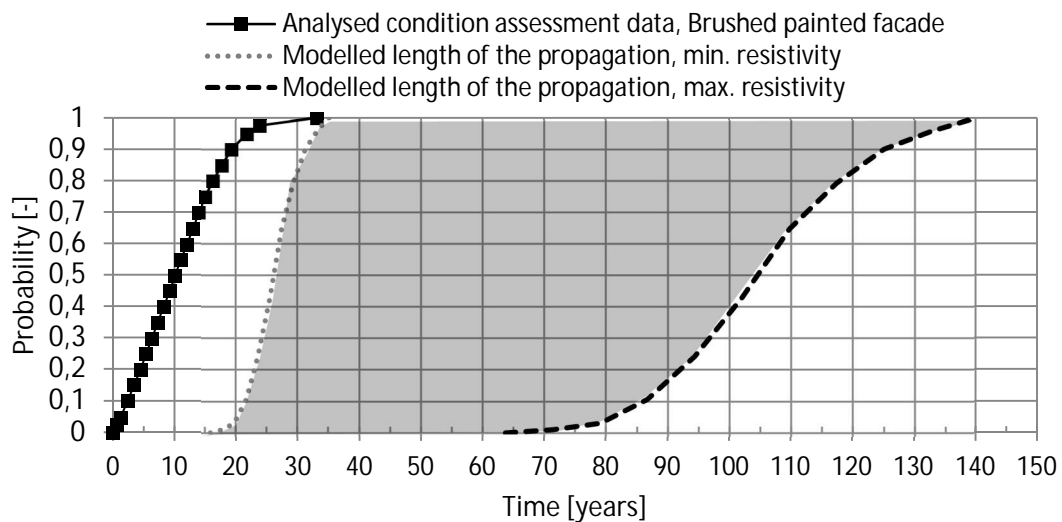
Figure 1.6 The sensitivity of the predicted corrosion propagation phase to concrete resistivity of 50-200 Ωm by the DuraCrete model

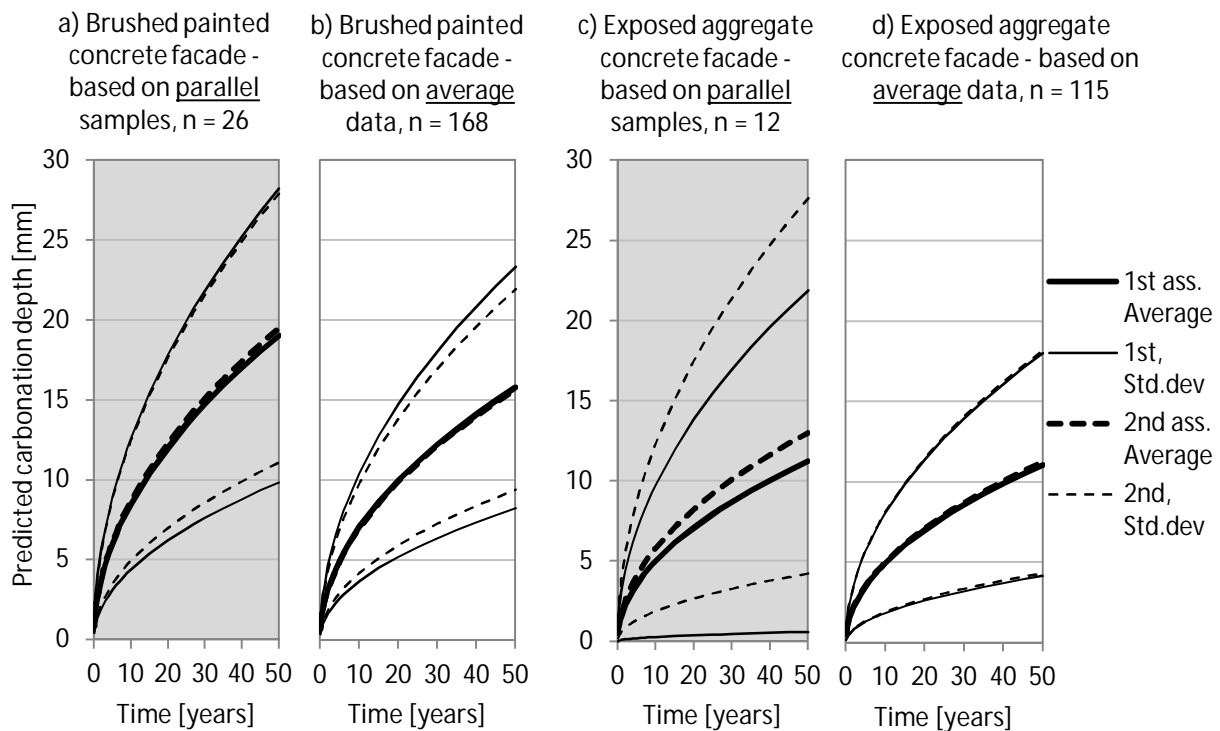
Figure 4.6 Carbonation of brushed and painted and exposed aggregate concrete facades modelled by parallel samples or by average data

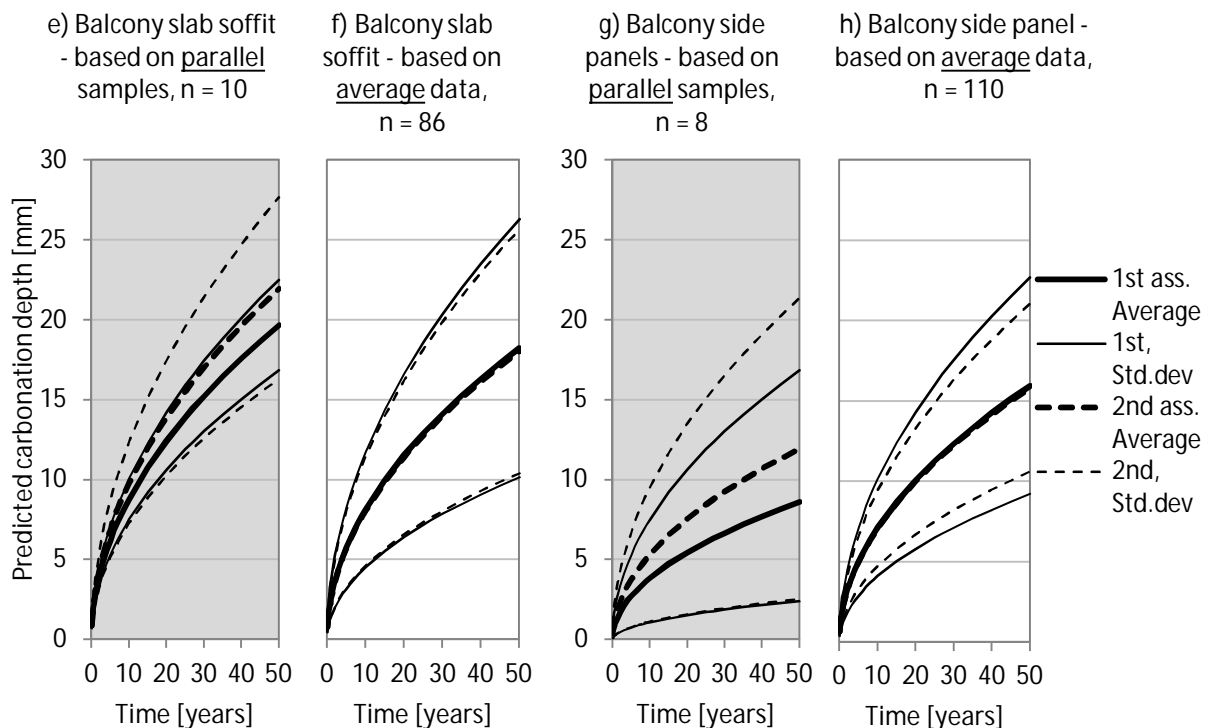
Figure 4.7 Carbonation of balcony side panels and slab soffits modelled by parallel samples or by average data

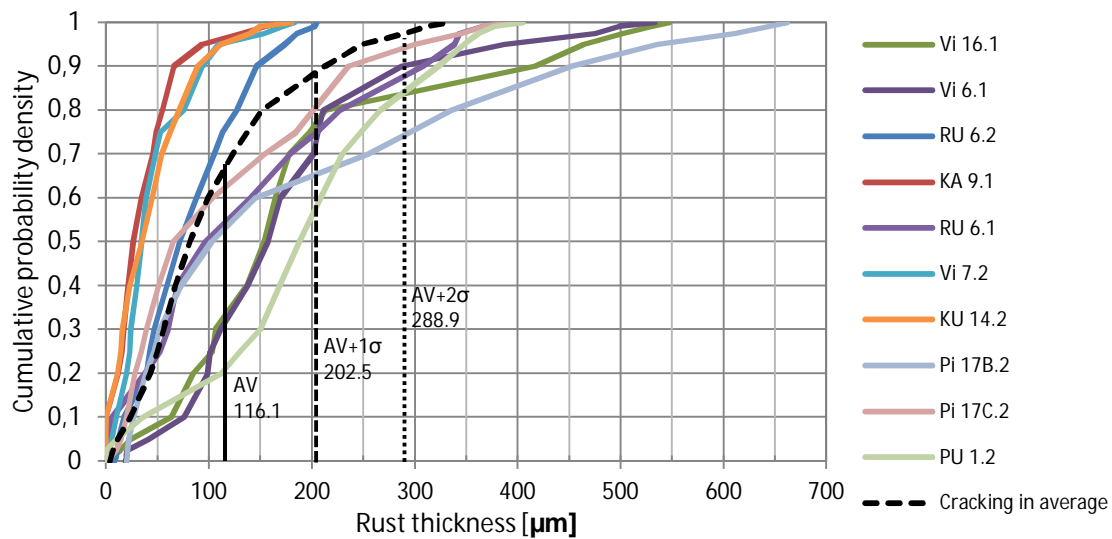
Figure 4.10 Measured rust layer thicknesses on reinforcement samples that have caused cracking of concrete cover (Average-curve, min = 4 µm, average = 116 µm, max = 332 µm)

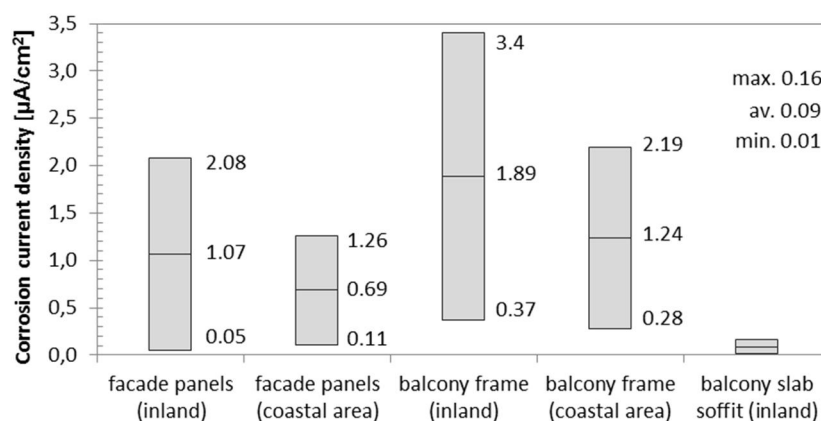
Figure 4.11 Monthly average corrosion current densities recorded in field measurements in an inland area and a coastal area in Finland

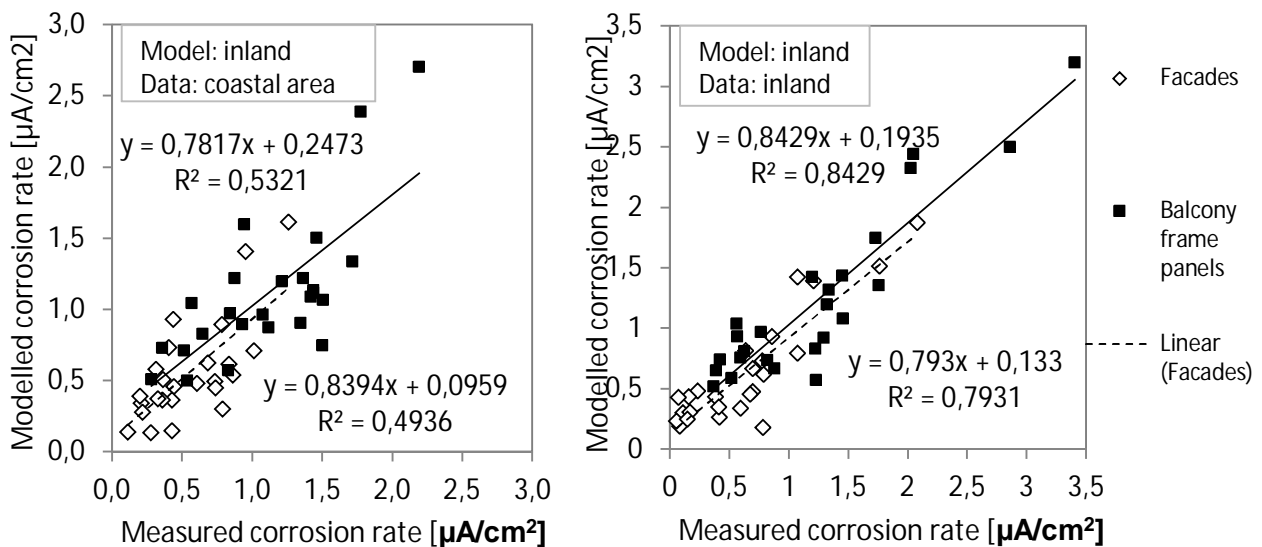
Figure 4.13 The correlation between the model generated from the inland data and the measured corrosion rate in both the inland and the coastal area

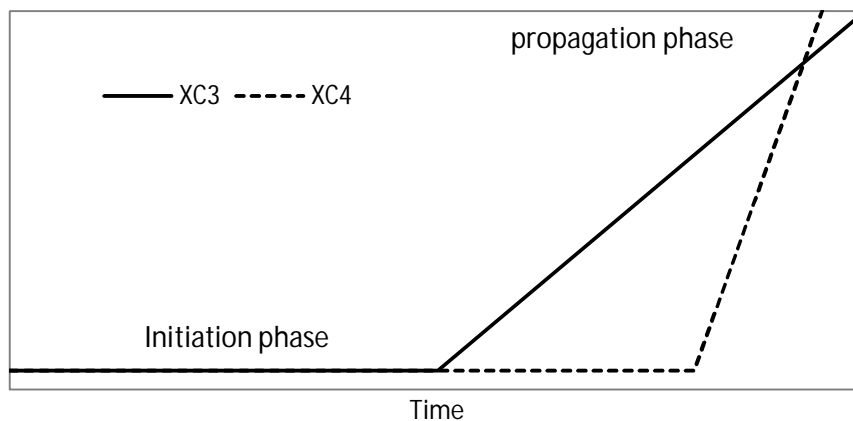
Figure 4.14 The relationship between XC3 and XC4 exposure classes in regard of initiation and propagation phases of corrosion (schematic)

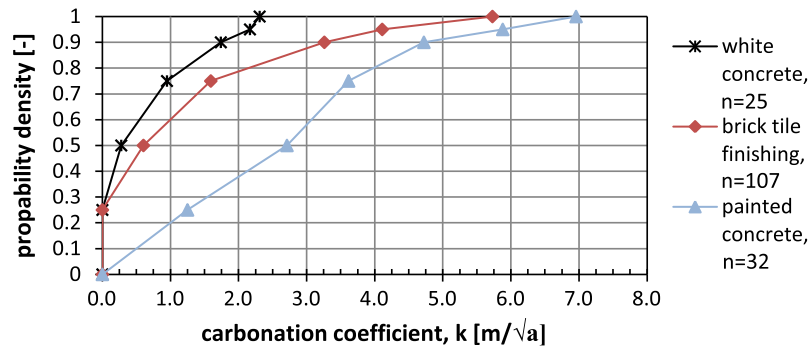
Fig. 5. Carbonation coefficients as cumulative graphs determined in facade condition assessments of buildings built in 1990–1995.

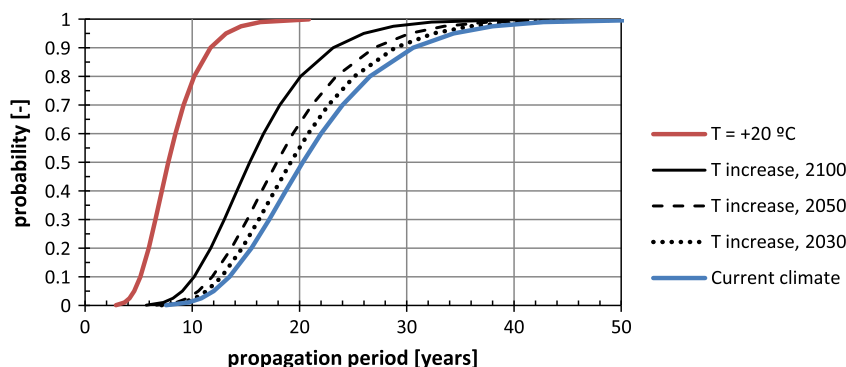
Fig. 13. The effect of increase in temperature on active corrosion of reinforcement in carbonated concrete according to fib 34 [41].

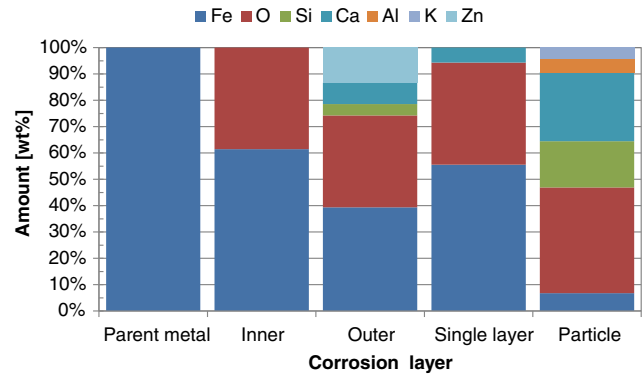
Fig. 6. The element composition (wt%) of different rust layers on corroded reinforcing steel samples. (Only elements > 5 wt%).

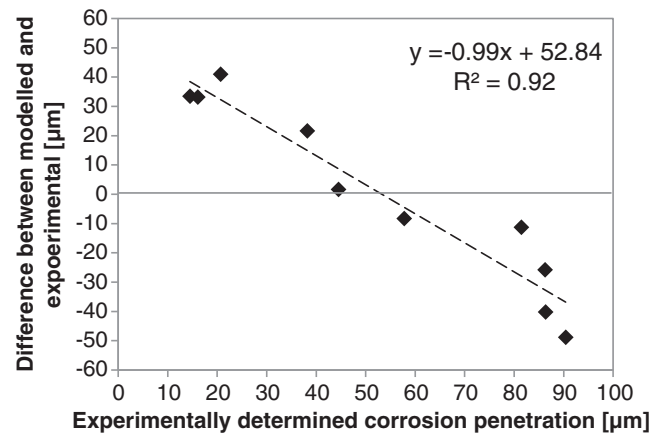
Fig. 10. The difference (error) caused by the Eq. (1) calculation compared to experimentally determined corrosion penetration.
