# Full-scale embankment failure test under simulated train loading

A full-scale embankment failure experiment was conducted in 2009 in Perniö, Finland. A small, extensively instrumented railway embankment on a soft clay foundation was brought to failure by loading over a period of 30 h. Instrumentation consisted of over 300 different measurement points, including 37 piezometers and nine automatically monitored inclinometer tubes. The relatively rapid loading simulated a heavy train coming to a standstill on the embankment. The primary purpose of the experiment was to gather field data of a failure caused by a rapidly applied load, with an emphasis on the pore pressure response in the clay foundation layer. The test was also used to assess the suitability of various instruments for real-time stability monitoring. The embankment failure was an asymmetric bearing capacity mechanism that is hypothesised to have been triggered by an undrained creep rupture. During the last 2 h of the experiment, pore pressure and displacements increased at an accelerating rate while the external load was kept constant. The time-dependency of the pore pressure and displacement responses was a key factor

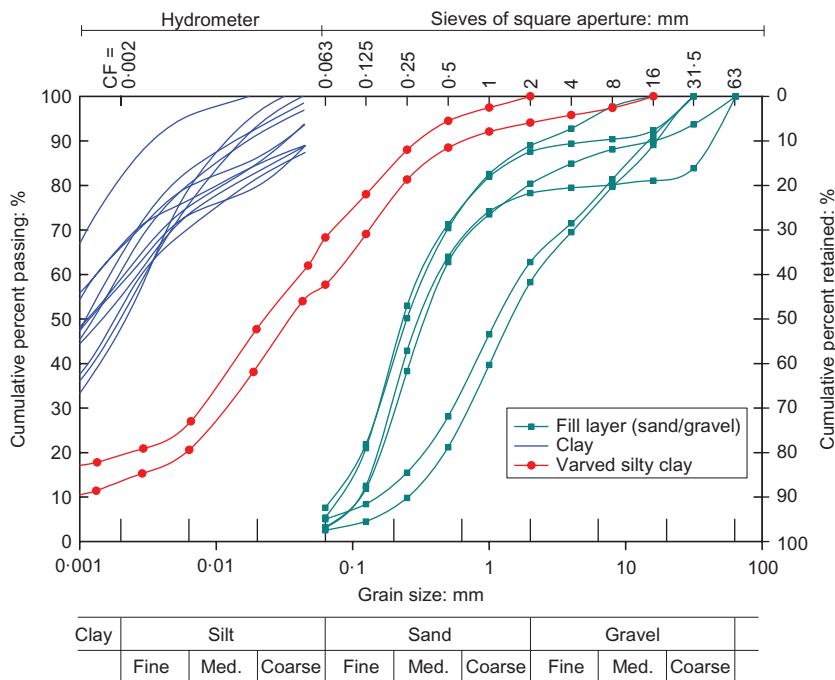
Fig. 4. Grain size analysis test results for Perniö soils

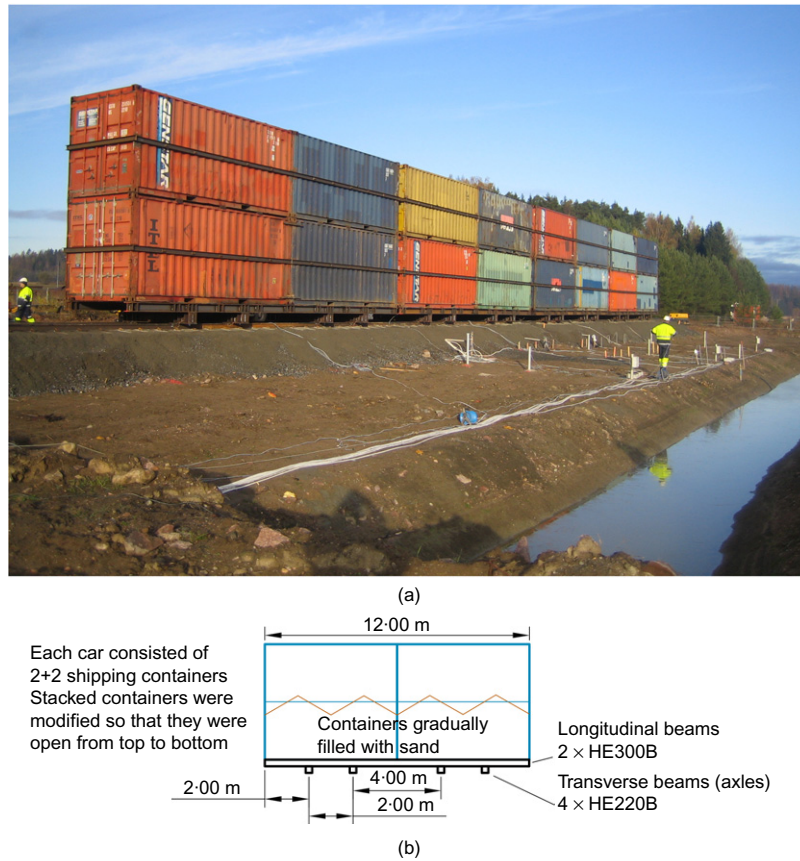
Fig. 7. (a) Test site and containers before loading; (b) container layout used to simulate train car loading pattern

A train coming to a standstill on the embankment was simulated by gradually filling modified shipping containers with sand. The containers rested on four steel frameworks that simulated four typical 12 m long two-bogey rail cars (Fig. 7). Each car had a stack of 2 + 2 containers. The tops of all containers and floors of the top containers were removed so as to be able to fill them without having to add the top row during the test. The frameworks distributed the load to the embankment by way of I-beams resting on the tracks. The

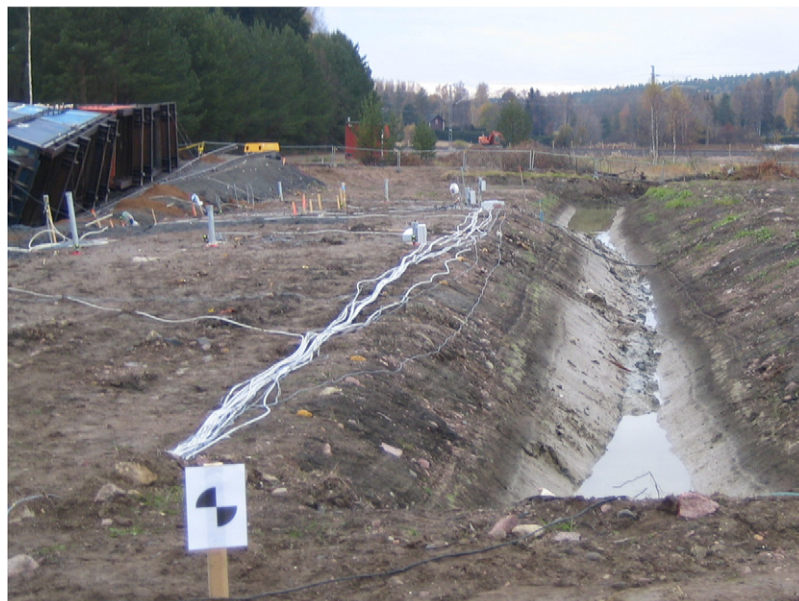
Fig. 10. Post-failure photograph of the embankment failure area at the Perniö test site

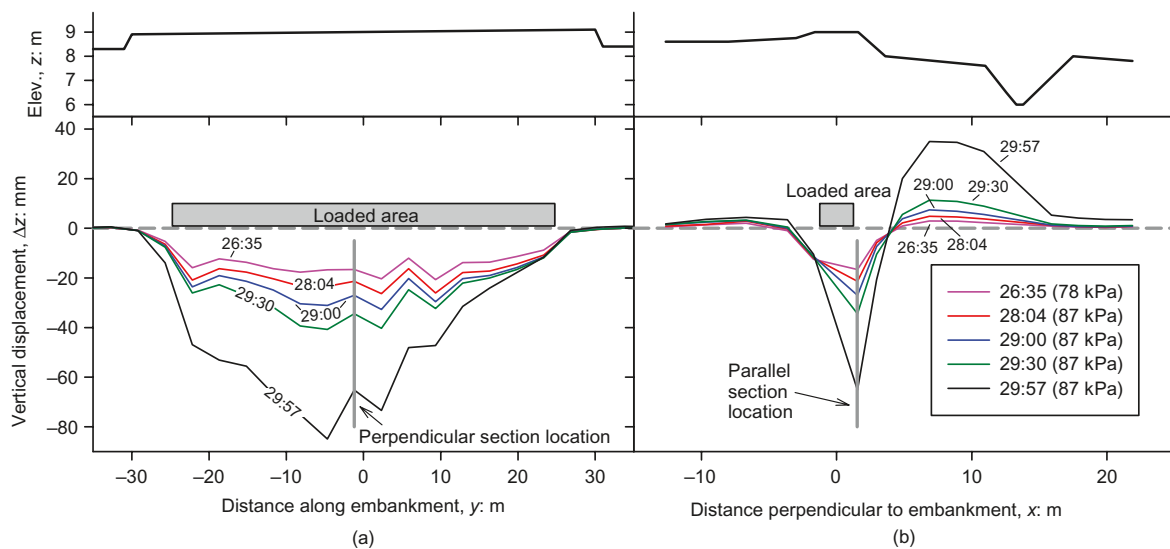
Fig. 14. Vertical displacement measurements at the ground surface: (a) along embankment crest; (b) perpendicular to embankment along section A–A

The vertical displacement response along the embankment centreline exhibited a fairly uniform and consistent trend (Fig. 14(a)), yielding a 'bowl-shaped' depression as movement occurred. Perpendicular to the embankment, the magnitude and direction of the measured vertical displacements were highly dependent on the distance from the embankment (Fig. 14(b)). The embankment exhibited displacement downwards under the load area, while a significant portion of the area between the embankment and the ditch moved upwards. The largest pre-failure settlements ( $-85$  mm) were observed at the embankment crest close to the centre cross-section (Fig. 14(a)). The largest upward displacements ( $+35$  mm) occurred close to halfway between the embankment and the ditch, approximately 7 m away from the embankment centreline (Fig. 14(b)). At the embankment toe vertical displacements were very small, which is a result of the particular failure geometry that occurred.

As shown in Fig. 11, Fig. 13 and Fig. 14, horizontal and vertical displacements continued to occur at a constant load level (87 kPa) past  $t=28:00$ , increasing at an accelerating rate until failure. Data from inclinometers and total station measurements indicated that during loading and prior to failure the soil mass between the embankment and the ditch moved so that lateral displacements on the ground surface (not shown here) were fairly uniform regardless of the distance from the embankment.
