## Suspended timber ground floors: measured heat loss compared with models

S. Pelsmakers, B. Croxford & C.A. Elwell

To cite this article: S. Pelsmakers, B. Croxford & C.A. Elwell (2019) Suspended timber ground floors: measured heat loss compared with models, Building Research & Information, 47:2, 127-140, DOI: [10.1080/09613218.2017.1331315](https://doi.org/10.1080/09613218.2017.1331315)

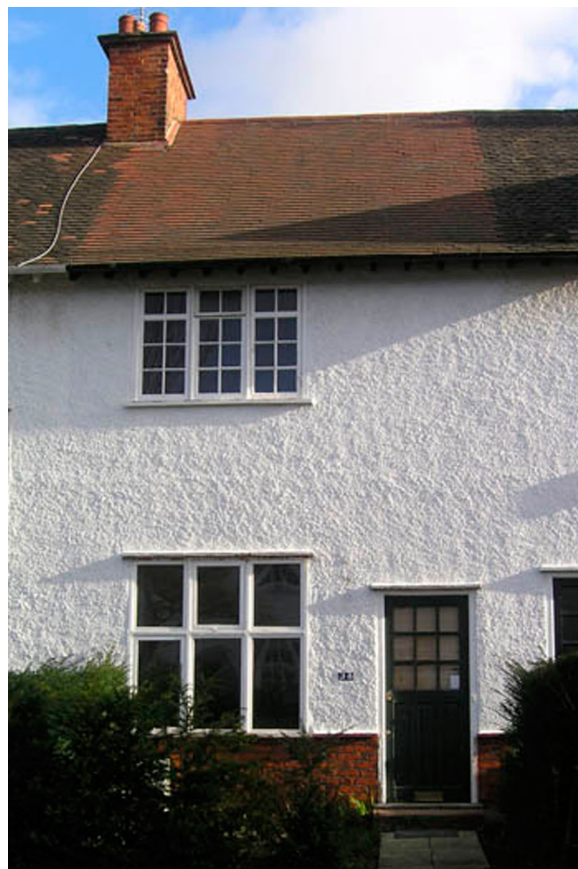
**Figure 1.** The case study house in the Brentham Estate conservation area, front facade.

*Note:* The wide hedge on the left-hand side is also partially sheltering an airbrick.

The case study house was a 1910 solid-wall, two-bedroom terraced house located in the conservation area of the Brentham Estate (Garden Suburb) in Ealing, west London (Figure 1). It was unoccupied during the duration of the 13-day study conducted in January 2014. Its front facade is west facing; the 12.15 m<sup>2</sup> living room floor (44% of the total ground floor area) had bare floorboards with three exposed airbricks located in the void between joists, allowing some airflow movement between floor sections (Figure 2). One airbrick (near sensor location 1) was sheltered by a hedge. On average the living room floor void was 250 mm deep below the 100 mm joists and was divided in four void sections by three sleeper walls (Figure 3). The ground surface of the floor void consisted of up to 150 mm concrete oversite underneath dust and rubble, ascertained from a site survey by drilling into the ground. Case

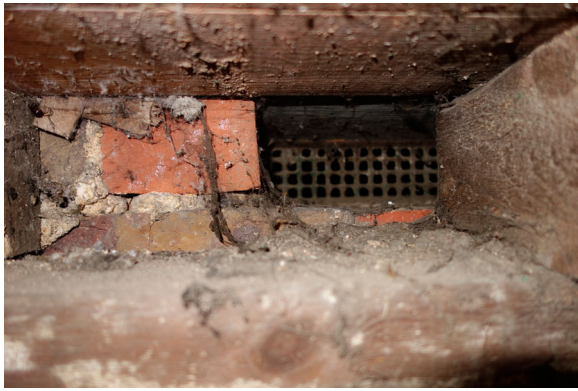
**Figure 2.** An airbrick in between the joists.

study floor characteristics are listed in [Table 1](#). Two airbricks on the back facade, below a different room, were partially protected by a greenhouse lean-to structure and services. The living room floor void was isolated from the floor voids elsewhere. Only the living room

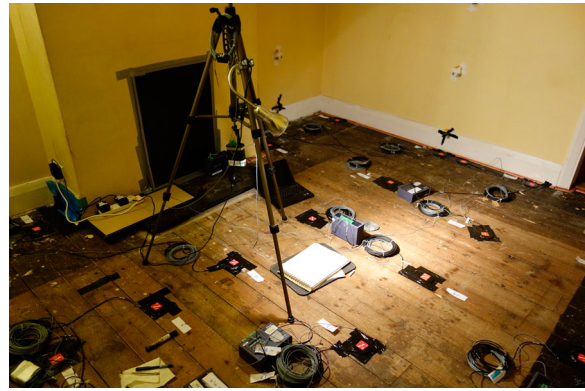
**Figure 4.** Instrumentation set-up on the bare floorboard surface of the case-study house.

The active sensing part of the heat-flux sensors (30 mm in the middle of the 80-mm sensor) was kept

free from any tape or instruments; sensor placement was undertaken with the use of infrared images and fixed with a thin layer of Servisol heat-sink compound (thermal conductivity = 0.9 Wm<sup>-1</sup> K<sup>-1</sup>; Farnell, 2014) and black duct tape (to best match the dark brown floorboard's colour and emissivity) along the edges and the first 100 mm of the lead. Sensors were connected to Eltek Remote Sensor GENII data loggers or Squirrel 451 L or 851 L data loggers and were downloaded at regular intervals to avoid data loss. Direct solar gain on all instruments was avoided by closing a white reflective window blind at all times. All measurements were taken at five-minute sequential intervals and for  $U$ -value estimation were analysed at daily intervals.
