Detecting Moisture and Mould Damage in Finnish Public Buildings

ACADEMIC DISSERTATION

ACADEMIC DISSERTATION
Tampere University, Faculty of Built Environment
Finland

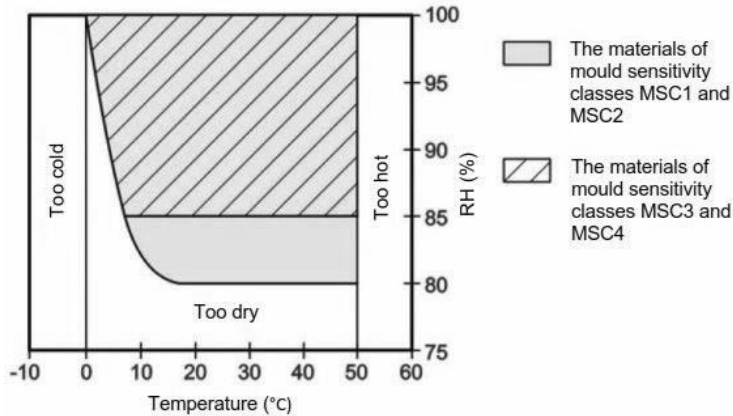
Figure 16. Finnish mould growth model: favourable relative humidity and temperature conditions for mould growth in different mould sensitivity classes (Building Physics Research Group, 2020).

Figure 16 presents the main data from the Finnish mould growth model (Building Physics Research Group, 2020). At typical Finnish indoor air temperatures (about +21 °C), mould growth starts in sensitivity classes MSC1 and MSC2 when relative humidity is over 80%. In sensitivity classes MSC3 and MSC4, mould growth starts when relative humidity is over 85%. However, mould growth is highly dependent on the length of time during which relative humidity exceeds these limits and also on how much these limits are exceeded.

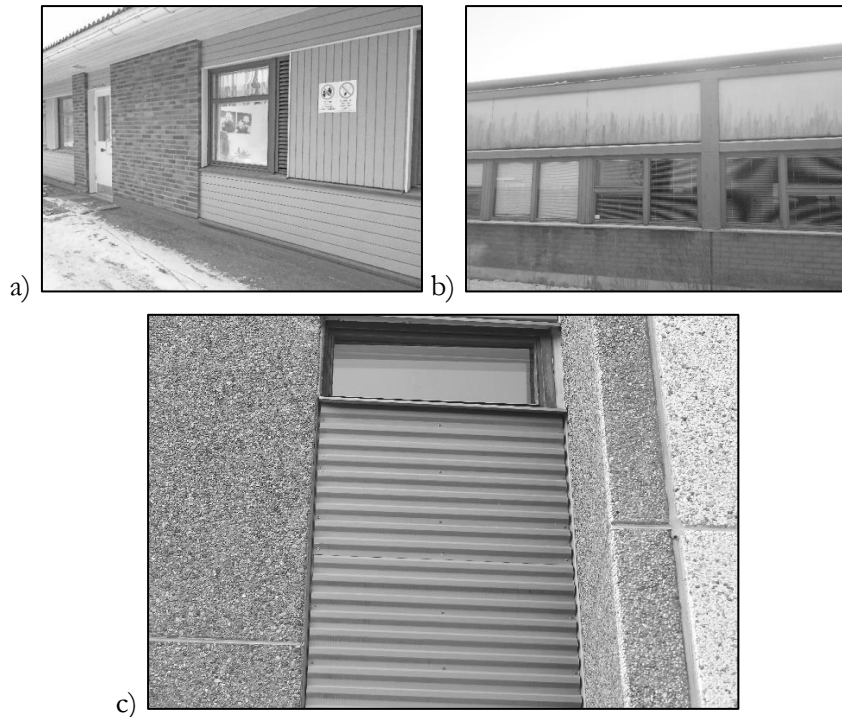
Figure 21. It is very common for façade material to vary in Finnish public buildings, especially around the windows. These examples include changes between a) masonry and wooden panels, b) masonry and a ventilated façade based on cement boards, and c) concrete and a ventilated façade based on metal panels.

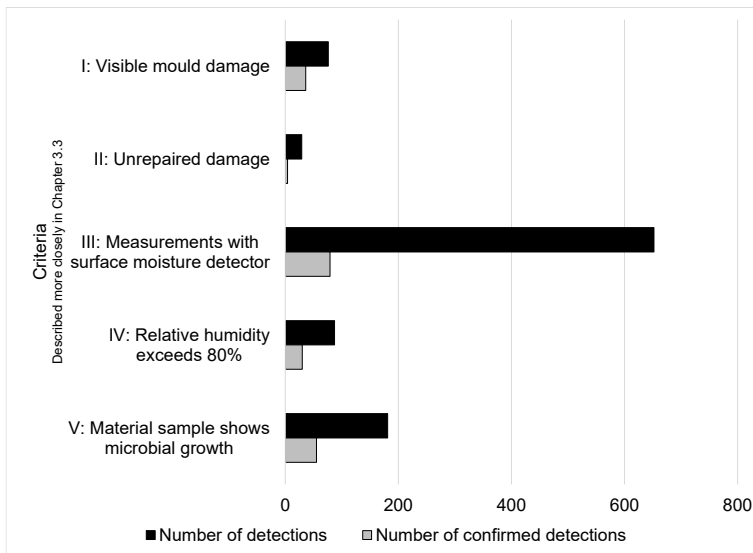
Figure 23. Criteria used to detect moisture and mould damage to structures and share of confirmed detections.

It is possible that, if the more precise criteria IV and V were used in moisture performance assessments to detect moisture and mould damage, the visual observations (criteria I and II) or the results of the measurements by the surface moisture detector (criteria III) may not have been written in the reports. It is also possible that the reports did not point out clearly that measurements, sampling or observations are done from the exact same locations, or that confirmation may have been done in the same room but not the exact same location. In conclusion, the share of confirmed measurements may be higher than presented.

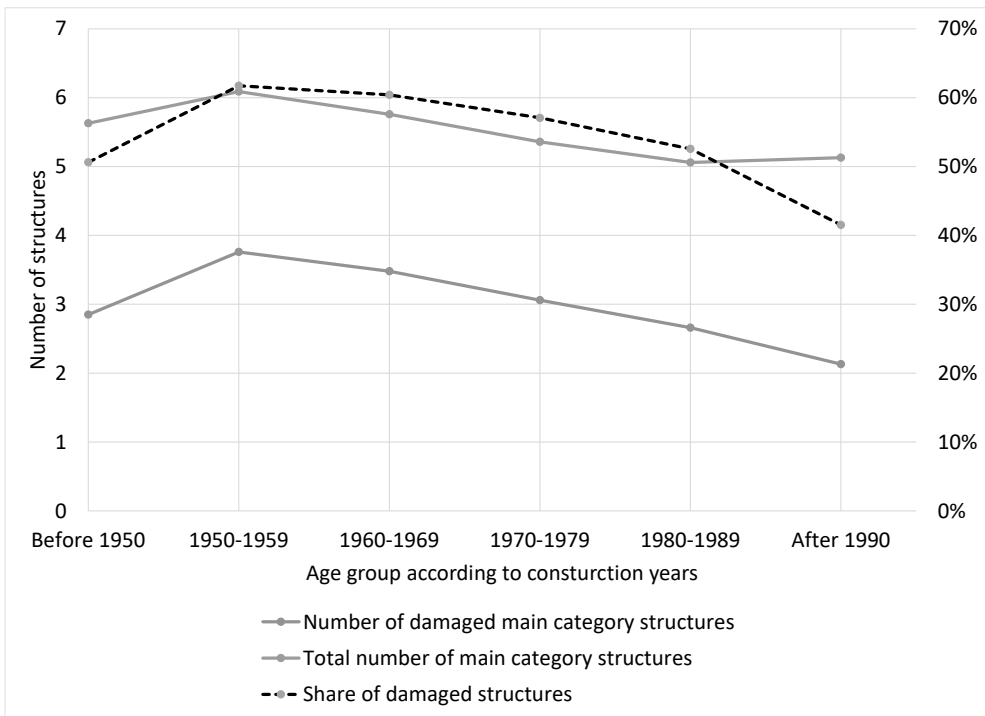
Figure 26. Number of moisture- and mould-damaged structures.

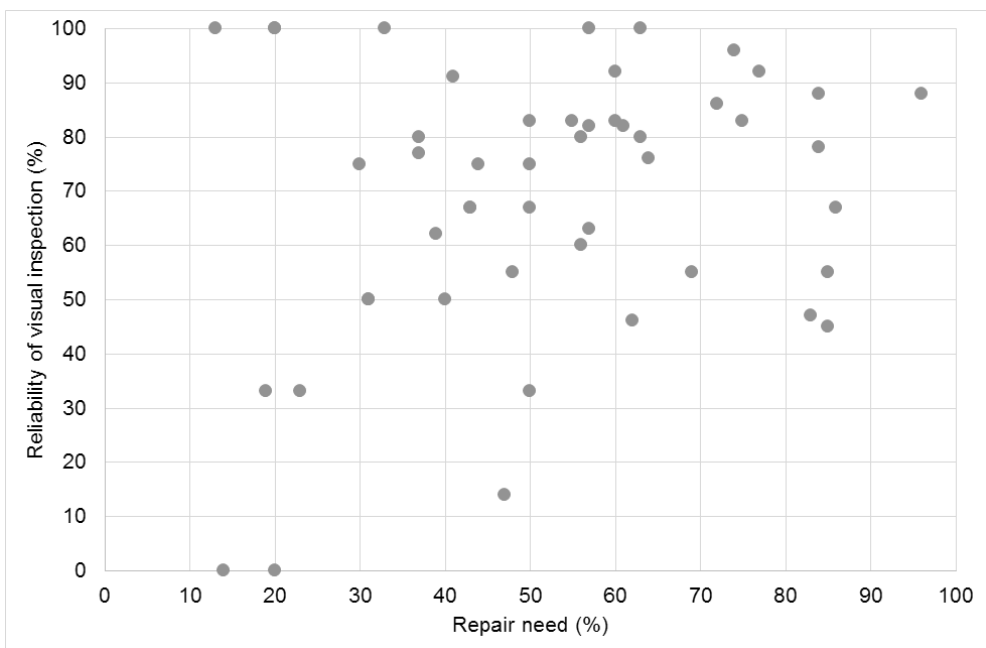
Figure 28. Correlation between repair need and the reliability of visual inspection (Annila & Lahdensivu 2020).

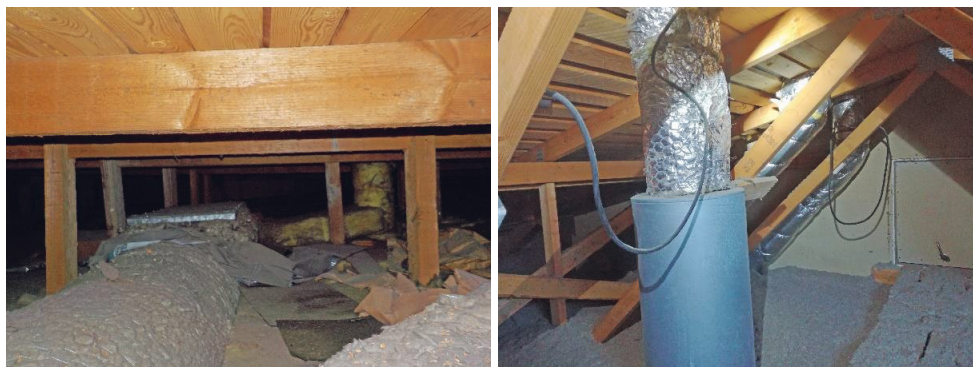
Figure 30. Inside the flat roof (left picture), there is not much space for a condition inspector to check the whole structure, so the reliability of detecting damage is lower than in ridge roofs.

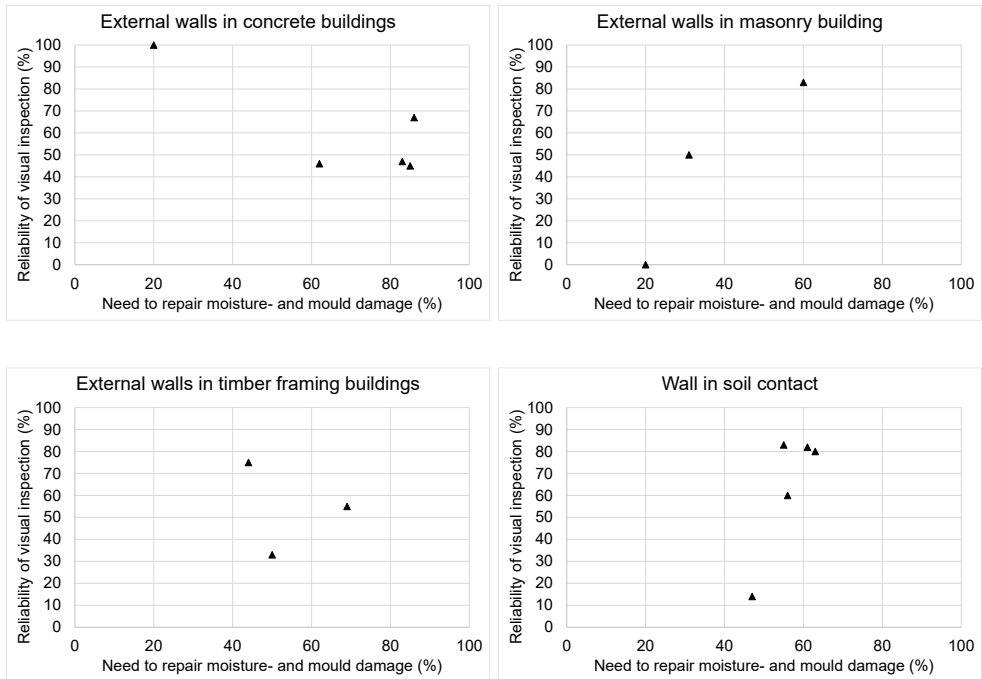
Figure 31. Correlation between repair need and the reliability of visual inspection in external walls (Annala & Lahdensivu, 2020)

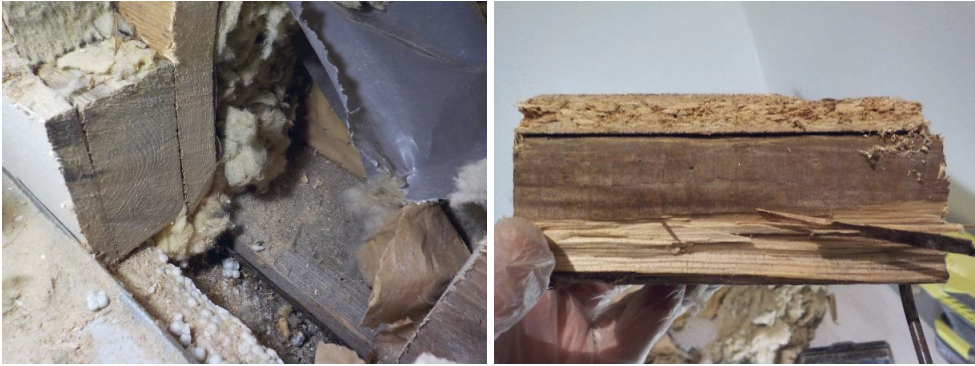
Figure 32. Dismantling of structures is usually necessary to detect moisture and mould in timber-frame buildings.

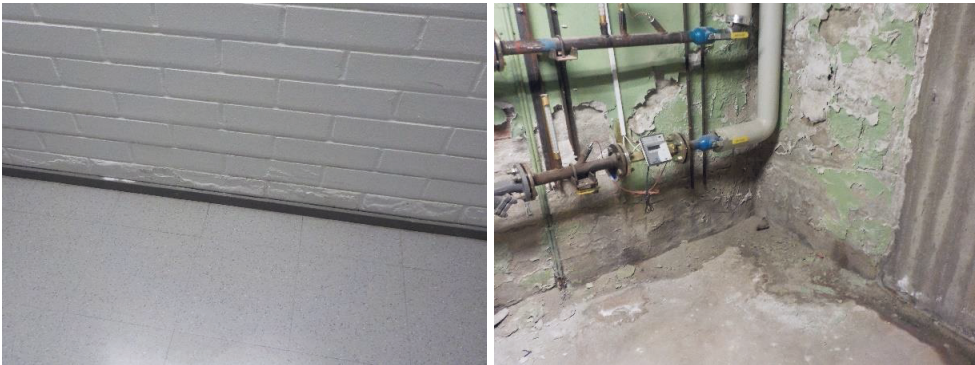
Figure 33. Examples of moisture and mould damage in a masonry wall and in a wall in soil contact.

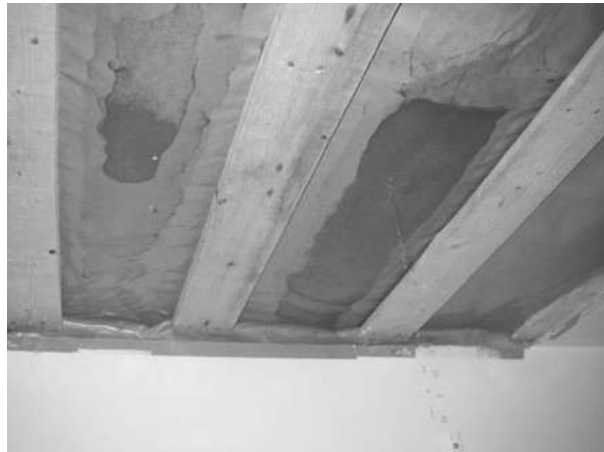
Water leaks, which may occur both in pipes and structures, have been made into a separate criterion among visual observations. These leaks have not necessarily led to moisture or mould damage by the time of the moisture performance assessment, but an unrepaired leak is highly likely to damage structures and materials. Thus, repair of observed leaks is as important as that of observed existing moisture and mould damage. Figure 4 shows an example of a leaky roof assembly.

Fig. 4 Example of leak in a roof assembly detected during a moisture performance assessment
