Reliability evaluation of CAN-bus connectors with tailored testing

Petteri Ojala, Jari Rämö, Juha Miettinen & Matti Vilkkö

ABSTRACT

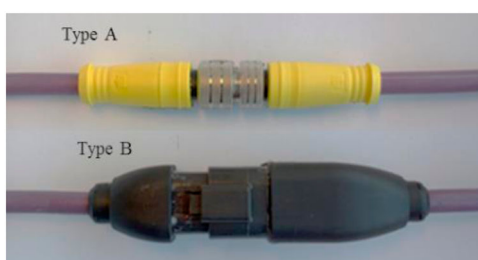
Figure 1. Two CAN-bus connectors with different designs: type A (top) and type B (bottom) (Ojala et al. 2017a). (Images are available in colour online)

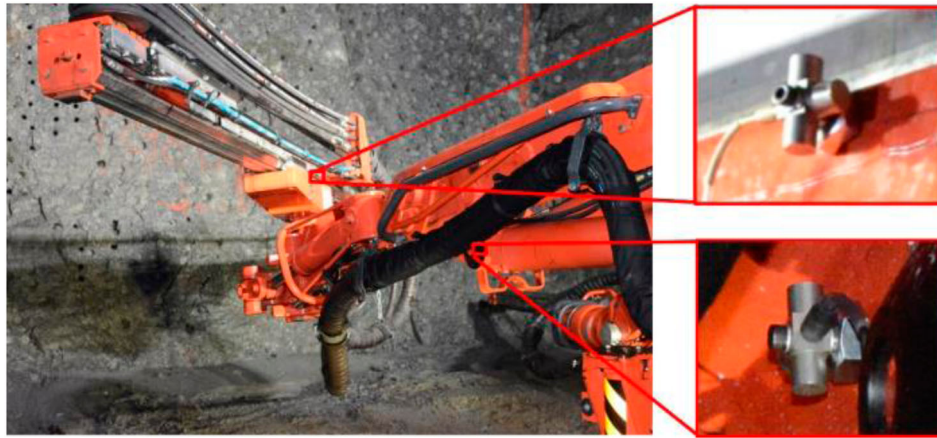
Figure 2. Underground rock drill (Sandvik) and 3-axial accelerometers (Ojala et al. 2017a). (Images are available in colour online)

Based on the presented stress factors, four tests were designed. Specialists of the mining industry and drill equipment were consulted to confirm the authenticity of the stress factors and levels used. Continuous humidity exposure was used as a common factor in all tests, since waterproofness is an essential criterion for components used in drill machinery and it is a representative factor for ingress protection. Each test was planned to study how a combination of humidity and another stress factor would affect the reliability of an IP67-coded connector. The tests simulated the worst-case scenario in normal operative use. The underground drill with 3-axial accelerometers attached to the base of the drill feeder and the boom are shown in [Figure 2](#).

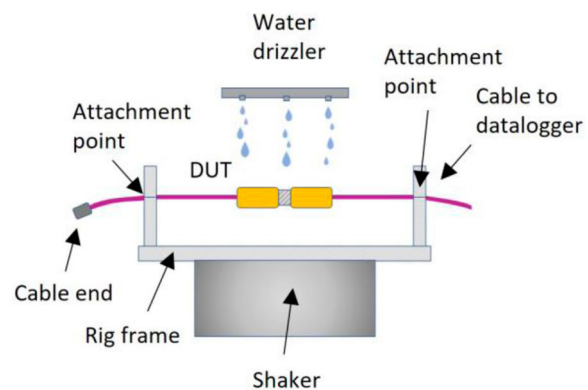
Figure 3. Schematic drawing of the resonance shaker test. (Images are available in colour online)

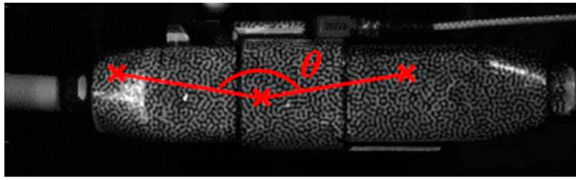
Figure 4. Observed geometry of type B in the resonance shaker test. (Images are available in colour online)

The mechanical response of the connector structure to the resonance frequency vibration was observed by high-speed imaging. Deflection of the DUT was measured with a digital image correlation (DIC) (Sutton et al. 2009) method that mapped three locations in a set of consecutive images. Deflection was used as a generic indicator of robustness. The observed geometry at the followed locations (red crosses) used in deflection measurements is presented in [Figure 4](#).

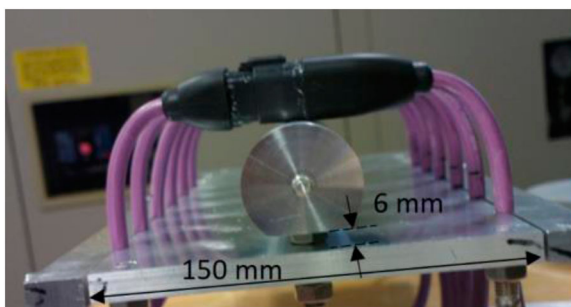
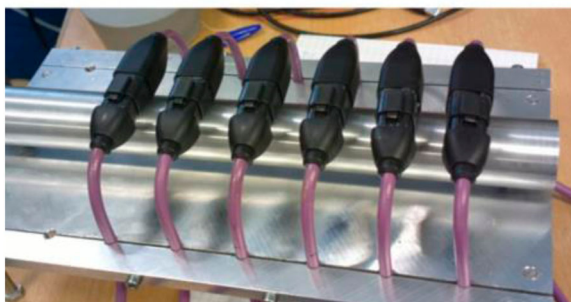
Figure 5. Test samples in the test rig used in the multivariate static test. (Images are available in colour online)

The sample rig with type B samples is presented in Figure 5.

The sample rig comprised two parts, a frame and a bar. The samples were attached to the frame and the bar projected static bending stress to the connector samples. In the initial position shown in Figure 5, the elevation between the bottom of the bar and rig frame was 6 mm; the bar merely touches the samples and bending stress comes only from the installation of the samples in the curved position. Elevation of the bar causes additional static bending and stretching stress, which is expressed as elevation from the initial position in millimetres.

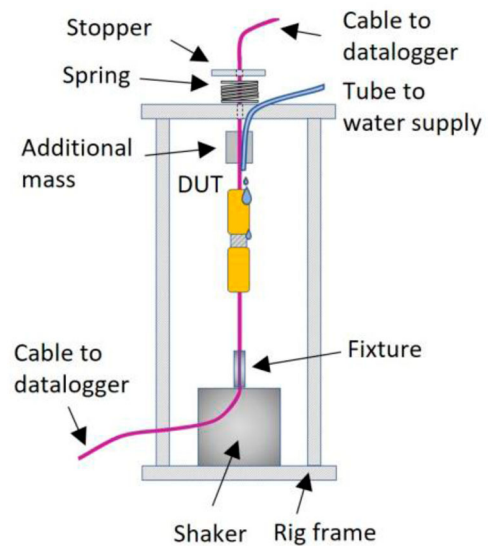
Figure 6. Schematic drawing of the test set-up combining vertical stretching and humidity exposure. (Images are available in colour online)

The mounting of the cabling is designed according to the range of boom movement, but part of the movement can be transferred to the cable and the connector, causing stretching stress. Furthermore, if the mounting of cable bundles enables horizontal swinging, the inertia of the cabling causes an axial force component to the connector cable joining point. This scenario is simulated with the DS test set-up presented in Figure 6.

resulting in stretching stress in each cycle. An additive mass was attached to the cable to simulate the inertia of a longer and heavier cable assembly. Between the stopper and the upper surface of the rig is a spring to lower the gradient of the stretching force. The humidity exposure was kept continuous by a water drizzler attached to the cable above the DUT.

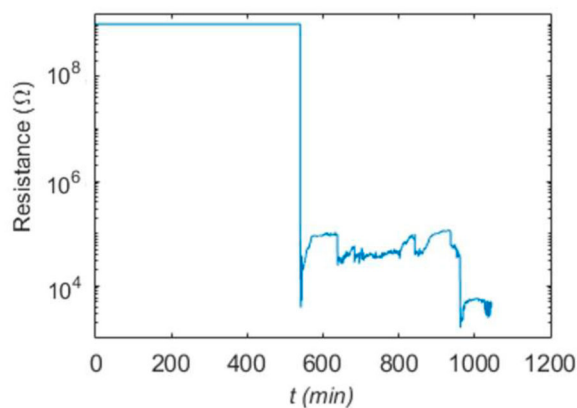
Figure 9. Measurement data of a typical fault of the SC failure mode in the RS test. (Images are available in colour online)

Depending on the details of the test set-up and monitored failure mechanism, the resistance data had different generic types. In the dynamic tests RS, DS, and DB, the degradation process was very clear and uncomplicated. The change in the monitored resistance quantities was drastic and permanent in both failure modes. In the data analysis of these tests, the first-hitting-time principle was used. When the observed quantity reaches a predefined level, the DUT is interpreted to have failed. Measurement data of a typical fault for the SC failure mode of the RS test is presented in Figure 9, and the PT failure mode for the DS test is shown in Figure 10. In all resistance data graphs, values beyond the range of the multimeters are set to $10^9 \Omega$ for presentational clarity.

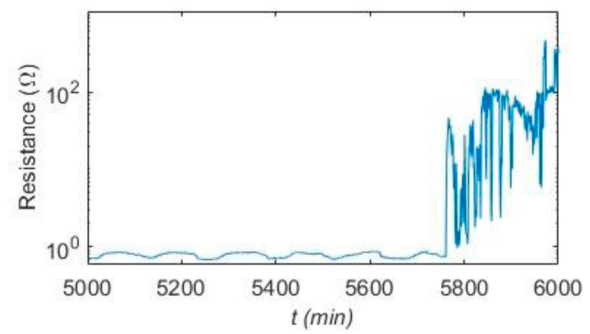
Figure 10. Measurement data of a typical fault of the PT failure mode in the DS test. (Images are available in colour online)

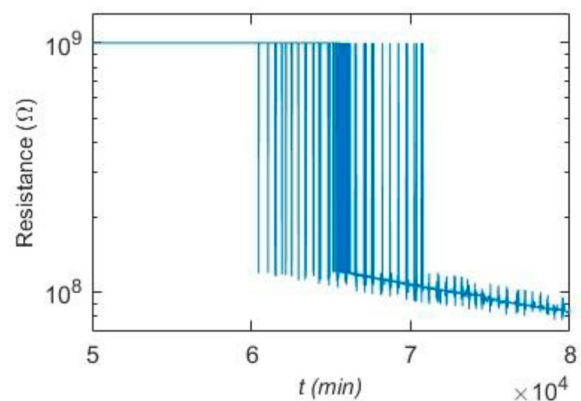
Figure 11. Observation of an intermittent fault in the salt fog (SF) test. (Images are available in colour online)

The SF test was static, and the observed degradation process was very different. After the first hit at the predefined threshold, the resistance reading returned to a

level indicating an intact condition. As testing continued, the threshold crossings became increasingly frequent until the resistance remained permanently at the SC level indicating failure.

remain above it, the DUT is interpreted to have failed. An example of the oscillating data of the SF test is presented in Figure 11.

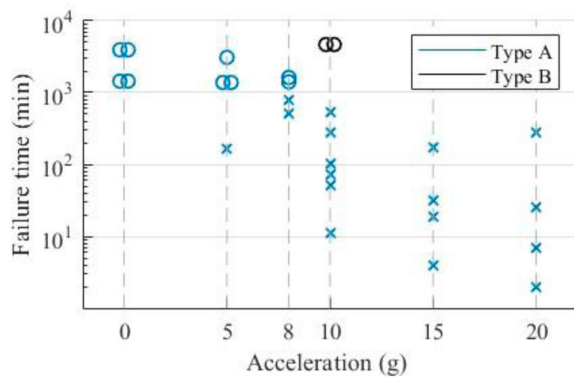
Figure 12. Failure time data of the SC failure mode in the resonance shaker (RS) test. Accelerating variable: Acceleration level of vibration. Failure times marked with a cross (x) and run-out data with a circle (O). (Images are available in colour online)

Failure time data for the tests that were carried out at many stress levels are presented in Figures 12 and 13 as graphs, and data for the tests that were run at only one stress level but observed two failure modes simultaneously are presented in Tables 2 and 3. The data are type-I censored (Meeker and Escobar 1998), where the data are either failure time or run-out time (where the sample has not failed in the duration of the test). In the tables, run-out times are marked with (ro) behind a numeric value. In Tables 2 and 3, each sample has two failure times, one for both of the SC and PT failure modes.

The resonance shaker test (RS) studied the effect of vibration on ingress protection. The results are very clear. Type B with a secured lock mechanism passed the test without failures. Type A with the threaded structure that relied on assembly with a special tool was vulnerable to vibration. The failure time follows the inverse power law-lognormal (IPL-lognormal) model where the lifetime decreases as the acceleration level of vibration increases (Ojala et al. 2017a).

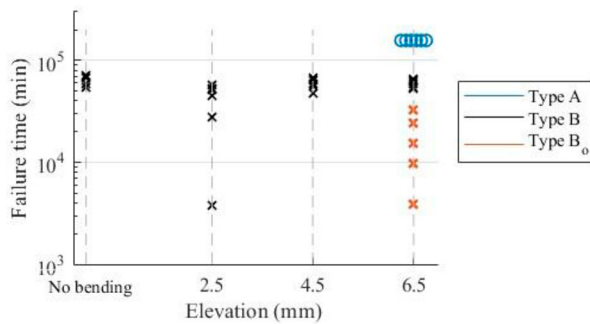
Figure 13. Failure time data of the SC failure mode in the SF test. Accelerating variable: Elevation from the initial position in millimetres. Failure times marked with a cross (x) and run-out data with a circle (O). (Images are available in colour online)

failed. Static bending was used as an accelerating stress variable, and it reduced the lifespan a little. There was no clear relation between the level of bending stress and lifespan.

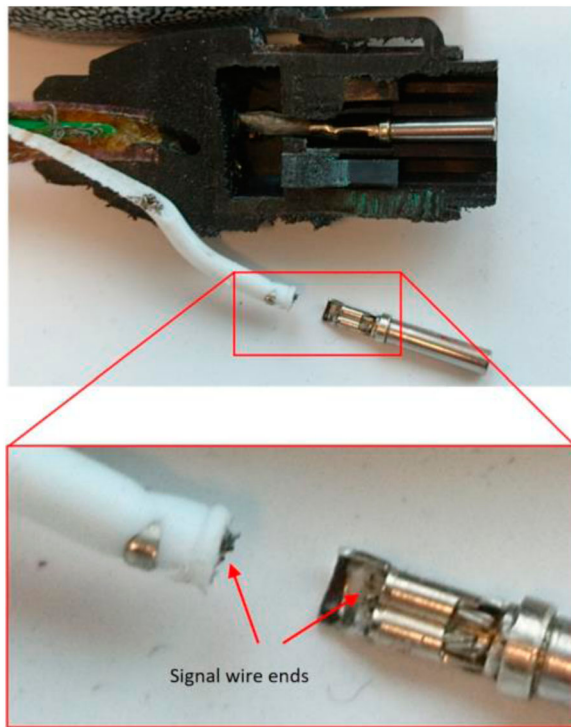
Figure 14. Severed signal wire inside the type B connector. (Images are available in colour online)

relation to the housing, it is very likely that the movement is transferred further into the structure. This movement causes metal fatigue in the signal wire-pin attachment and leads to component failure, as presented in Figure 14 (Type B, sawed open).

The second failure mechanism was fatigue damage to the signal chain contacts. The type B sample that was tested to failure in the DS test was studied more closely to confirm the mechanism of failure. The sample was sawn open and the signal wire was

found to be severed close to the connection of the wire and the contact pin. The opened type B component is presented in Figure 14.
