# Fretting Behavior of WC-Co-Cr Coatings Against QT Steel in Bolted Joint

**Keywords** finite-element method · fretting fatigue · fretting wear · thermally sprayed coating · WC-10Co-4Cr

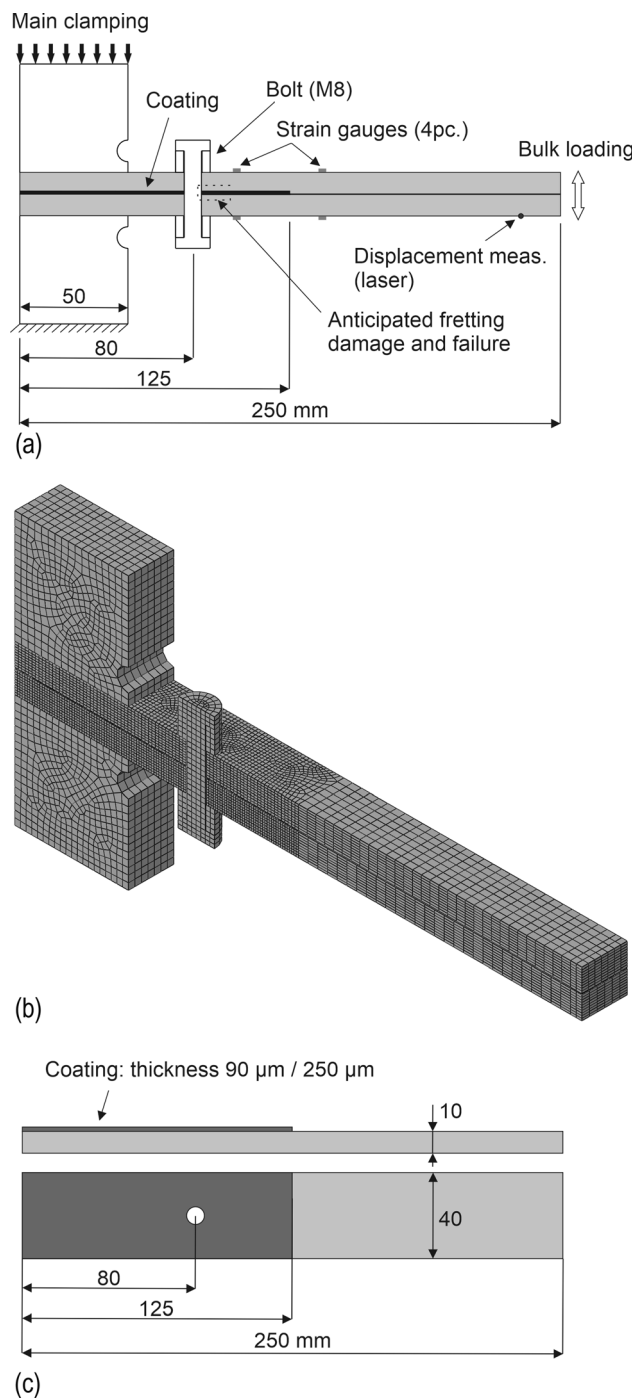
**Fig. 1** Illustration of (a) the fretting test setup and (b) the FEM model mesh (only half of the test setup is modeled due to symmetry) and (c) schematic depiction of the coated specimens

The fretting tests were carried out by using an in-house developed flat-on-flat fretting test device in so-called bolt joint configuration (Fig. 1). The test methodology was originally developed by Juoksukangas et al. Ref 12 for steel-to-steel contact and was modified in the current study for coating-to-steel and coating-to-coating contacts. As shown in Fig. 1, the test arrangement consists of two flat test specimens which are held together by a single strain gauge instrumented M8 bolt (with constant preload applied with torque prior to the test and controlled continuously, as explained below) and at one end by the main clamping. The specimens are subjected to bulk cyclic bending loading via eccentric mechanism connected to the opposite end (referred to as the “free end” throughout this paper). Fretting conditions at the contact interface between the specimens are created by the combination of the imposed bulk bending and the preload of the bolt; cyclic slip at the interface takes place because the contacting surfaces have always opposite signs of bending strain, whereas cyclic shear stresses at the interface result from the interfacial friction and the contact pressure created by the bolt preload. It should be noted that the bolt itself is not carrying any shear load due to the clearance between the bolt and the hole. Furthermore, the test arrangement does not allow for direct measurement of the contact stresses and slip. Instead, as discussed later, FEM calculations are used to determine the distribution of stresses and slip as well as the frictional dissipation at the contact interface. In short, the most severe fretting damage is expected to take place near the axial centerline on the free end side of the bolt hole.

During the experiments, data are collected from several sources: bolt preload (with strain gauges attached axially to the bolt), specimen bending displacement (with laser sensor) and specimen bending strain with four strain gauges

(two gauges on each specimen, as illustrated in Fig. 1a). As in Ref 12, the data from the strain gauges are linearly interpolated to obtain the nominal bulk stress at the center of the bolt hole.

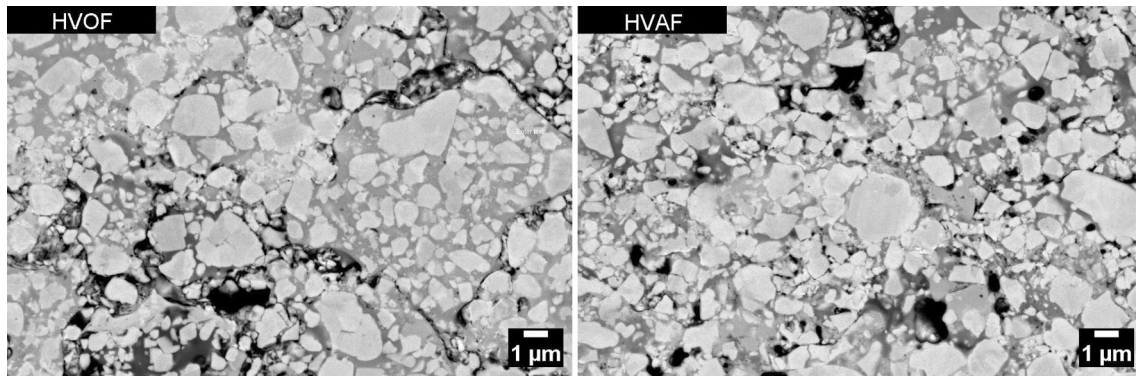
**Fig. 2** High-resolution SEM (backscatter electron) micrographs of the HVOF and HVAF sprayed coatings

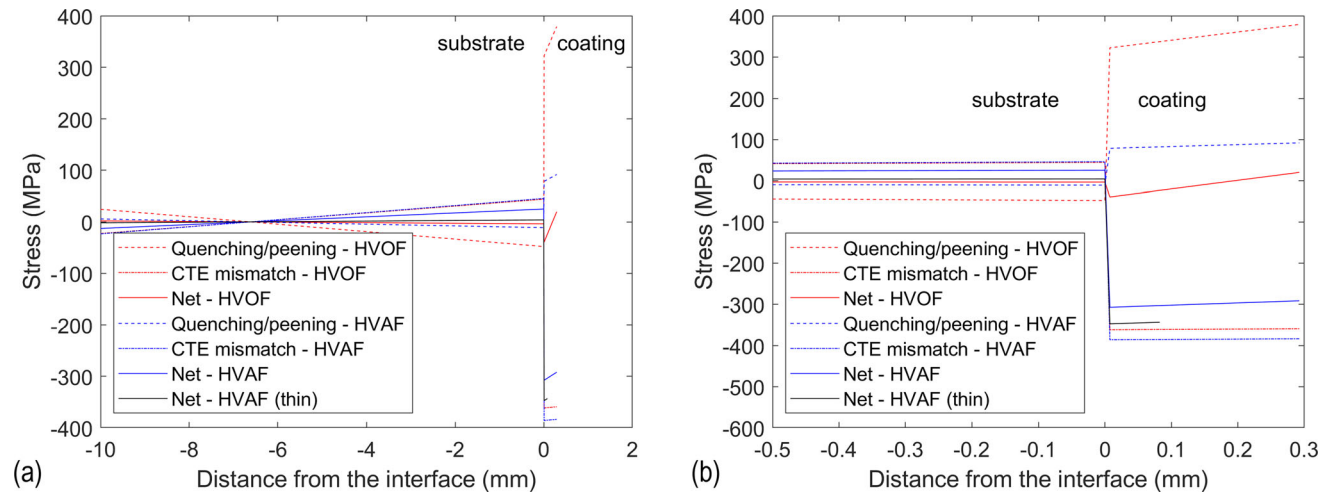
**Fig. 3** In plane stresses at different depths according to the Tsui and Clyne analytical model: (a) full specimen thickness and (b) zoom-in of (a) near the coating/substrate-interface

The through thickness stresses in the samples according to Tsui and Clyne's analytical model Ref 38, 40 are shown in Fig. 3. The HVAF method generates a compressive stress of about 300 MPa in the coating, while the HVOF method generates a tensile stress on the surface of the coating, which becomes a compressive stress as it moves toward the substrate. The difference is logical considering the flame temperature, which is much lower in the HVAF process compared to HVOF process. Due to the melting degree of the powder particles in the HVAF process, during the deposition stage, the peening effects, which generate compressive stresses, are stronger, whereas in the HVOF process the dominant stresses are quenching stresses, which are always tensile stresses (Ref 22). When the coating cools down after the coating phase, the relatively large CTE difference between the coating and the substrate shifts the stress state of both coatings toward net compressive stress.

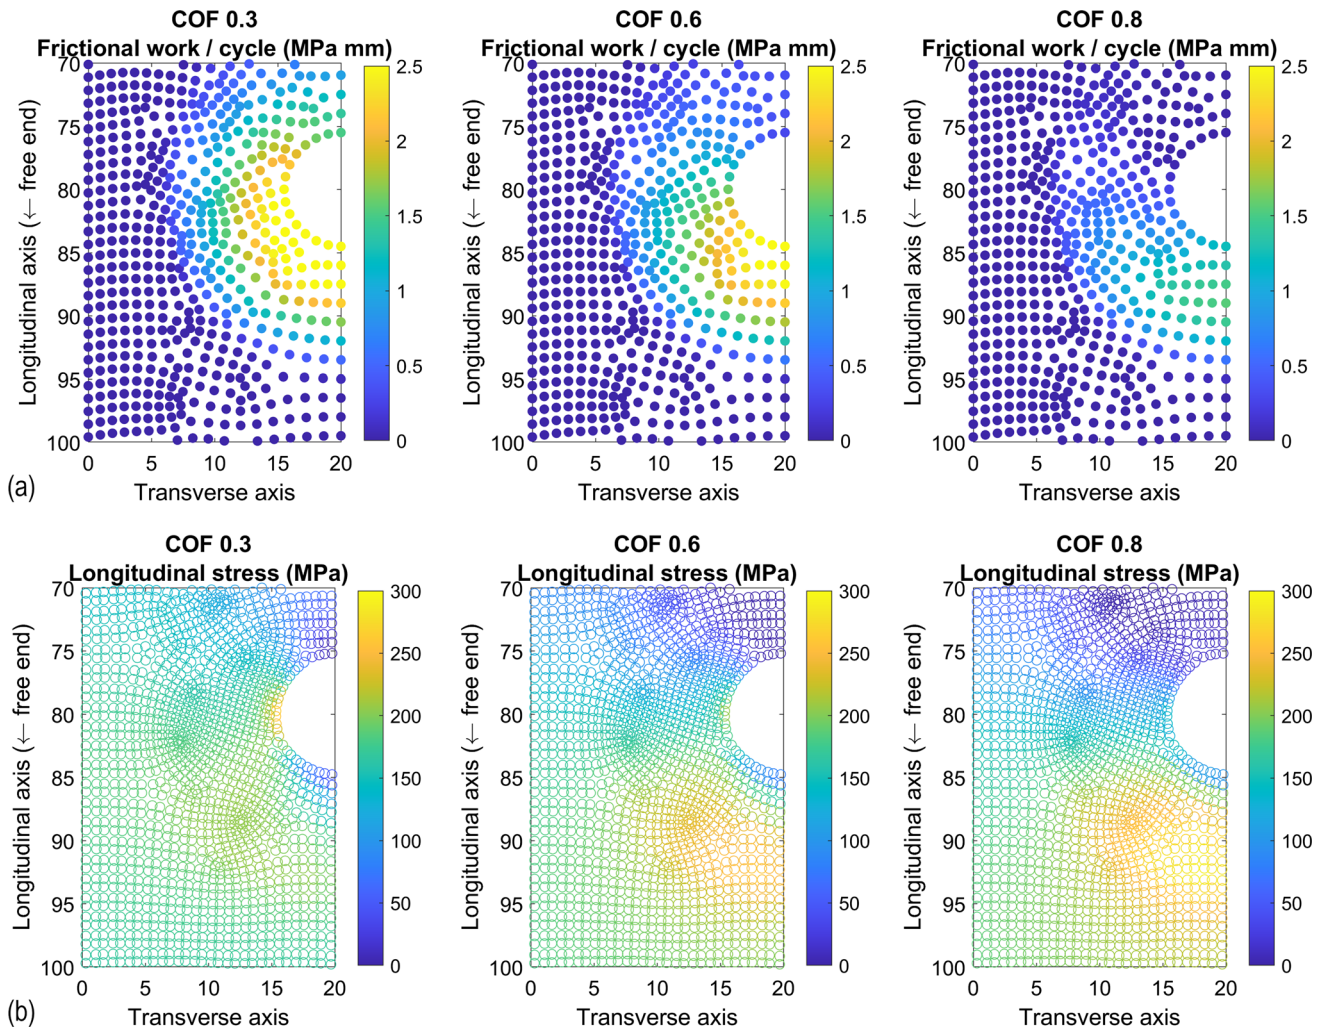
**Fig. 5** Simulated field data for the 250  $\mu\text{m}$  coating-to-steel contact case, (a) calculated frictional work (per unit area) at the contact interface (per cycle) and (b) axial stress in the coating at the moment

of maximum bending displacement. The rows correspond to interfacial COF of (i) 0.3 (ii) 0.6, (iii) 0.8

As noted above, the main simulation parameter affecting the distribution of the frictional dissipation is the coefficient of friction; the effects of coating thickness and the type of contact (coating-to-steel versus coating-to-coating) were found to be small in the used simulation approach. Figure 5(a) shows examples of the simulated frictional dissipation for different COF in the case of coating (250

$\mu\text{m}$ )-to-steel contact (additional data, i.e., contact surface pressure as well as shear stress and slip on the contact surface are presented in Appendix). As can be seen in Fig. 5(a), for a low value of COF (0.3) notable frictional dissipation takes place on a wide area surrounding the bolt hole, whereas with higher values of COF (0.6 and 0.8) frictional work is concentrated on an area extending up to a distance of  $\sim 10$  mm from the hole edge toward the free end. Comparison with experimental data (Fig. 4) indicates that the main fretting scar location can be predicted well in the coating-to-steel case with a high COF ( $\sim 0.8$ ). This estimated value of COF is in good agreement with previous reports for hardmetal coating-to-steel contacts; Kubiak et al. Ref 32, 33 reported a value of  $\sim 0.7$ , whereas according to Okane et al. Ref 34 the COF is low ( $\sim 0.3$ ) at the start of loading but increases to 0.6–0.8 as the number of cycles increases. In these previous studies, the coatings were prepared with HVOF process, but the results of the current study indicate similar behavior in HVAF coatings. It is also noteworthy that the application of the hardmetal coating on one of the contact surfaces seems to have a small reducing effect on the COF compared to the steel-to-steel case. This has been reported earlier (Ref 31–34) and can also be deduced by comparing the current data to earlier studies on the same steel alloy in uncoated state. (Both Juoksukangas et al. Ref 12 and Hintikka et al. Ref 37 reported steady-state COF values between 0.8 and 1.0 for the steel-to-steel contact.) In the coating-to-coating case (Fig. 4b), in contrast, the fretting damage takes place closer to the hole, which implies that the COF is somewhat lower.

Figure 5(b) presents the axial tensile stress field in the coating at the moment of maximum bending displacement. Due to the symmetric bulk loading, in general the

maximum tensile stresses correspond also to the cyclic stress amplitude (i.e., local mean stresses are close to zero). As can be seen, the simulation data indicate that high local tensile stresses, up to  $\sim 300$  MPa, appear within the coating in the same region as the frictional dissipation on the surface. Corresponding stress field is also formed in the steel counterpart with generally lower stress level (maximum near 200 MPa) due to the difference in the Young's moduli between the coating and the steel. In the tests run until failure the locations of the final fracture were the following (fracture location measured as the distance between the fracture and the edge of the hole on the centerline): in the thin and rough HVOF coating-to-steel contact (Fig. 4a) 6.1 mm, in the thick and ground coating-to-steel contact 9.7 mm (HVOF) and 5.1 mm (HVOF), and in the coating-to-coating contact (Fig. 4b)  $\sim 3$  mm. Comparison of this data with the simulations indicates that

the final fatigue fracture took place within the area associated with major frictional dissipation and high axial stress amplitude. The relatively high tensile loading might contribute to the damage process of the (brittle) coating also in the absence of fretting-induced surface damage. Based on the experimental characterization, in general the coatings did not crack outside the main fretting damage area. However, in the coating-to-coating case some minor cracking was observed in the test interrupted after 10,000 cycles in the vicinity of the specimen edges close to the main fretting scar. The cracking tendency of the coatings in the studied loading conditions is discussed later in more detail.

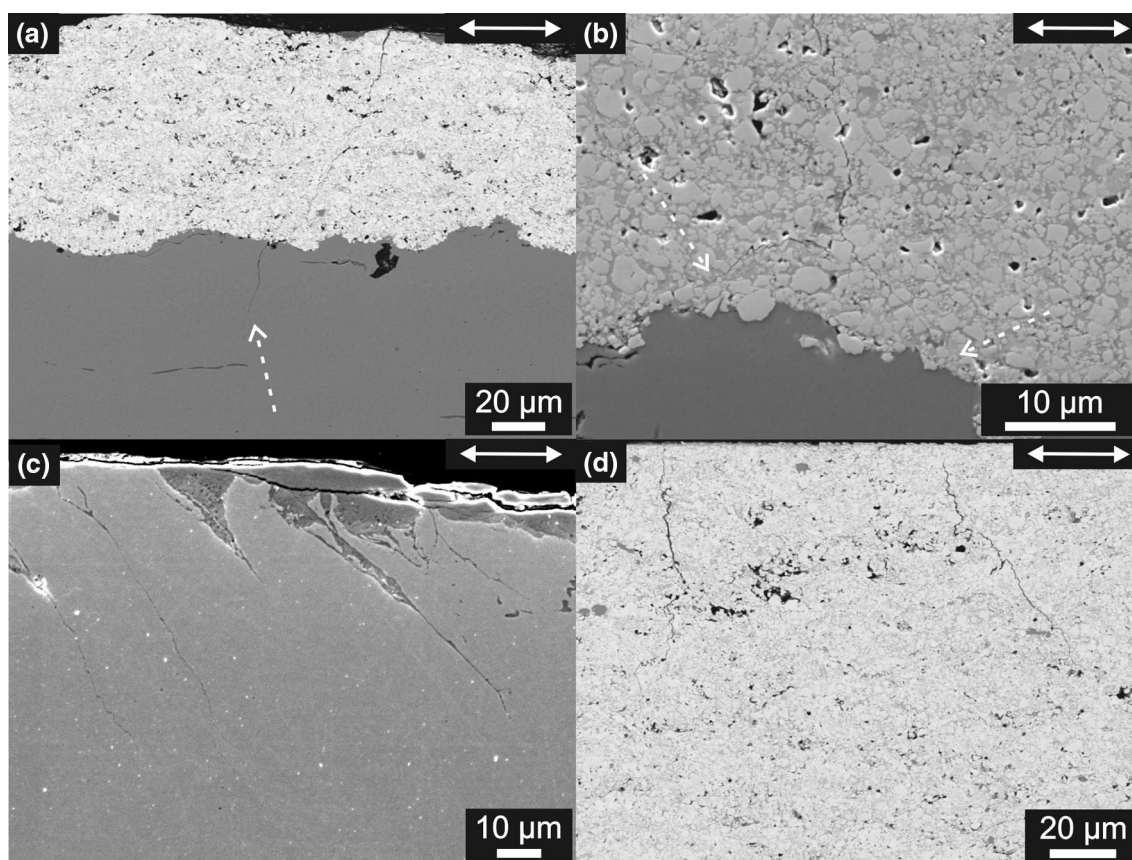
**Fig. 7** (a) Primary crack (marked with dotted arrow) propagated from the coating to the base material in the case of thin and rough HVOF coating against steel (specimen pair loaded until failure), (b) crack tip (marked with dotted arrows) in thick and ground HVOF coating against steel (specimen pair loaded until failure), (c) cracks in steel

specimen against thick and ground HVOF coating (specimen pair loaded until failure), and (d) cracks in the thick and ground HVOF coating in the case of coating-to-coating contact (specimen pair loaded until 10,000 cycles). The slip direction is marked by the arrows

In all the coating-to-steel specimens loaded until failure, the steel counterparts fractured completely, whereas the coated specimens remained whole. However, in the case of thin HVOF coating against steel, a crack in the coating had propagated to the substrate steel, as shown in Fig. 7(a). It is therefore evident that in this case failure of the coated specimen side was also a likely possibility. In the case of thick coatings against steel, relatively large cracks were observed, but in all cases the cracks were stopped latest at the interface of the coating and the substrate steel, as exemplified in Fig. 7(b).

primary fracture, notable number of shorter cracks were formed, as shown in Fig. 7(c) for a steel specimen against thick and ground HVOF. In the coating-to-coating specimen pair loaded until failure, in addition to the primary fracture, several secondary cracks had propagated from the coating to the substrate steel. Compared to the case of coating-to-steel contact, the cracks in the coating-to-coating case were strongly opened, and fragments had detached from the surface at the crack nucleation spots. Already after 10,000 cycles, the coated surfaces were heavily cracked, and the cracks had grown to a depth of about 50 micrometers, as illustrated in Fig. 7(d). Wang et al. Ref 35 proposed in their study that in suitable loading conditions abrasive wear could slow down the formation of fretting fatigue cracks by wearing out the microcracks. It appears that in the current study this mechanism was not significant enough to affect the total lifetime, since especially in coating-to-coating cases, strong abrasive wear and the formation of detrimental fatigue cracks took place simultaneously. The crack growth in the coatings appears to be driven by their relatively high defect density and brittleness, which promotes both abrasive wear and fatigue crack propagation.

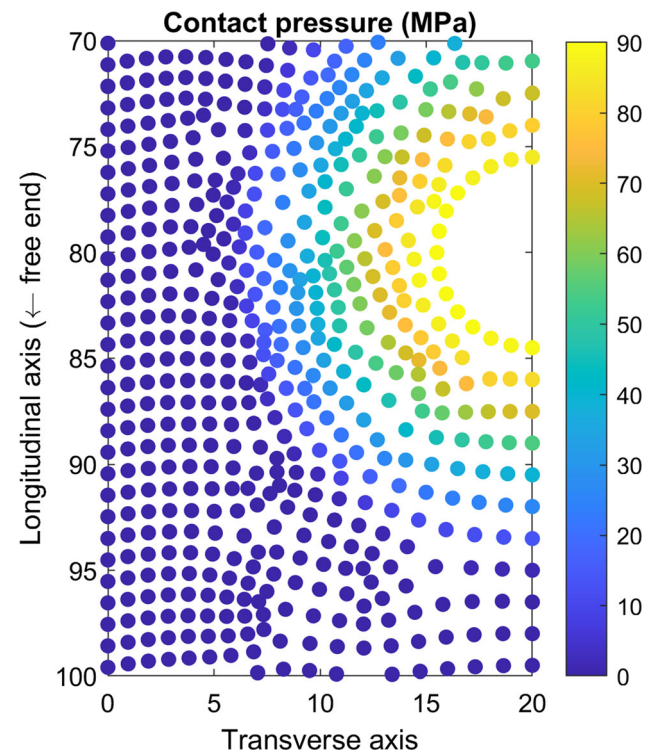
**Fig. 8** Simulated contact surface pressure at the start of cyclic loading for the 250  $\mu\text{m}$  coating-to-steel contact case presented in Fig. 5 of the main text and in Fig. 9 (data common to all studied COF)

Figure 8 and 9 presents the simulated contact pressure as well as shear stress and slip on the contact surface for the different simulation cases depicted in Fig. 5 of the main text.

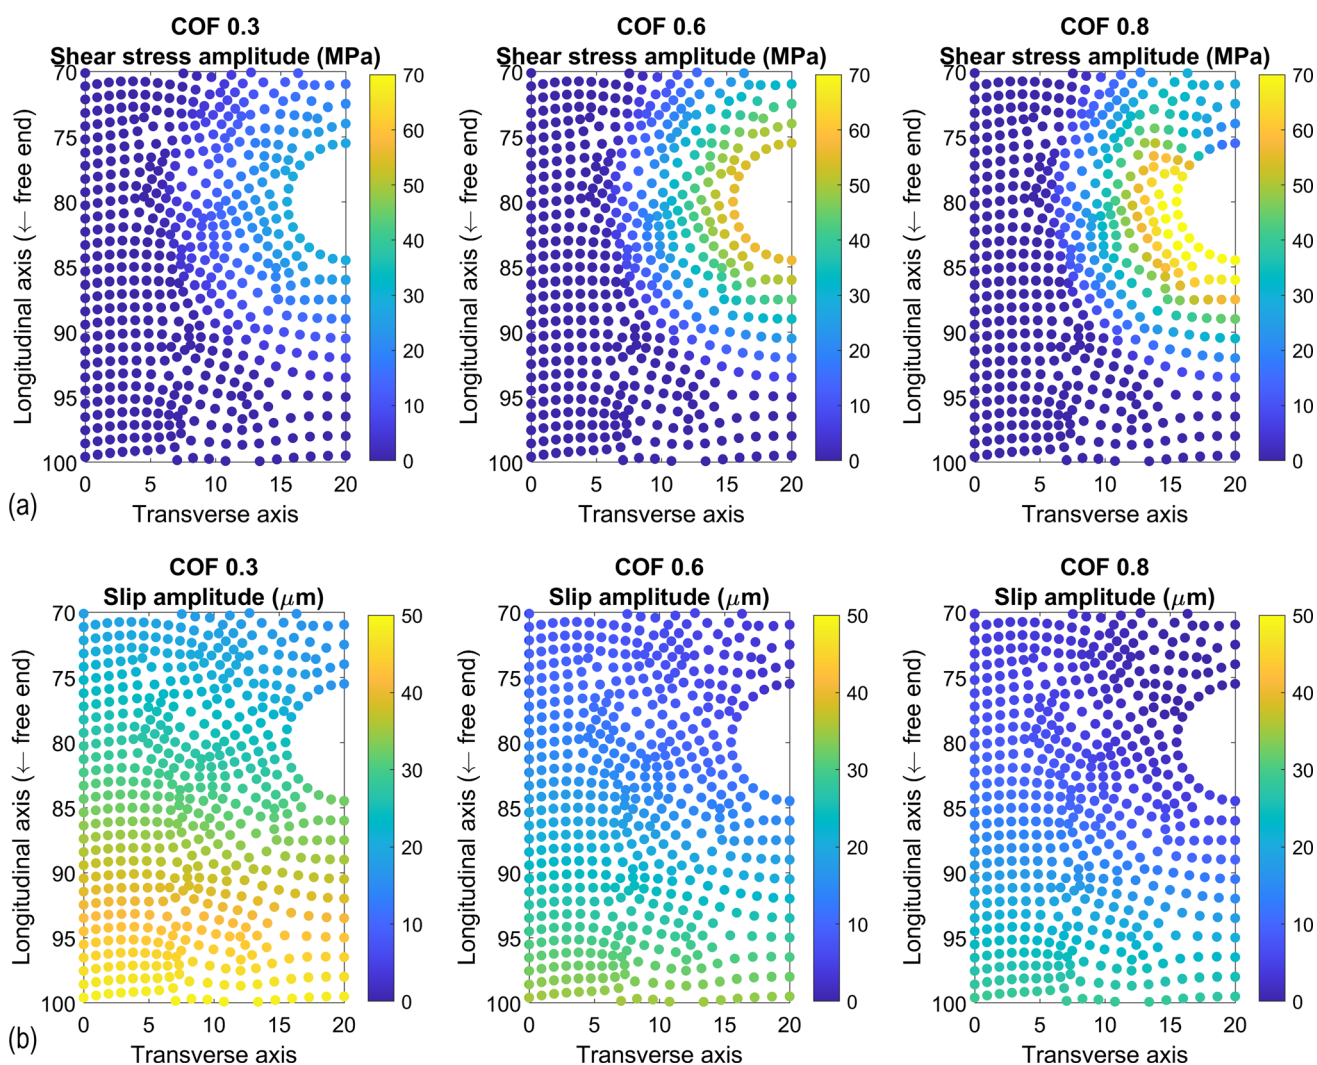
**Fig. 9** Additional simulation data for the 250  $\mu\text{m}$  coating-to-steel contact case depicted in Fig. 5 of the main text, (a) shear stress amplitude and (b) slip amplitude in the axial direction

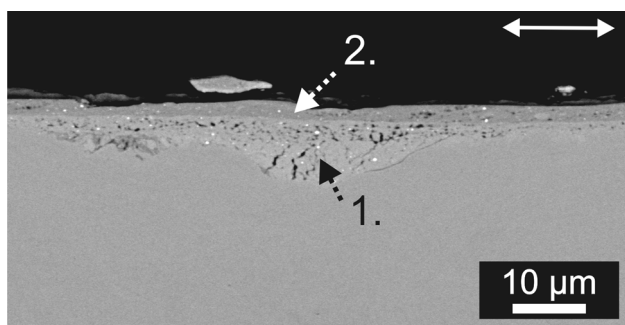
**Fig. 10** Surface of a steel specimen tested until failure against thin and rough HVOF coating. The rectangles marked with 1. and 2. denote the locations of the EDS analyses

Figure 10 and Table 7 present the results of the EDS analyses of the tribologically transformed structure and third body layer on the surface of a steel specimen tested until failure against thin and rough HVAF coating.
