MATTI AALTO WATER NETWORK MANAGEMENT PLAN FOR KEETMANSHOOP, NAMIBIA Master of Science thesis

TAMPERE UNIVERSITY OF TECHNOLOGY
Master's Degree Programme in Civil Engineering
AALTO, MATTI: Water Network Management plan for Keetmanshoop, Namibia
Master of Science Thesis, 47 pages, 8 Appendix pages
October 2014
Major: Environmental Engineering of Communities
Examiner: Professor Jukka Rintala, Development Manager Saila Kallioinen
Keywords: non-revenue water, water distribution network, development,
Keetmanshoop, Namibia

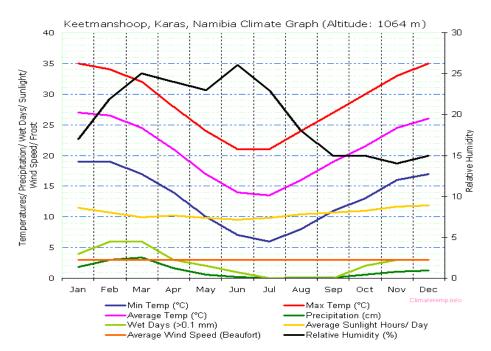
Figure 1. Climate Graph of Keetmanshoop (climatemps.com 2013).

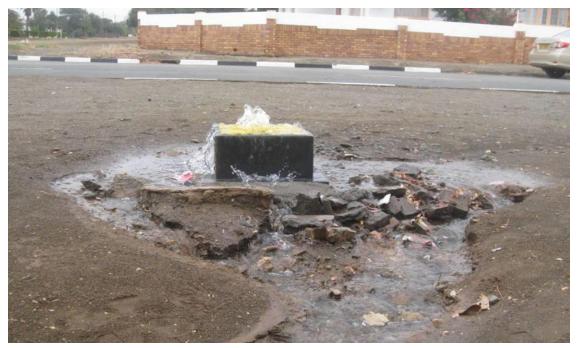
Photo 1. A Fire hydrant opened for reducing pressure to help fixing a leak nearby. The leaking pipe was not possible to close by valves. (Photo: Pekka Pietilä)

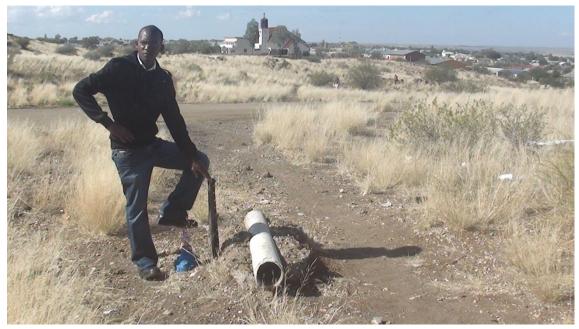
Photo 2. A new valve clearly marked with a metal post. Pipes are not deep and the valve is almost on ground.

Also plumbers (August 8th 2012) said that renewing gate valves is the most important matter to get better network. Plumbers are ready for installing if they get the valves. Amounts of meters and valves in municipality's stores in October 2012 are in *Appendix* 6.

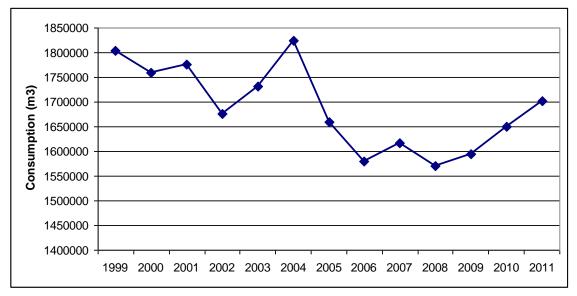
Figure 3. Annul water consumption in Keetmanshoop in 1999-2011 according to NamWater's accounting.

Municipality of Keetmanshoop bought 1 722 000 m^3 water from NamWater in financial year 2011-2012. The annual consumption has varied between 1 570 000-1 820 000 m^3 in 1999-2011 (*Figure 3*).

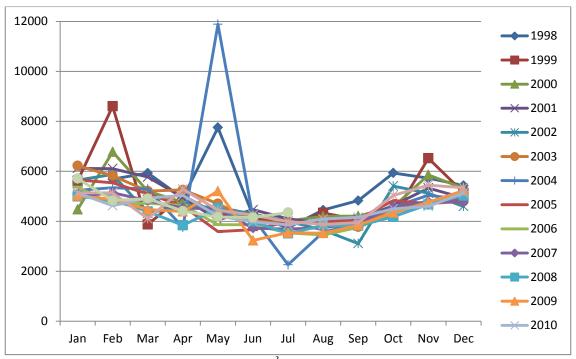
Figure 4. Daily water consumption (m^3/day) in Keetmanshoop in years 1998-2012 based on NamWater's billing from municipality.

In Keetmanshoop more water is used during summer than during winter (*Figure 4*). Highest volumes are in February (mean 5590 m³ / day) and lowest volumes are in July (mean 3760 m³ / day). The main explanation of variation may be irrigation, because gardens need to be irrigated more in summer than in winter. Real evidence about the reasons of the variation does not exist. Volumes of water use for irrigation cannot be evaluated according to current knowledge.

The billing is done according to NamWater's meter once a month on average, but the billing period may vary from two to six weeks. The meter has been broken seven times (months) in 1998-2012 and consumptions of those months were estimated. (NamWater 2012a)

The highest billed consumption in May 2004 is based on the average of the earlier months because the meter stood. The billing time was only 14 days, which was not taken into account in billing. Because the time was less than half of normal, the consumption was evaluated more than twice as big as in earlier months. In addition, normal consumption in May is less than in earlier months.

Billing in February 1999 and in July 2004 are also calculated quantities and may have same kind of evaluation inaccuracies. NamWater installed new water meters in November 1999, which may somehow explain the extreme value of that month. Explanation for extreme value in May 1998 was not found.

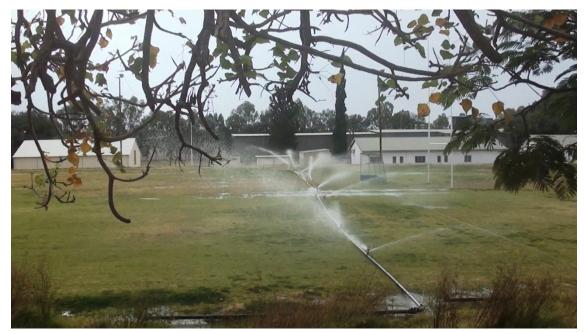
Photo 3. Irrigation may be the main reason of periodical variation of water use.

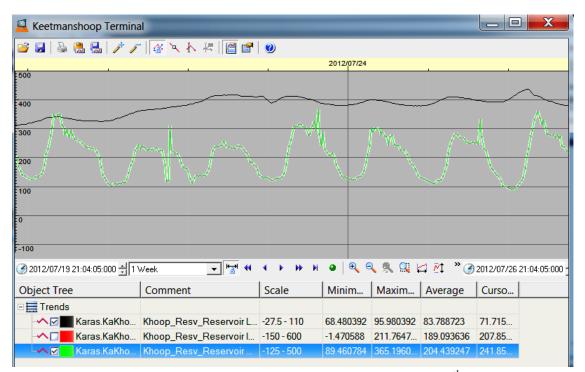
Figure 5. Water input to Keetmanshoop network from evening of 19^{th} July to evening of 26^{th} July 2012. Screen print from NamWater's information system (NamWater 2012a). Numbers of y-axis are cubic meters per hour (m^3/h) .

NamWater's continuous metering shows the water flow from its reservoirs to municipal water network (*Figure 5*). Readings of the meter and readings of NamWater's other meters before the reservoirs are quite similar (NamWater 2012a).

Continuous metering provides with good possibilities to monitor night flow and leaks. During the week in *Figure 5* night flow varied between 90-110 m³/h. Peaks in the curve are leaks. For example, short lived big leaks can be noticed on 23^{rd} and on 25^{th} of July. Reason of lower consumption in 21^{st} of July is that supply to Tseiblaagte was shut off for two hours.

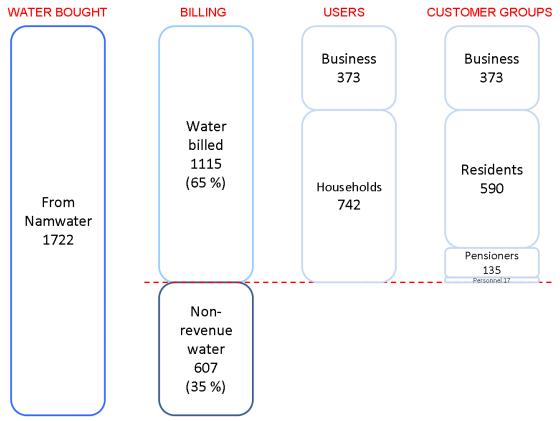
Figure 6. Volumes of billed water in different customer groups in financial year 2011-2012. Numbers are $*1000 \text{ m}^3$ /year.

Municipality of Keetmanshoop billed 1 115 000 m³ water in financial year 2011/2012. Business users use about one third of billed water and households two thirds (*Figure 6*). Volumes are based on municipality's accounting summary. Billing is based on meter readers' monthly readings. Accounting is quite reliable, but some billing corrections that are made afterwards may be excluded from the summary. Still, error of billed volumes is less than 5%.

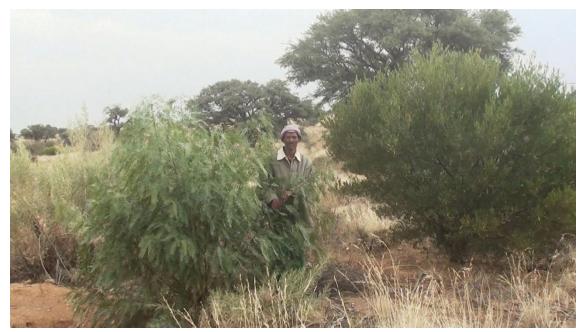
Photo 4. Green bushes during dry season are clear signs of leaks.

Tens of valves are leaking in Keetmanshoop's network. Water on ground surface and green bushes during dry season are signs of leaks (*Photo 4*). These signs exist mainly near valves, but in some places the situation looks more like pipe leaks. It seems that generally green bushes grow when the leak is small. After the leak grows also water penetrates on the surface. Despite of tens of leaks are known the municipality does not consider fixing of small or medium leaks as an important issue. Plumbers concentrate on fixing big pipe bursts and only few smaller leaks were fixed during the two-month field work of this study.

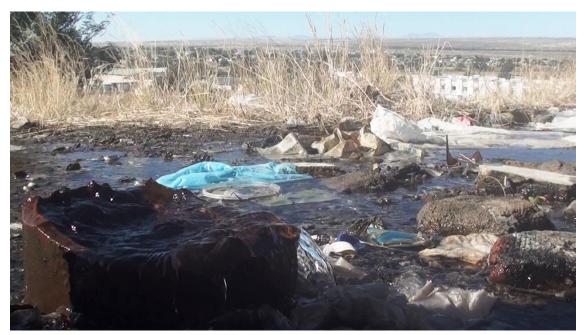
Photo 5. A leaking value on Canon Cop hill. It was possible to measure the water loss caused by this leak by a cup and a stopwatch.

In June 22^{nd} about $15m^3/day$ leaking valve was found on Canon kop and it was fixed in July 23^{rd} (*Photo 5*). In July $21-22^{nd}$ the old reservoir of Canon kop filled up because of a mistake in fixing. Night flow during that night was $135m^3/h$, which means about $30m^3/h$ loss. The total volume of water lost during this leak was approximately $800m^3$.

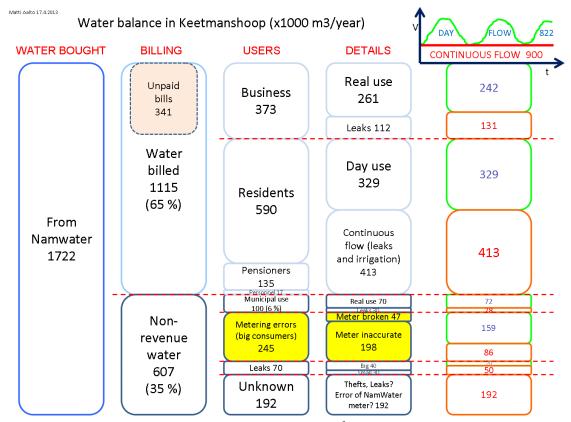
Figure 7. Water balance in Keetmanshoop ($x1000 \text{ m}^3$ / year). Numbers are based mainly on year 2011-2012 and partly year 2010-2011. "Unpaid bills" is an average of years 2008-2012. Detailed calculations are explained in their own chapters.

Water balance of Keetmanshoop is shown in *Figure 7*. According to these calculations municipality loses 4 000 650 N\$ from 537 000 m^3 of water per year counted by Nam-Water's tariff 2011-2012. In addition, the unpaid bills cause economic losses and extra work for municipality. When looking the situation from the perspective of all water users, it seems that about half of water is lost through leaks in one of the driest countries in the world.

Numbers in *Figure* 7 are best approximations and margins of error are quite big in columns "Details" and "Continuous flow", and also in contents of NRW. Especially the continuous flow of households seems to be big, but direct evidence about it does not exist.

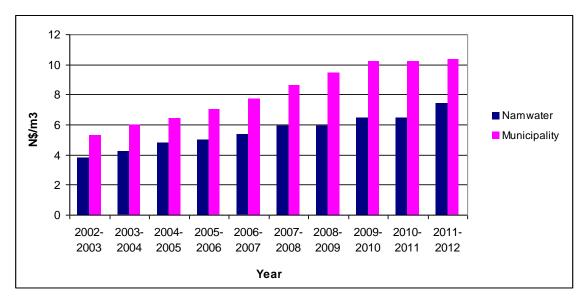
Figure 8. Development of water tariffs in Keetmanshoop in 2002-2012.

Water tariffs have increased steadily during the last ten years (*Figure 8*). Municipality's profit has also increased until 2011, but it is still seldom enough for maintenance costs. In 2011-2012 municipality bought water for 7.45 N\$/m³ and sold for 10.32 N\$/m³.

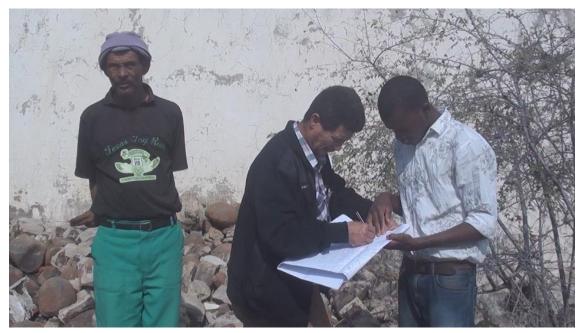
Photo 6. Water distribution map is an important tool in network management. A few persons are used to use it in Keetmanshoop at the moment.
