TAMPEREEN TEKNILLINEN YLIOPISTO
TAMPERE UNIVERSITY OF TECHNOLOGY

NIKO KORHONEN
TENSILE CAPACITY OF THE GROOVED STEEL PIPE PILE

Master`s thesis

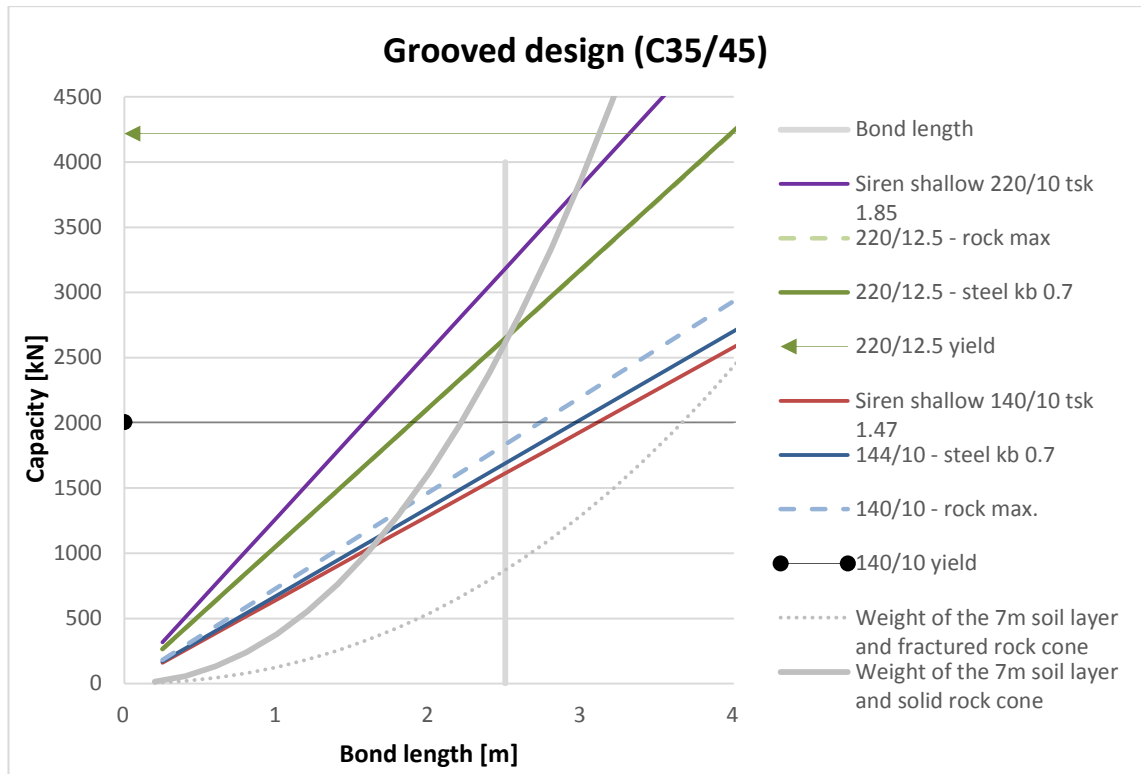
Figure 16. Comparison of the capacity of each failure mechanism studied.

If this knowledge is used in the case of rock cone failure where the rock cone acts as belled base and therefore tries to lift the soil over the rock. The most conservative approach is to use the cylinder form. If this weight is added to the weight of the rock cone, based on Eurocode, this failure mechanism is not critical in deep soil layers expect in case of fractured bedrock.

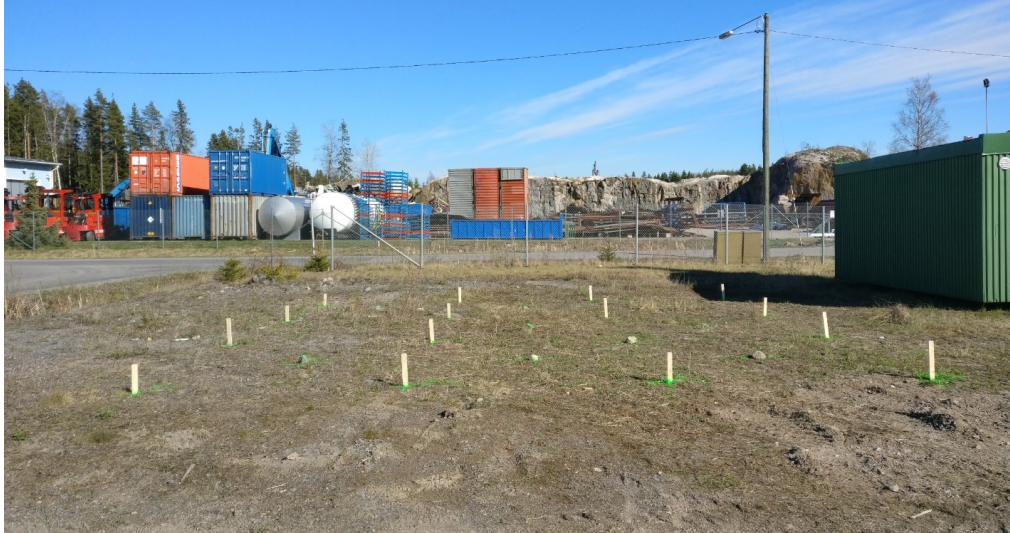
Figure 20. Marked test site in Rusko

The test was carried out in summer of 2017 between May and June at Turun Siirtomurske Oy's yard. The test site was measured and marked according to design layout before drilling so that piles could be drilled to the right spot as planned. The test site was marked and can be seen in Figure 22. The drilling and grouting was done by Suomen Teräspaalaus Oy and Tampere University of Technology was responsible for the loading and monitoring during the pull out test. Turun Siirtomurske prepared the load structure for the load test. They cut the support piles all to the same level around 10cm over the ground level and made the pile consoles for the loading test. The loading structure can be seen in Figure 23.

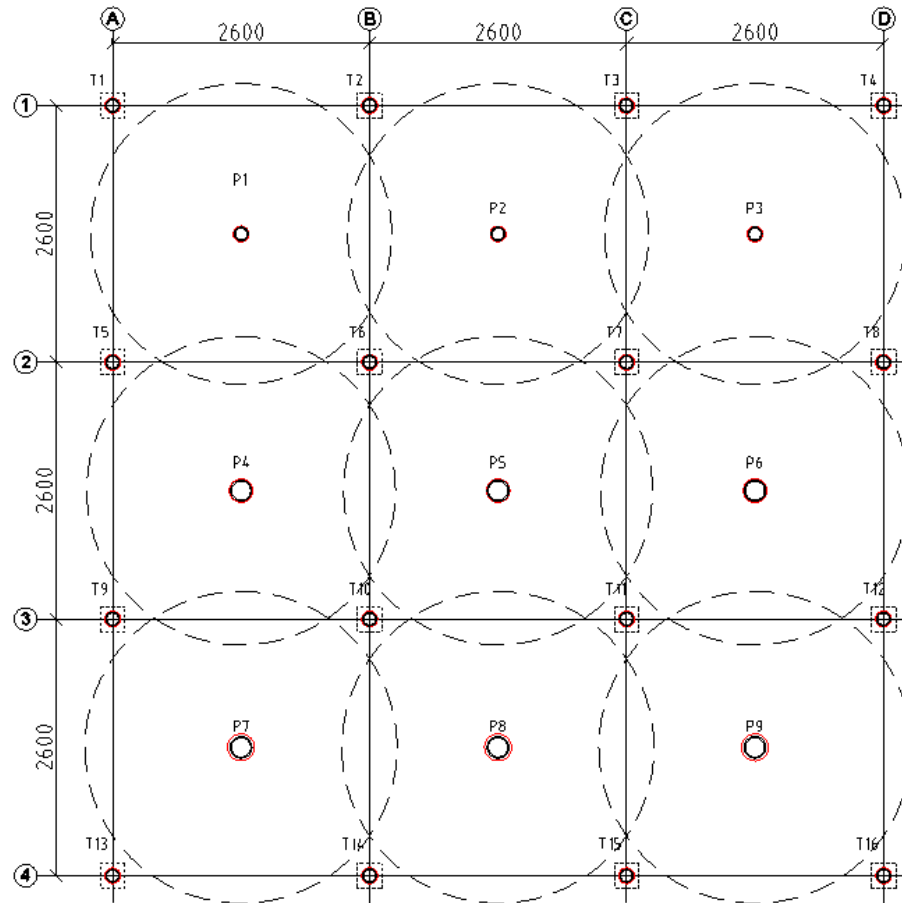
Figure 21. *Layout of the site*

For the loading test, 16 support piles labelled as T1 to T16 were drilled in to the bedrock and 9 test piles labelled as P1 to P9 were drilled and grouted into the bedrock. The test piles were drilled into the depth of 2.5m and support piles minimum of 0.5m. The test piles were delivered by SSAB. Three of the piles were RDs 140/10 and six of the test piles were RDs 220/12.5. All the support piles were RDs 140/10. Steel grade of the piles were S550J2H.

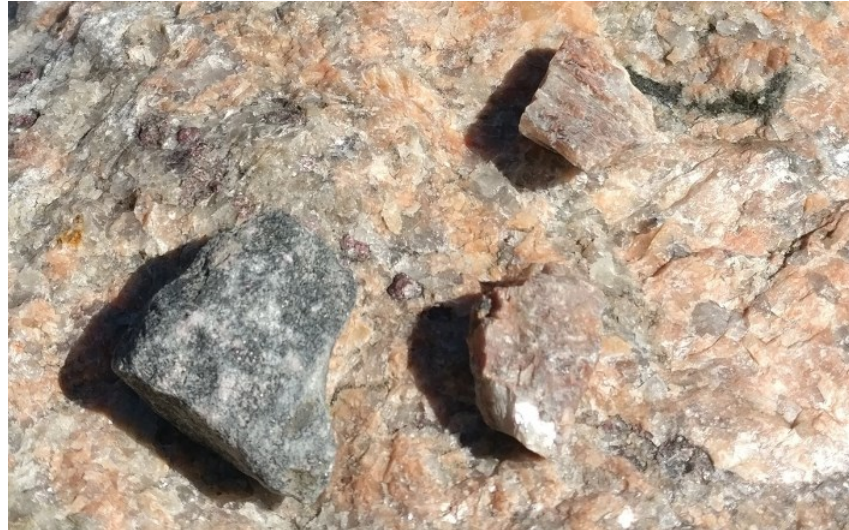
Figure 24. Gneiss and granite particles from the site

The construction site was located in Rusko. The ground conditions consist of around 0.5–1.0 m deep filling layer, 5–7 m deep clay layer and the granite bedrock. The conditions were known from the experience of the landlord and were estimated with the test drills. From the database of the Geological Survey of Finland (2017) can be seen that the soil at the site is clay and the bedrock is plutonic granite rock. It is worth to notice that the site is situated next to transition zone of the bedrock where the rock changed from biotite paragneiss to granite. By the drill chipping and the rock samples, which could get during drilling, the bedrock was estimated to be granite with some gneiss particles as seen in Figure 24. Granite was estimated include lots of quartz.

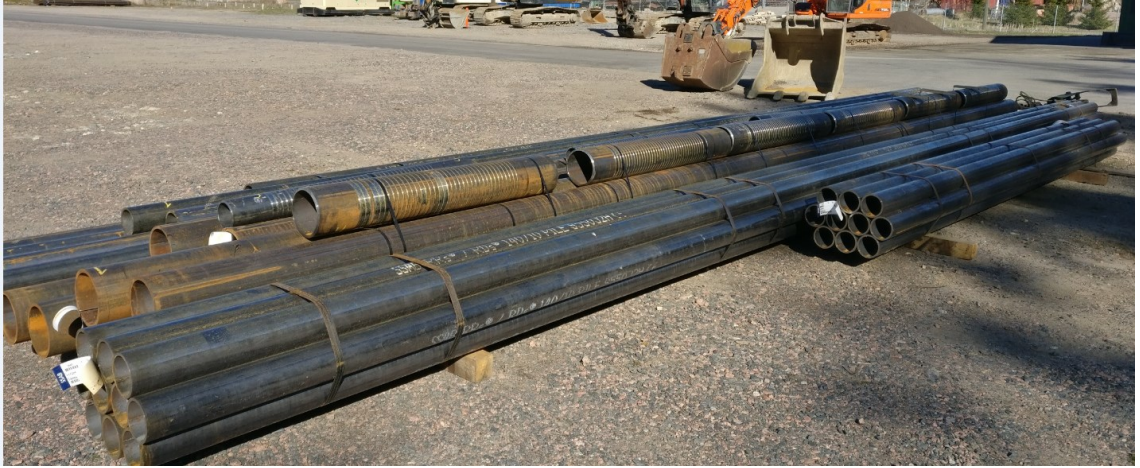
Figure 25. RDs pile elements

All the pile elements which were used can be seen in Figure 25 and was delivered and manufactured by the SSAB. All the piles were either RDs 140/10 with outer dimension 139.7 mm and wall thickness 10 mm or RDs 220/12.5 with outer dimension 219.1 mm and wall thickness 12.5 mm. All the piles were made from high yield strength steel S550J2H. According to inspection certificate the piles and the parts meet the demands of European standards by European technical assessment ETA-12/0526 and are CE marked. The welds are tested with NDT-test by SSAB and the yield strength from tensile test clearly exceeds the declared strength. By the chosen steel grade S550J2H and the chosen groove type, better yield strength and bond strength should be acquired based on the previous research. Also 12.5mm wall thickness chose to be used to avoid any limits to the yield strength during the loading. For RDs 140 piles only 10 mm wall thickness was possible.

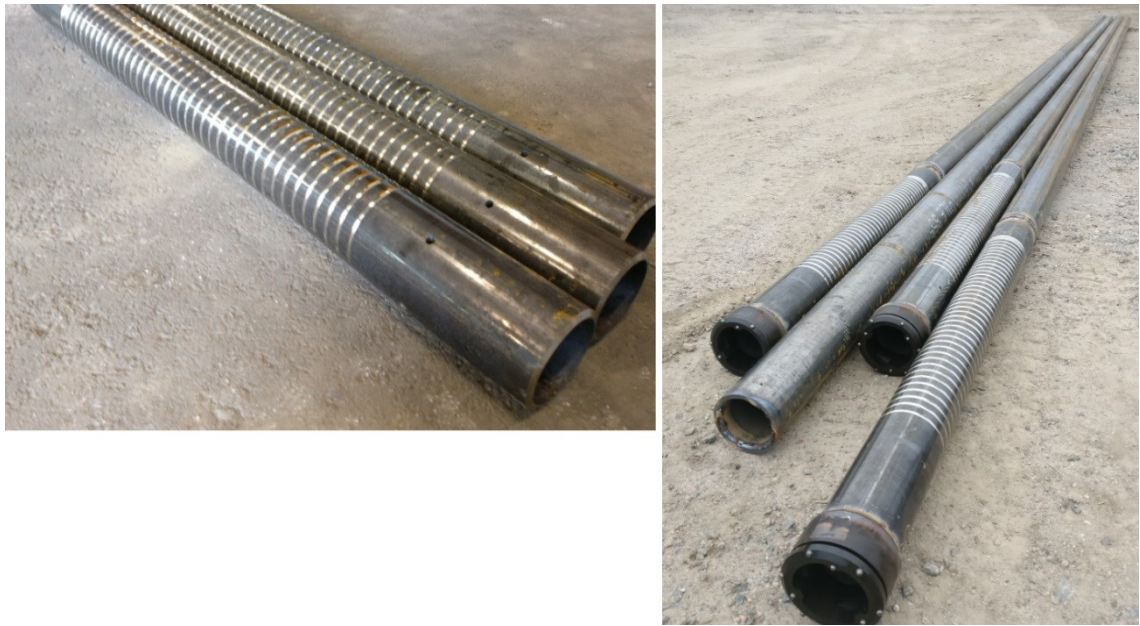
Figure 27. Grooved part of the test pile and final RDs 140/10 piles

At the test site the lower part of the pile and upper part was joined together by manual metal arc welding. Ring bits were also added to the piles by welding to complete the test pile profile. The complete pile structure can be seen in Figure 27.

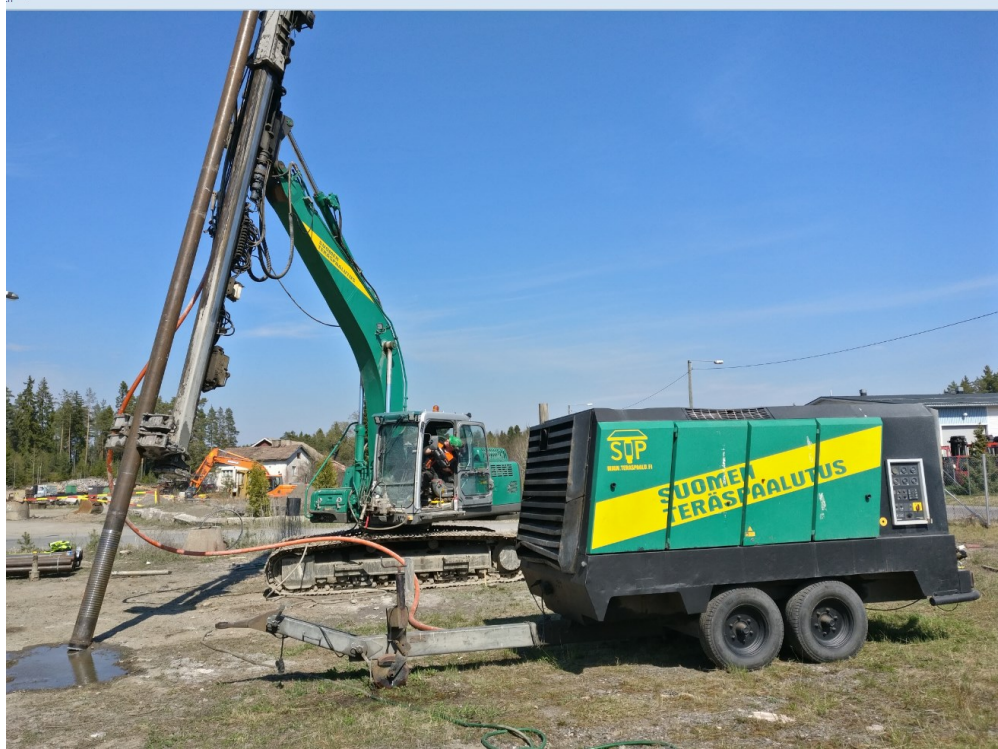
Figure 28. Drilling rig and compressor

Suomen Teräspaalaus used excavator with separate SPD drilling rig and separate compressor for the drilling which was proven to be a very flexible combination. The drilling rig which can be seen in Figure 28 used compressed air for the down the hole hammer and for the flushing the soil from inside. Water was used to bind the dust and the drill cuttings while drilling. Water could also be used to flush the pile from inside after drilling.

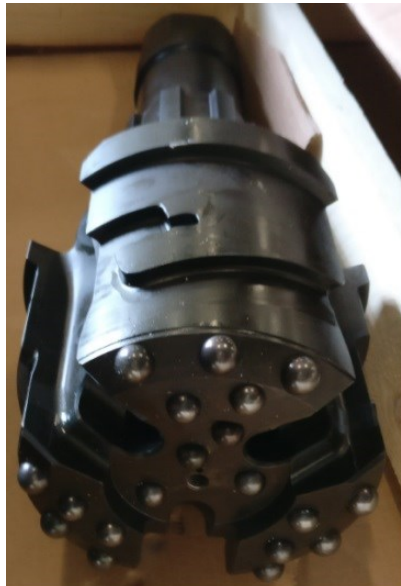
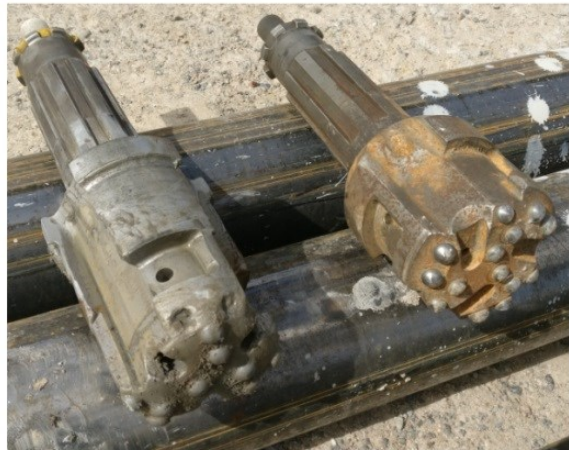
Figure 30. *Pilot bits which was used for drilling*

The method for the drilling was down the hole concentric drilling which was described in chapter 2.3. The pilots for the drilling were DTH-Prime and DTH-RoX DS. Ring bits for the test piles was DTH-Prime 139.7/10 with reamer diameter of 161 mm , DTH-Prime 219.1/12.7 with reamer diameter of 241 mm and DTH-RoX DS XL2 with the oversized reamer diameter of 273 mm which can be seen in Figure 31. Pilots and ring bits can be seen in Figure 29 and Figure 30. Four inch down-the-hole hammers were used for the RDs 140 piles and six inch hammers were used for the RDs 220 piles.

DTH-RoX DS

DTH-Prime

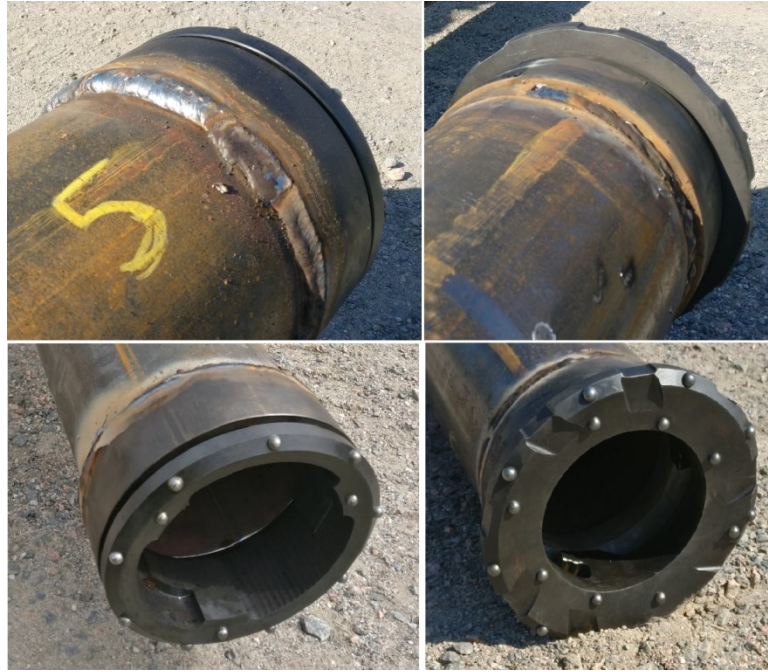
Figure 31. *Robit DTH-Prime (left) and DTH-RoX DS XL2 (right) ring bits*

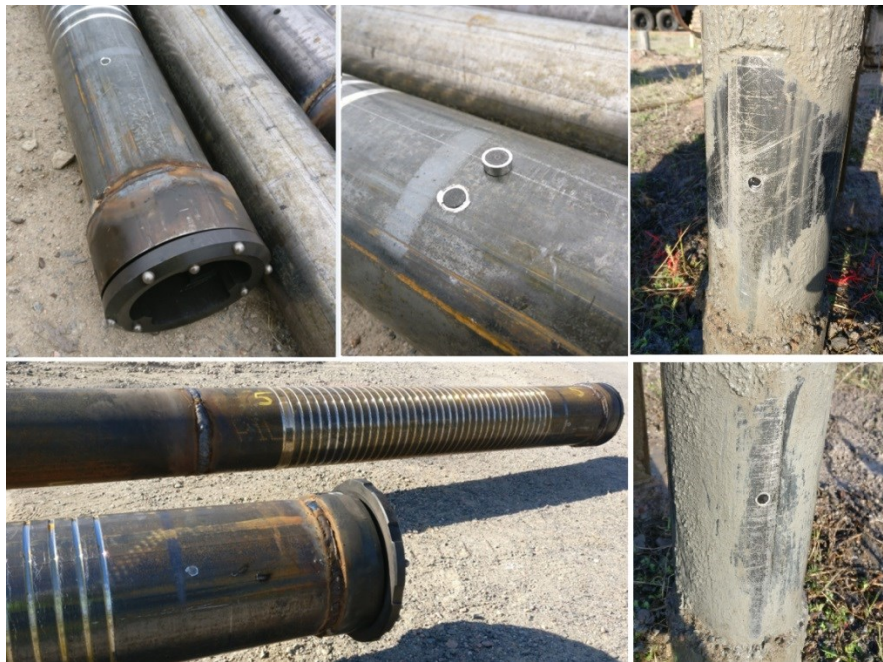
Figure 32. *Grouting valves before and after drilling*

The grouting valves were installed into the grouting holes just before drilling. Grouting valves which can be seen in Figure 32 were used to prevent grout to flow back to the pile after grouting. Valves were installed into the holes with a hammer. The tolerances were designed so that the valve would fit tightly into the hole. According to manufacturer valves opens with the 2/3 bar pressure and can ensure 50 l/min grout flow. Thus at least 2/3 bar over pressure is needed for the grouting.

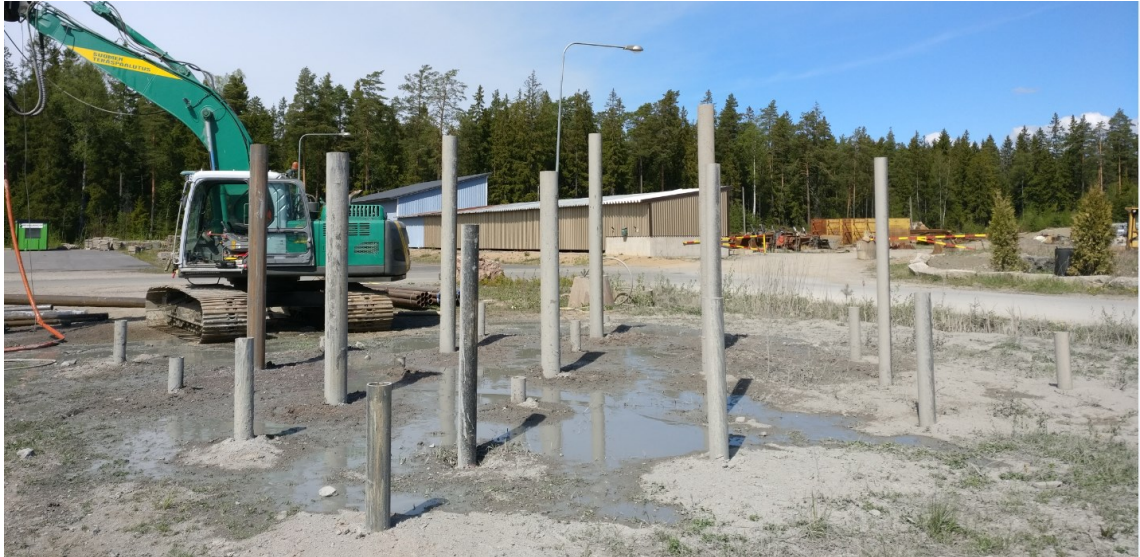
Figure 33. The test site after drilling

The final test site after the drilling can be seen in Figure 32. At this point it was clear that some of the test piles were too short for the load structure assembly and thus they needed to be continued by welding extra lengthening pieces.

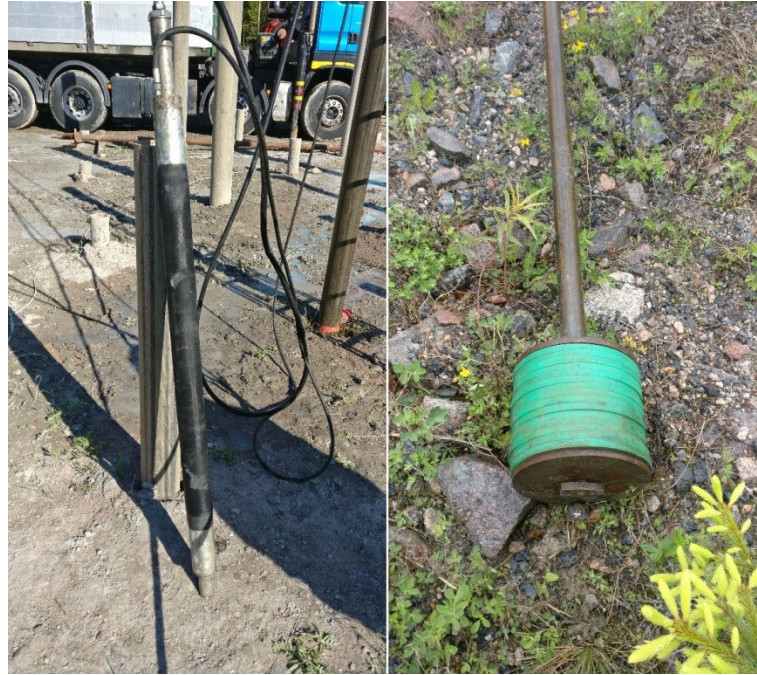
Figure 34. Tube-à-manchettes

Flushing was done with the same single stage tube-a-manchette method than grouting. At first the manchette was laid down to the pile bottom and then lifted 400 mm to ensure that manchette is just over the grouting valves. The manchete was tighten either with the pneumatic jack in RDs 220 piles and with hydraulic pressure in RDs 140 piles due to different type of tube-a-manchette setup. Both tube-a-manchettes can be seen in Figure 34.

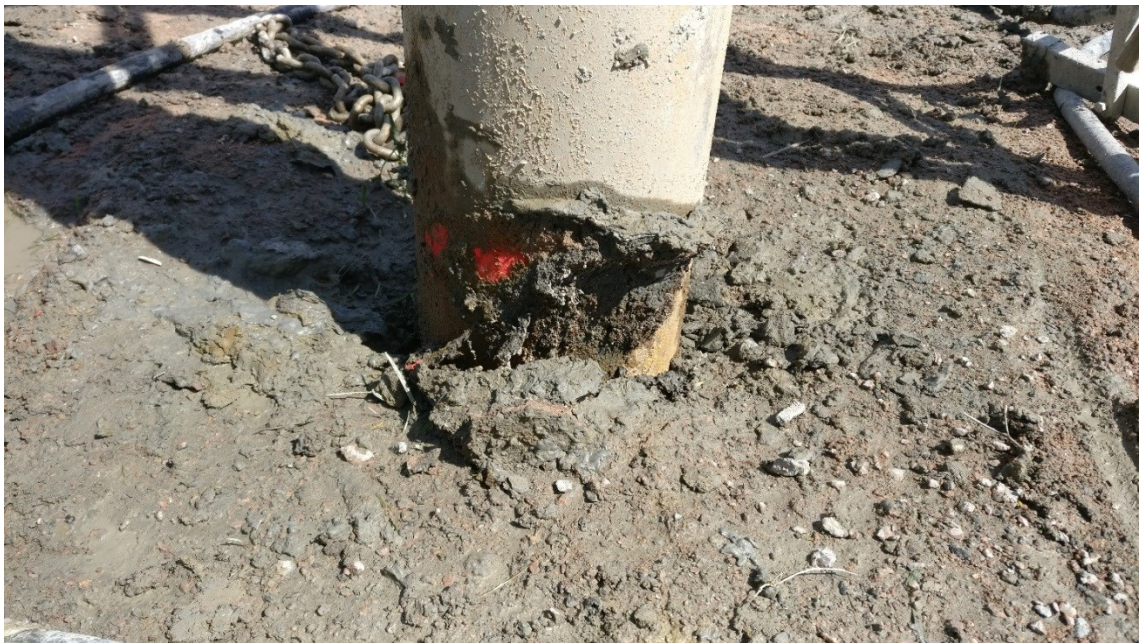
Figure 36. P6 RDs 220 pile which rose from the ground

Pile number P6 also got stuck but it managed to get open with flushing pressure of 12 bars. At the same time pile rose upwards 10 cm from the drill hole which can be seen in Figure 33. At this point flushing and grouting was continued because the studied bond strength does not actually depend on the bond length thus the results from the test will still be comparable. Later same problem occurred with pile P4 while grouting and it started rose continuously. The pile was first anchored to the support pile and after grouting pushed back with the HIAB crane which was used to lay down the tube-a-manchette into the piles.

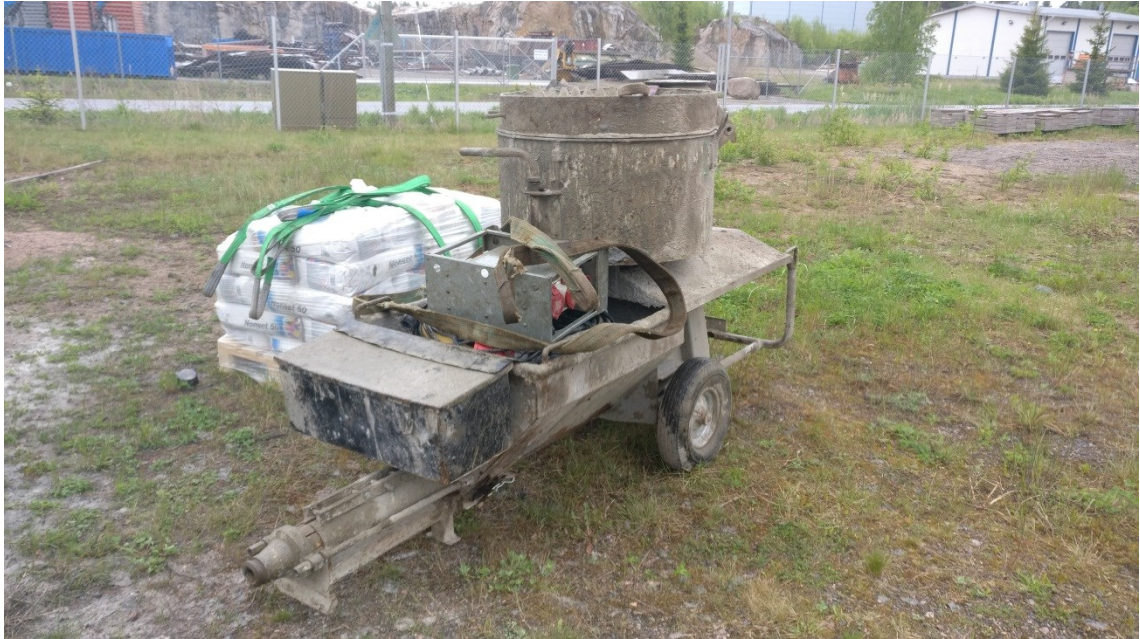
Figure 37. The grout mixer

The grouting was done in two phases. The first phase was to grout a pile three times the volume of annulus plus volume of the pile tip. Second phase was to release the tube-a-manchette and continue grouting with the second part of the batch and lift slowly the tube-a-manchette up from the pile. The second phase was made to provide counter pressure and may prevent grout backflow from the annulus. The piles had also grouting valves installed to prevent the backflow but grout could flow back to pile from the bottom of the pile. Thus the grouting quality wanted to be ensure. When the designed volume of the grout was used the manchette was completely lifted up and moved to next pile.

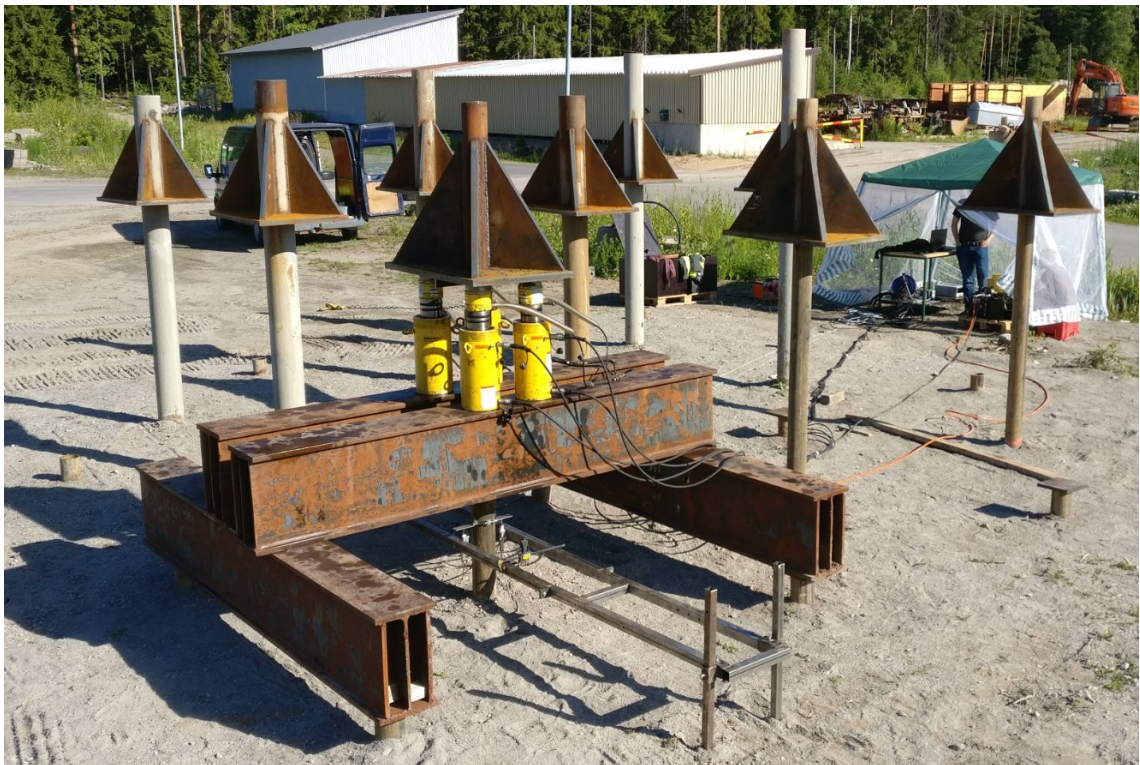
Figure 39. The loading structure and the test site

Design for the loading structure was mostly same which was used in previous (Sirèn 2015) study. Difference for her research was the length and size of the upper steel beams. These beams were longer thus it gave more space to examine the movement of the soil. The loading structure for the test which can be seen in Figure 39 composed of four steel beams, four hydraulic jacks and the loading console which was welded to the test pile. Idea was to use the jacks to lift the console structure which was welded to the pile. Thus the tensile force was induced to the pile. The force and displacement of the pile was measured and recorded electronically.

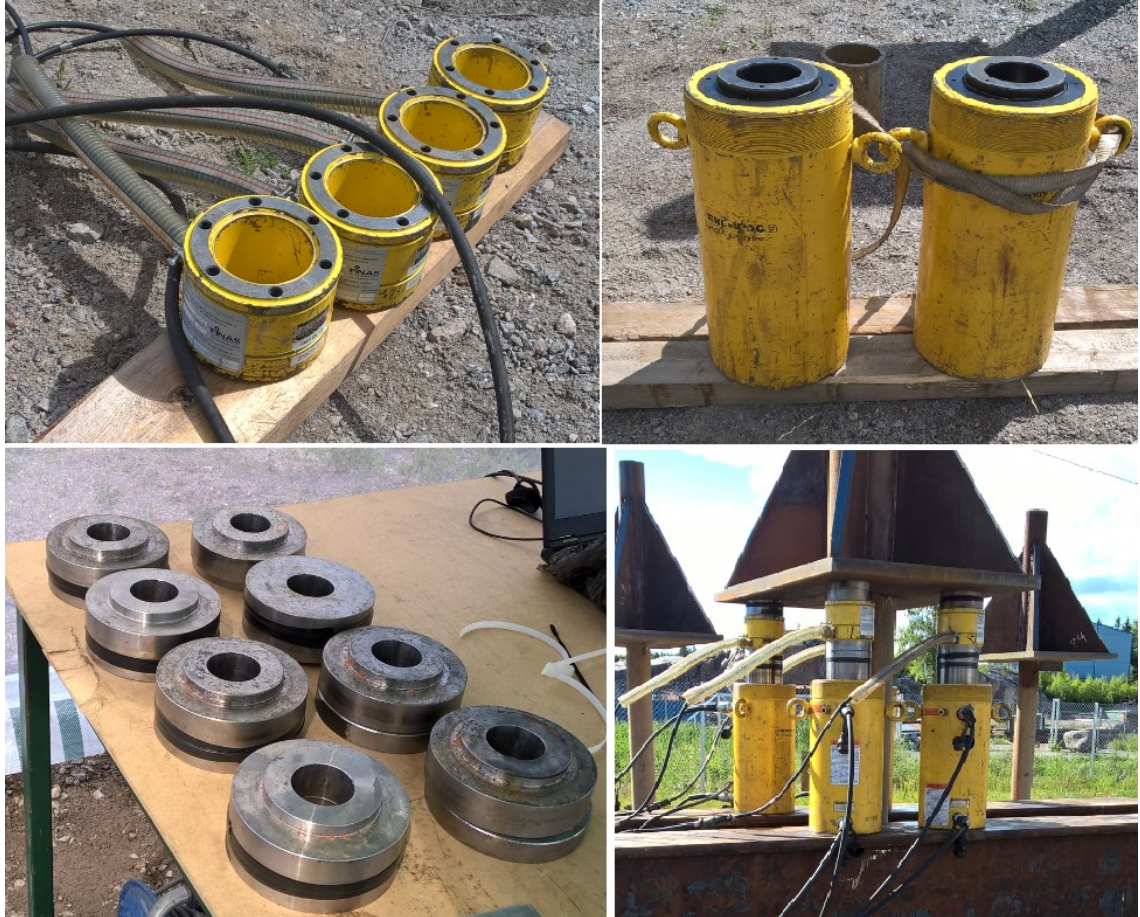
Figure 40. Hydraulic jacks and load cells

The force was measured with the load cells which were installed between the console structure and the jacks. There were also two calottes with spherical surface on both sides of the load cell to ensure that the load cell is at balance and measures only vertical force component. The load cell type was BL-100TE from Kyowa which could monitor a maximum load of 1 MN. Force was recorded on every second.

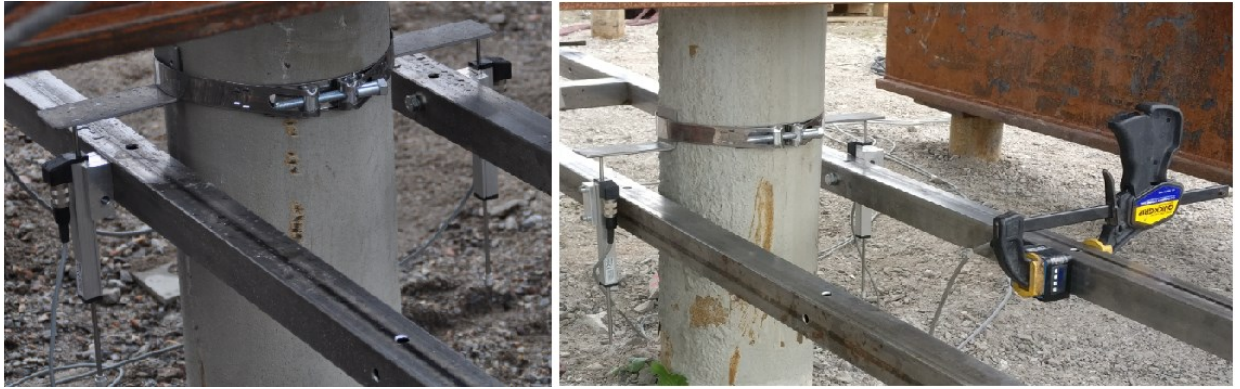
Figure 41. Displacement sensors

Displacement of the pile and the soil were also monitored during loading. Under the steel beams next to the pile a steel rack was installed for the displacement gauges. Two displacement gauges were installed on both side of the pile to monitor the displacement of the pile. As seen in Figure 41, steel bands with two metallic corner pieces were installed to pile surface and two displacement gauges to the rack next to pile. The displacement sensors were installed so that the sensor touched the metallic corner piece on the pile. In the gauge was spring which try to push the sensor upwards. The corner piece was made to prevent the movement. Thus when the pile moves upwards due to uplifting force the corner piece and the sensor also moves upwards and measures the displacement. The sensors displayed an average displacement from these two sensors. Model of the sensors was Novotechnik TRS 100. Accuracy of the sensors was 0.002 mm and the maximum displacement of 100 mm. Measuring interval for the test was 1 second. Results for the test could be seen live from the computer as force – displacement graph.

There were also two laser displacement sensors installed to the rack. These sensors were installed away from the pile at the distance of 50 cm and 110 cm. Idea for the sensors was to observe the ground movement around the pile on the soil surface. The laser was pointed on to the soil surface thus it could measure variance of the distance to the rack. This position was calibrated as zero thus the difference could be seen if the displacement occurred. After installation there was some fluctuation on the results of the sensor so accuracy of the laser was estimated to be around 1 mm probably due to disturbance from the sunny weather conditions.

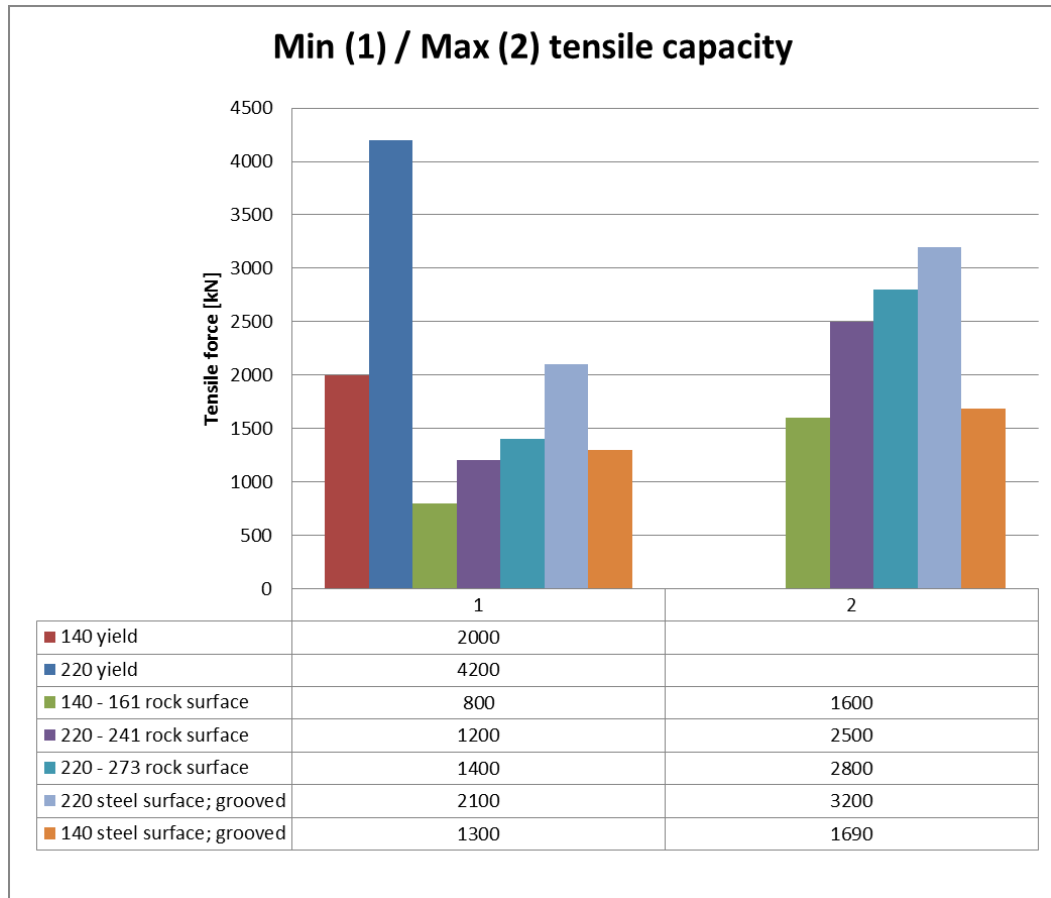
Figure 42. Minimum and maximum tensile capacity for the estimated failure modes before loading [kN]

Based on the average bond strength from the Sirèn's research the average tensile capacity for the piles could be calculated by Equation (2).

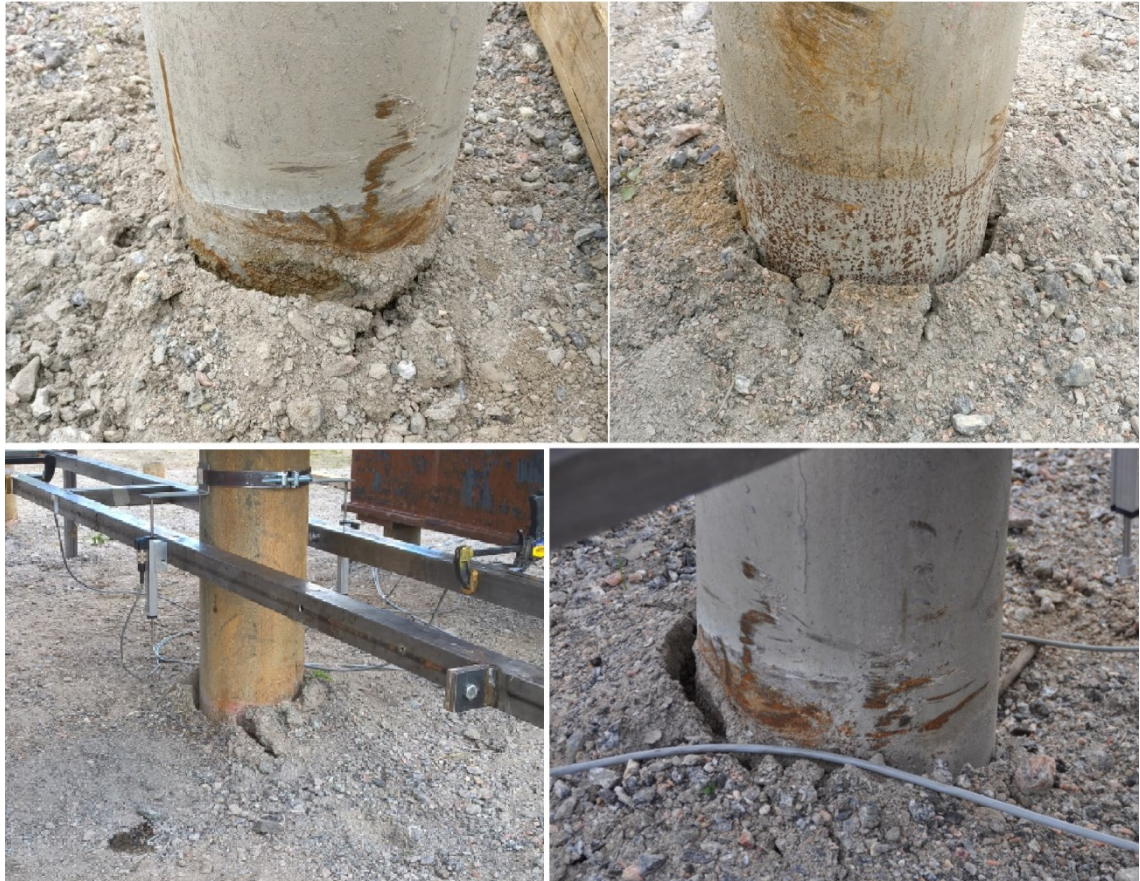
Figure 47. *Displacements next to test piles after loading*

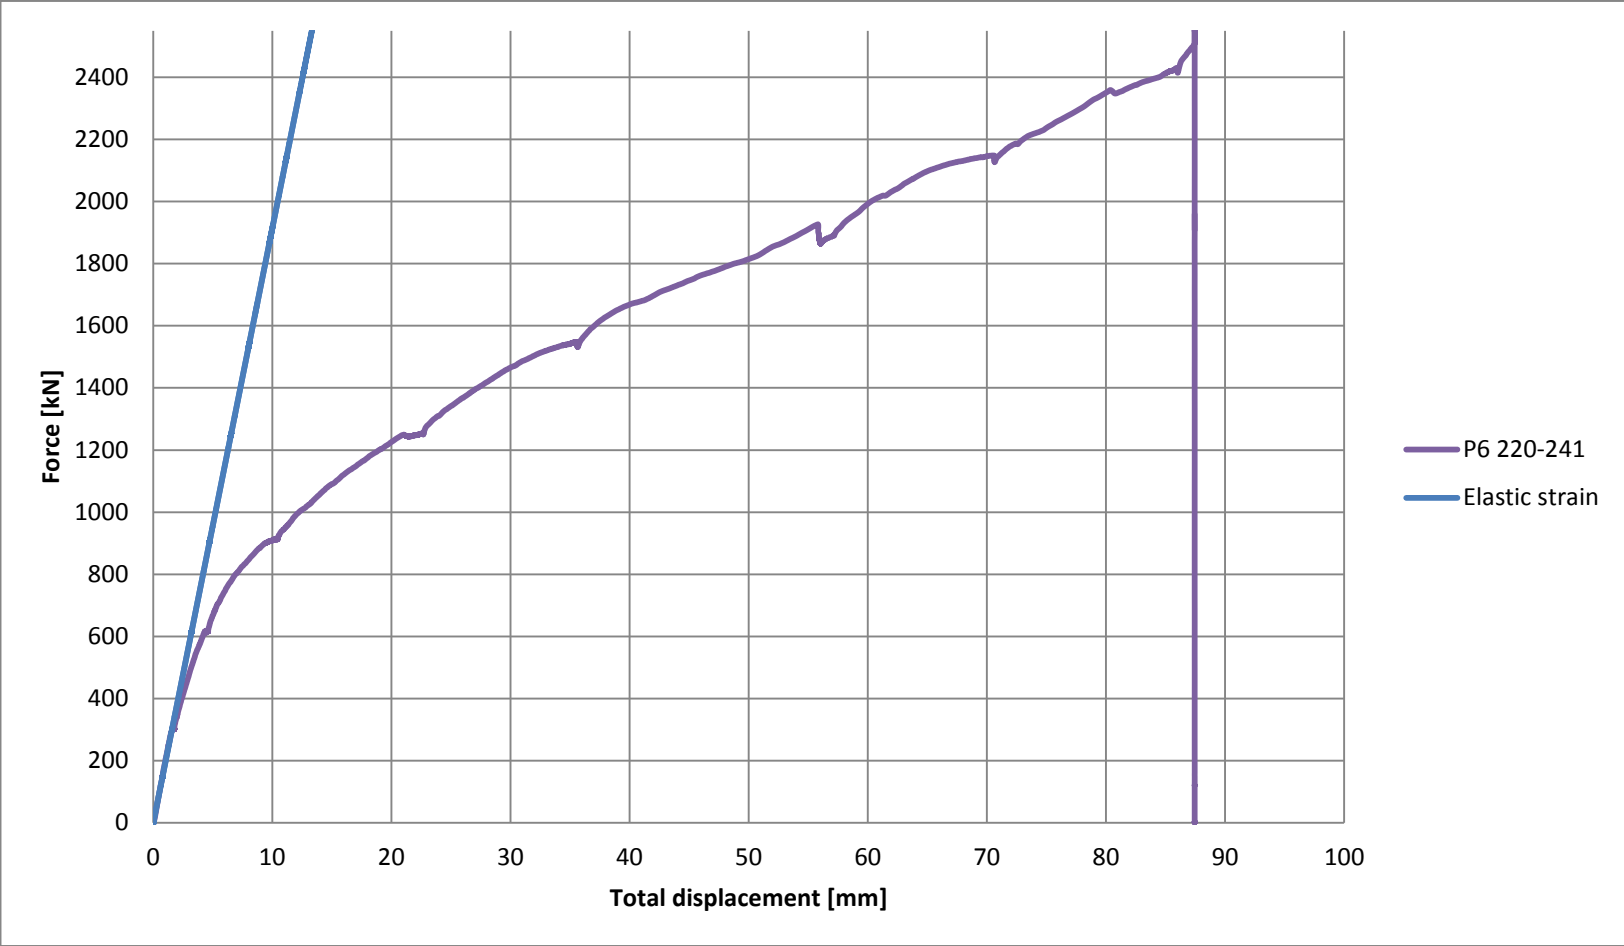
APPENDIX 7: FORCE — DISPLACEMENT GRAPH P6
