Erosive and abrasive wear performance of carbide free bainitic steels – comparison of field and laboratory experiments

Carbide free bainitic (CFB) steels have been tested in two heat treated conditions and compared with currently used quenched and tempered (QT) steel in an industrial mining application subjected to erosive-abrasive wear. A conventional sliding abrasion and a new application oriented high-stress erosion wear tests were performed in laboratory. The results of the erosion and the field tests were compared. The microstructural changes were investigated by optical and scanning electron microscopy. The hardness and hardness profiles of the steels were measured. The results showed that in the laboratory tests, the abrasion and erosion wear rates of the CFB steels were 35 and 45 % lower respectively in comparison to the QT steel. In the field test, the mass losses of the CFB steels were about 80 % lower in comparison with the QT steel. The improved wear resistance of the CFB steel can be explained by its higher hardness and higher work hardening. The erosion wear test was able to simulate the work hardening effect and the wear mechanisms observed in the field test samples

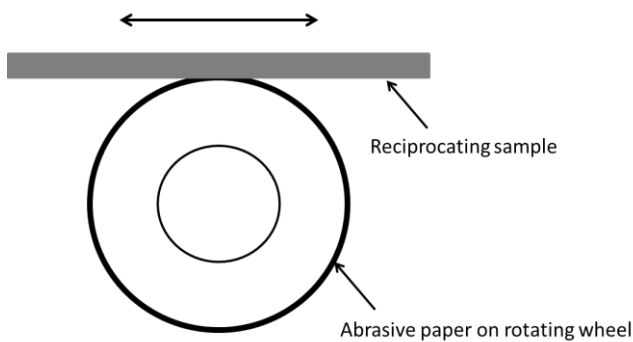
Abrasion wear tests were performed at Lulea University of Technology using a modified ABR-8251 abrasive wear tester, presented in Figure 1 [13]. The tester uses a flat reciprocating sample, sliding on top of abrasive paper (width 6 mm) wrapped around the surface of a wheel. The paper moves a certain distance after each reciprocating movement of the sample and new paper is mated for the next stroke. The initial surface roughness of the samples was approximately 15 μm . The abrasive paper used consisted of a mixture of 60% Al_2O_3 and 40% ZrO_2 particles with a grain size of approximately 270 μm and a measured hardness of 1750 $\text{HV}_{0.3}$. The sliding distance used was 180 m and the load was 16N. The mass of the samples was measured before and after the test. Hardness and surface roughness of the samples were also measured before and after the tests.

Figure 1: Test configuration for abrasion wear tests.

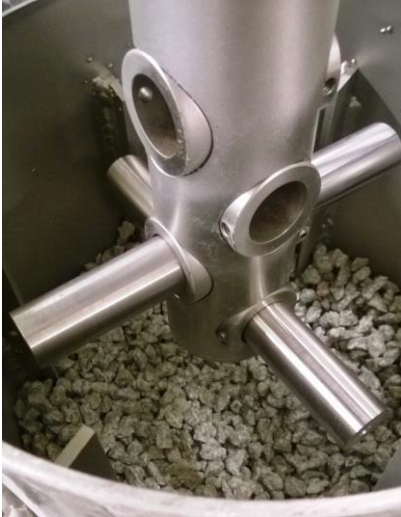
In this study, the tester was used with dry 8-10 mm granite gravel. Figure 2 presents the test configuration, showing the round $\text{Ø} 25$ mm samples and the granite abrasives. During the tests the samples were located at the two lowest levels, as seen in the figure, on the rotating main shaft. For ensuring that the wear conditions were equal for all the samples in the test, sample rotation [14] was utilized, i.e. all samples were tested on the both sample levels in each test. In each test one sample of each steel, with a dummy sample to complete the four sample configuration, was used. Three tests were

Figure 2: Dry-pot test configuration for the erosion wear tests. Before the start of the test samples are submerged in to the abrasive bed. The shaft rotates anticlockwise during the test.

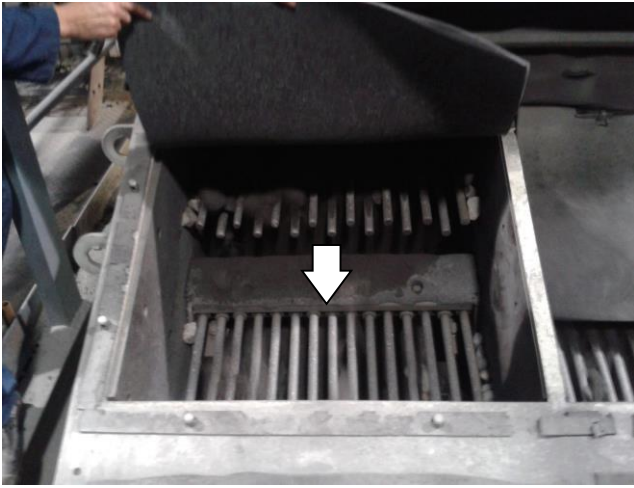
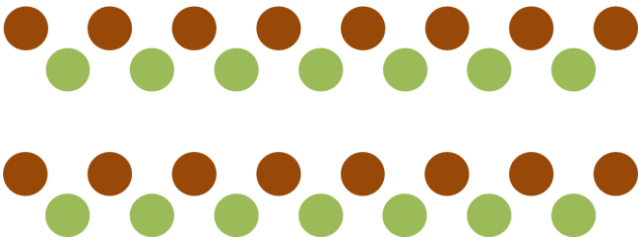
Section 1

The iron ore pieces, consisting of magnetite and gangue, were moved by sliding and shaking from the upper level set of bars to the lower level and then to grids with different mesh sizes. The arrangement with an upper and a lower set of bars is presented in Fig. 3. In each machine 30 QT and 30 CFB bars were mounted and subjected to the wear; CFB 270 steel bars were mounted in one machine and CFB 300 in the other. The bars were located in two sections of each machine; the QT bars on top in the first and CFB bars on top in the second section. The test lasted for 28 days and about 125 000 tons of material passed each section. The hardness and the mass of each bar were measured before and after the test.

Figure 3: The field test arrangement of bars in one of the sections used for the tests. Upper Fig. with half of a Mogensen sorting machine, showing upper and lower levels with 15 bars each. The arrow shows the direction of the ore flow. Lower Fig. shows principal sketch of upper and lower level set arrangement of bars. Different colors designates different test materials.

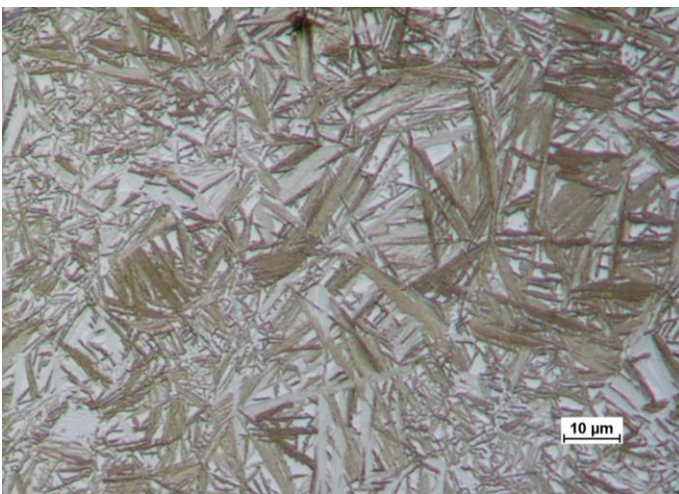
The CFB microstructure contains fine ferritic-austenitic laths and in addition also small white grains of blocky austenite and/or martensite (MA). This can be seen in Fig. 4 in which the microstructure of CFB300 is shown. The microstructure was similar in both CFB steels.

Figure 4: Microstructure of Nital etched CFB300 showing carbide free bainite lath structure enclosing small white areas of austenite and/or martensite (MA).

Hardness values of the white MA constituent were lower than for the alloy in average; hence the MA constituent mainly consists of austenite. The amount of MA constituent was measured to 5.1 ± 1.9 % for CFB270 and to 10.7 ± 1.3 % for CFB300 samples.

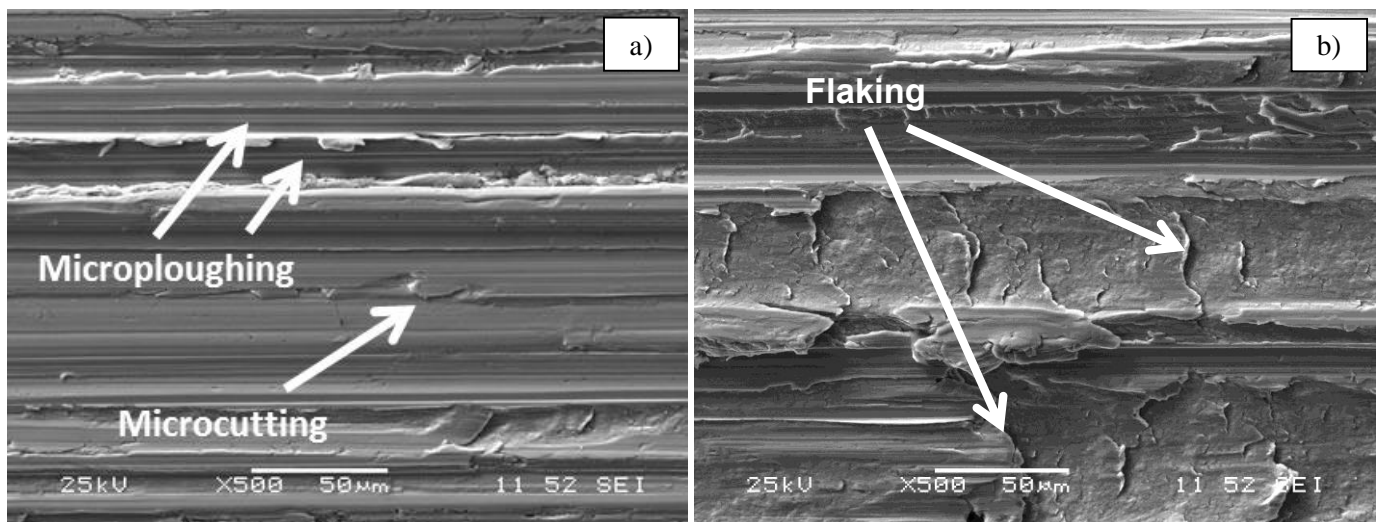
The wear test results showed that the mass loss was lower for the CFB steels but that the R_a values were about the same for all tests. SEM analysis of the worn surfaces revealed three different wear mechanisms, presented in Fig. 5. Whereas QT steel showed more of ductile flaking in comparison with the both CFB steels, the much harder CFB steels showed more microploughing and microcutting as a result of the abrasive wear test. No difference between the CFB270 and CFB300 wear surfaces was detected.

Figure 5: SEM image after abrasion wear test of a) CFB270 showing microcutting, and microploughing, b) QT showing flaking.

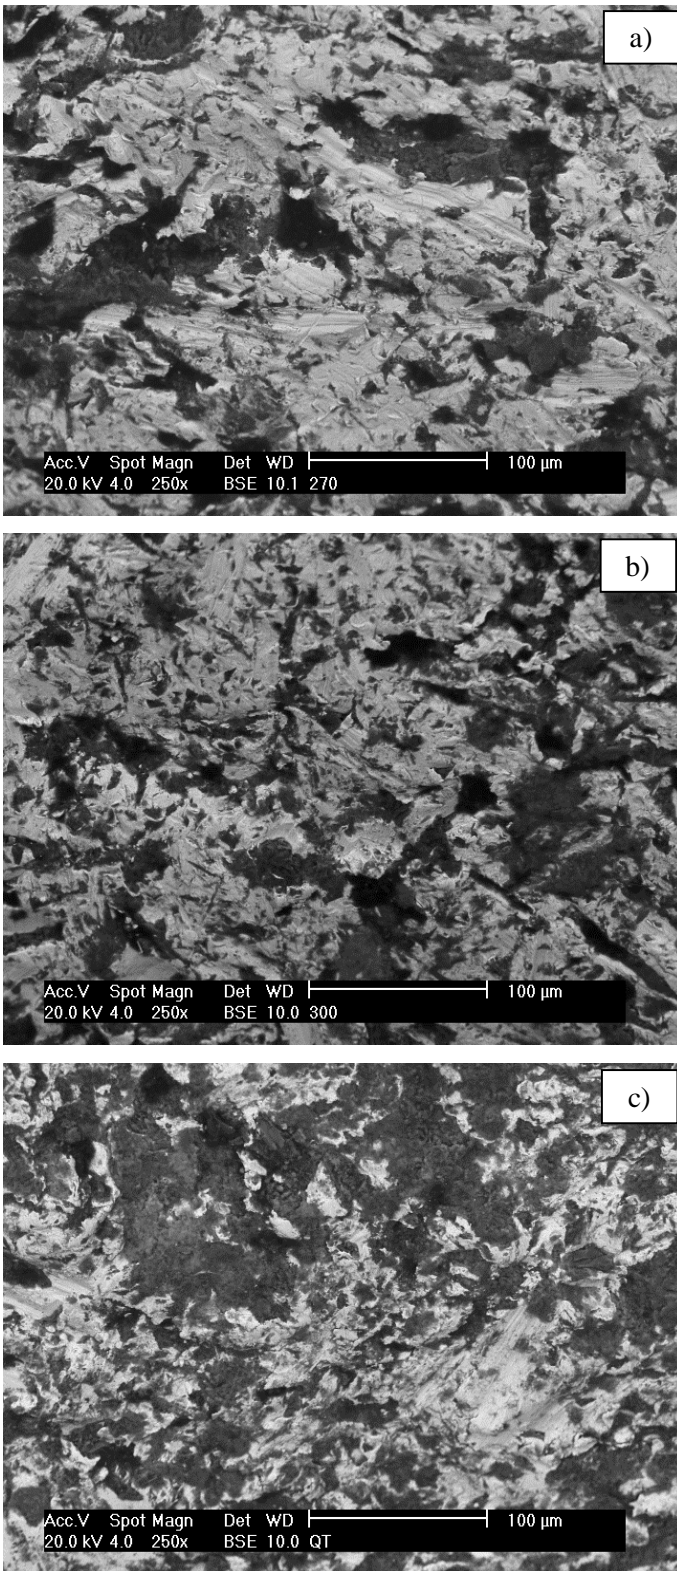
Figure 6 presents SEM image from the wear surface of the erosion tested CFB270 sample. Image was taken with the backscatter detector (BSE), thus the regions appearing dark are embedded gravel and lighter regions are steel. The image is acquired 3 mm from the sample tip along the centerline, i.e. the leading side of the sample during the test.

All materials showed similar wear surfaces in general with heavily worn areas due to the multiple impacts with high velocity. The main difference between the QT and the CFB samples after the dry-pot test were the length of the scratches. The wear surface of the CFB showed short scratches whereas the QT wear surface were highly deformed with dents. Also it was clear that the amount of embedded abrasives was highest in the QT samples. The two CFB qualities showed much lower, but still notable abrasive embedment in the surfaces.

Figure 6: Scanning electron image of erosion tested a) CFB270 sample, b) CFB300 sample and c) QT sample, showing embedded abrasives and short scratches on the erosion surfaces.

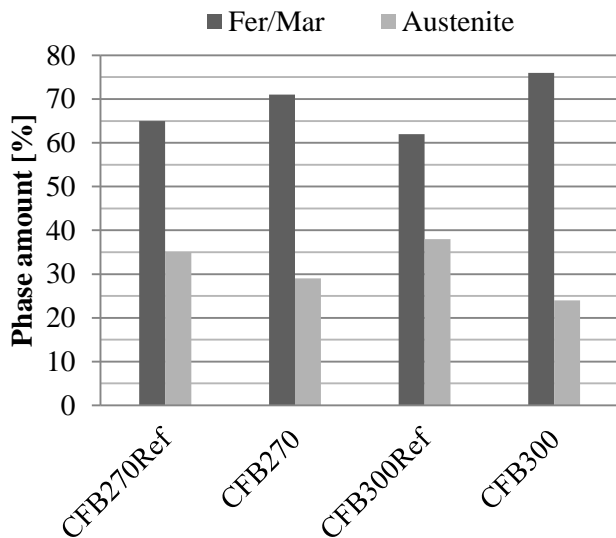
The measurement of the phase composition at the surfaces by XRD after the erosion tests showed that the amount of austenite had decreased for the austempered materials as a result of the erosion as seen in Fig. 7. In addition to austenite, also the ferrite/martensite amounts were measured. The increase of the ferrite/martensite amount after erosion test in comparison to the reference values is caused by the transformation of austenite to martensite by the erosive wear of the surface.

Figure 7. Austenite and ferrite/martensite amounts before (Ref-values) and after erosion tests.

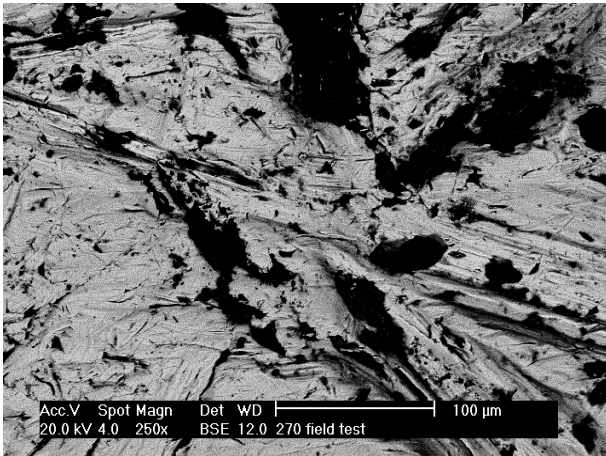
Figure 8 presents SEM BSE image from the wear surface of CFB 270 sample tested in the field. The image was acquired from the centreline of the sample, i.e. the top side of the steel bars in the sorting machine. In the field test the large, up to 5 kg, ore pieces caused larger scratches than what was observed in the dry-pot tests. In addition, the deformed areas were larger in size and showed clearer surface topography. Otherwise the wear mechanisms for CFB steels were the same, consisting of heavy deformations due to high energy impacts and abrasive scratching. The QT instead showed heavily cut surface and areas with very high deformations.

Figure 8. Scanning electron image of field tested CFB270 sample, showing embedded abrasives (dark) and longer scratches on the wear surface.

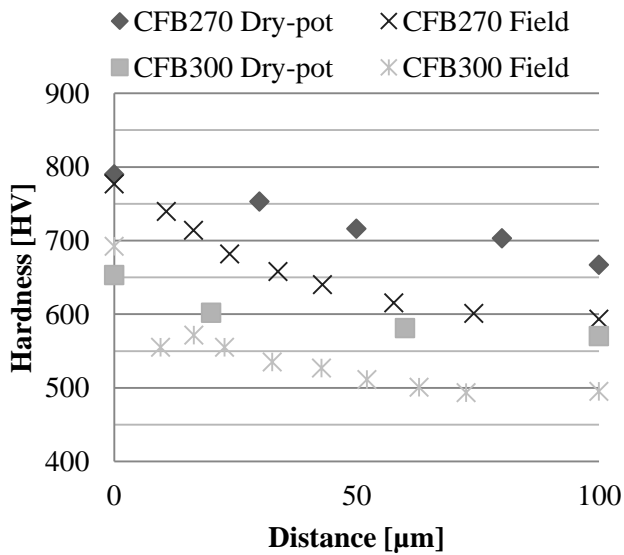
As the wear surfaces showed similar wear mechanisms in the dry-pot and field tests, the cross-sections from the tested samples were also characterized with SEM and by hardness measurements. Hardness profiles were measured from the cross-sections of the surfaces with maximum nominal particle impact angle (90°) for the field tested bars as well as the bars used in the dry pot erosion tests with a micro-hardness tester with a load of 50 g. Fig. 9 shows that the hardness profiles for both CFB-materials were quite similar after the tests. The surface hardness values are from Tables 3 and 4, thus measured with 200 g load.

Figure 9. Hardness profiles after field tests and dry-pot tests of the two CFB materials, CFB300 and CFB270.

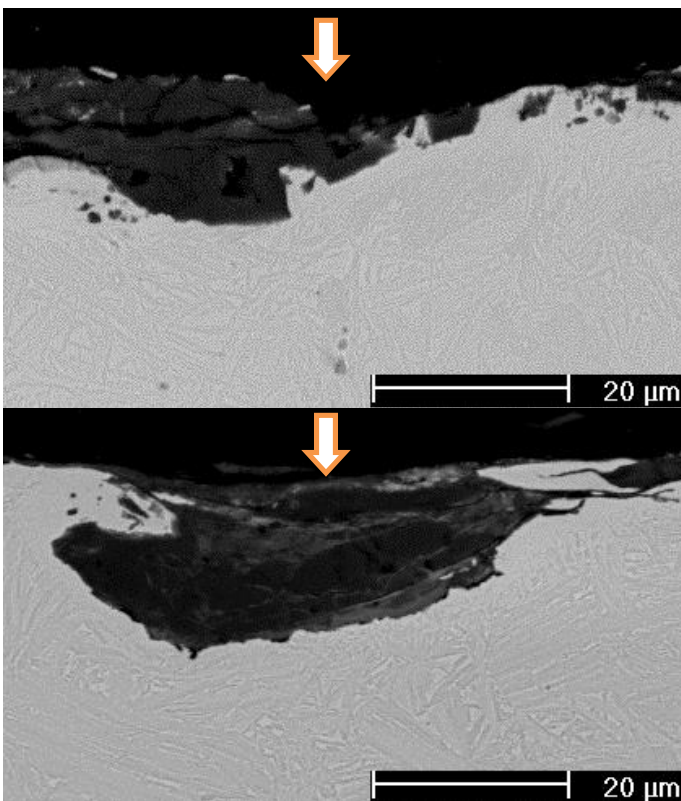
Fig. 10 shows the cross sections of the field tested and the erosion tested surface of the CFB 300 sample. The arrow is indicating the estimated impact direction of the abrasives towards the sample surface. The direct impacts towards the surface produced similar large dents in the both surfaces. Penetration and deformation depths of the abrasives were in average about twice as deep in the field tested specimens, caused by the larger and heavier particles.

Figure 10. The cross-section of the erosion tested (above) and the field tested (below) CFB300 specimen. The arrow indicates the direction of the impact.

When the cross-sections of the dry-pot samples were characterized, two different features were found. Towards the direction of rotation, the cross section had more craters produced by impacts whereas in the sides the cutting marks were dominant. Similar features were also found on the cross-sectioned field tested samples and both types of samples had embedded stones. In the field tested samples these layers were more distinct mechanically mixed layers of steel and

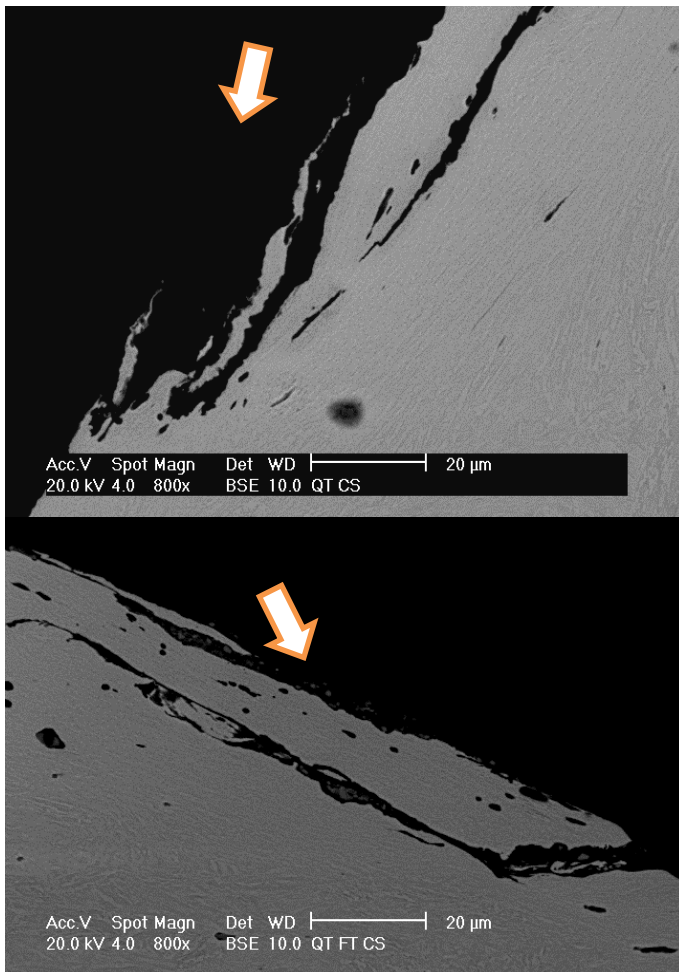
Fig. 11 shows the cross sections of the field tested and the erosion tested QT samples. Now the arrow is indicating slightly oblique impact angle for the particles, as the figures are taken from the side part of the round bars. It can be observed that the lateral impact towards the surface produced similar main features into the both surfaces with entrapment of the abrasives and the formations of plastically deformed lips.

Figure 11. The cross-section of the erosion tested (above) and the field tested (below) QT specimen. The arrow indicates the direction of the impact.

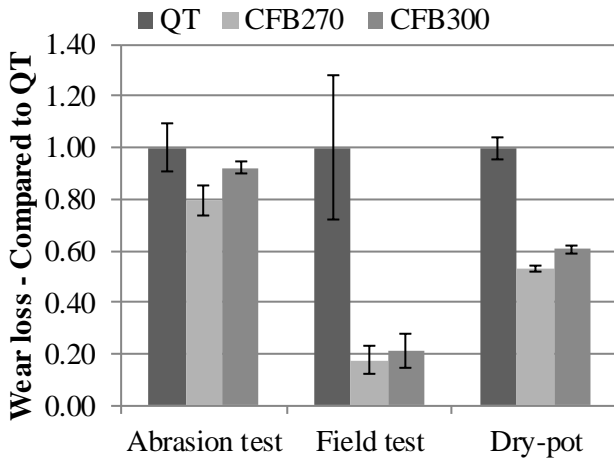
While the wear performance of CFB-steels was compared against QT-steels in an application subjected to a combination of erosive and abrasive wear, the main focus was the comparison of two laboratory wear test methods to a field test. Laboratory scale studies were performed with a conventional abrasion tester and an application oriented dry-pot erosion tester. Fig. 12 presents comparison of all wear tests. The results are scaled to the result of QT reference material in each test. The summary of the results shows that the dry-pot test method is much closer to the real industrial application as the conventional abrasive paper wear test. Also the deviations in the dry-pot results are smaller than in the abrasion test.

Figure 12. Summary of the wear test results.

Laboratory scale abrasion studies scaled the materials in similar order as in the field tests, but the differences between the QT reference steel and the CFB steels was clearly dissimilar. Also the wear surfaces were dissimilar, as the predominant wear mode in abrasion tester was 2-body abrasion. The work hardening effect was not observed while the wear involved only sliding of the surface against sand paper. This low-stress wear test method results in ploughing tracks on the samples surface but the load on the surface is not high enough to result in any work hardening effect or notable surface deformations.

The dry-pot condition was more severe with high speed combined with larger abrasive size than in the abrasion test. The wear resistance of the samples increased with increasing surface-hardness, but not linearly. High number of impacts with large size abrasives work hardened the surface and increase in the surface hardness was observed after the dry-pot tests, as was presented in Fig. 10. Furthermore, the surface and cross-section studies of the wear tested samples showed that the dry-pot method did produce very similar wear mechanisms and material response, i.e. work hardening, surface deformations and tribolayer formation, in comparison with those obtained in the field test.

In the field test, the difference in mass losses between the QT samples and CFB samples was higher than in the dry-pot test. The field tested surfaces contained longer cutting marks which exposed more fresh steel surfaces towards the impacts. In the dry-pot tested samples, the level of embedment was observed to be higher in the wear surfaces. Cutting was also observed but not as extensively as in the field tested samples. Nevertheless, it should be noticed that the field tested surfaces were studied after service of 28 days, whereas the dry-pot tested wear surfaces after a relatively short test period. Also the abrasives were different types in the dry-pot and the field tests, and the particle size was much larger in the field test. Nevertheless, the test materials showed similar erosion wear surfaces and similar surface deformations in both tests, which is a valuable finding for simulating real industrial applications in laboratory scale.
