Case Study on the 20 Years Propagation of Carbonation in Existing Concrete Facades and Balconies

Key words: Concrete, carbonation, corrosion, field measurement, service life, modelling

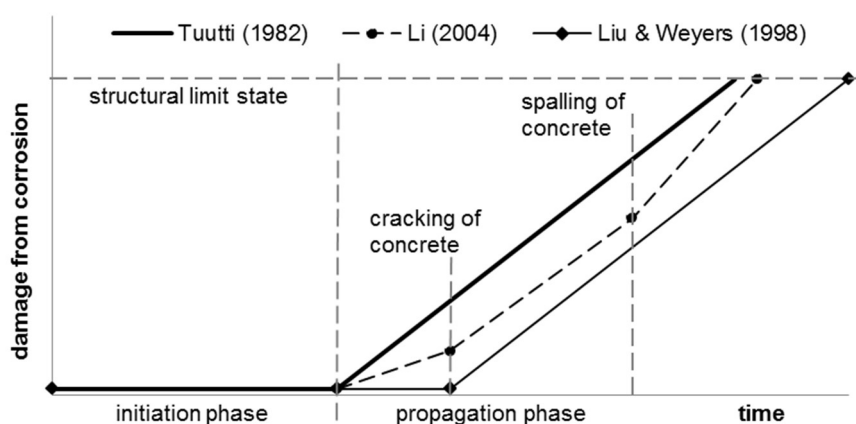
Figure 1 – Models for reinforcement corrosion utilizing the principle of initiation and propagation.

Carbonation induced corrosion of reinforcement together with freeze-thaw damage in concrete facades and balconies are the major degradation mechanisms causing repair need in Finland [1]. Corrosion of steel reinforcement in concrete is commonly regarded as an electrochemical phenomenon meaning that corroding reinforcement works as a mixed electrode where cathodic and anodic areas are formed on the steel surface [2]. The size of anodes and cathodes determine the nature of corrosion. Corrosion due to carbonation is general over the reinforcement surface with relatively evenly spaced cathode and anode areas. [3]. Because concrete protects steel from corrosion as a protective layer for the reinforcement, corrosion does not initiate immediately. This has been taken into account by depicting reinforcement corrosion as a process consisting of two or more consecutive phases [4, 5, 6] as shown in Figure 1.

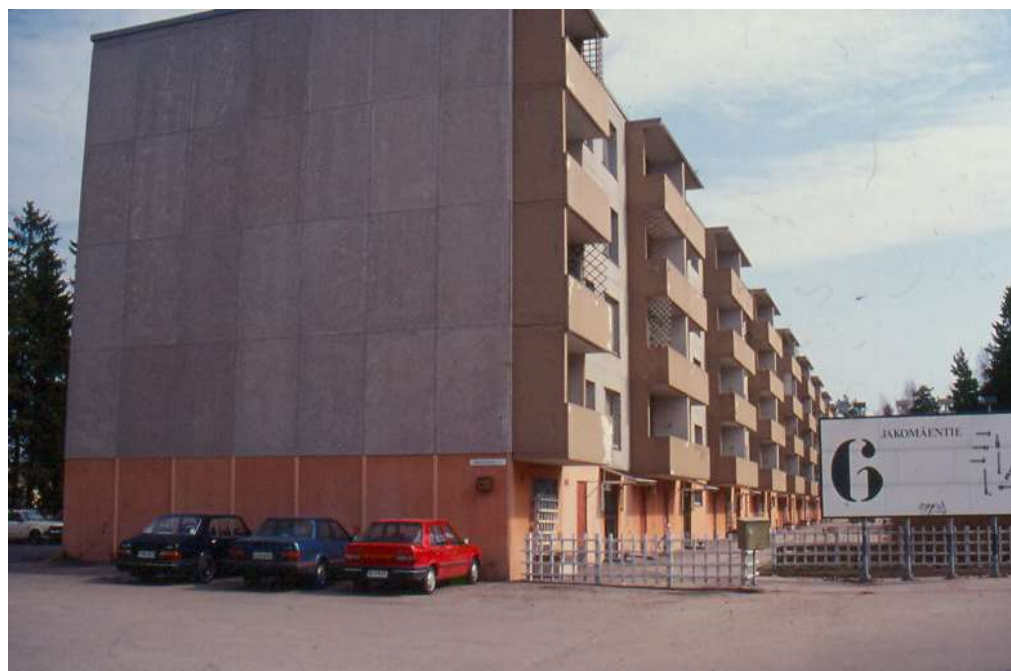
Figure 2 – Case building in 1994 during first condition investigation.

The case study building was completed in 1968. It was a 5-storey block of flats with exposed aggregate concrete facades and suspended concrete balconies, see Figure 2. The structure of this building consist of prefabricated sandwich facade panels and balcony slab, frame and parapet elements. The surface of facades was exposed aggregate concrete and balconies were painted with non-permeable paint. The typical dimensions of precast panels of the case study building are shown in Table 1 based on the first condition assessment. The case study building was demolished

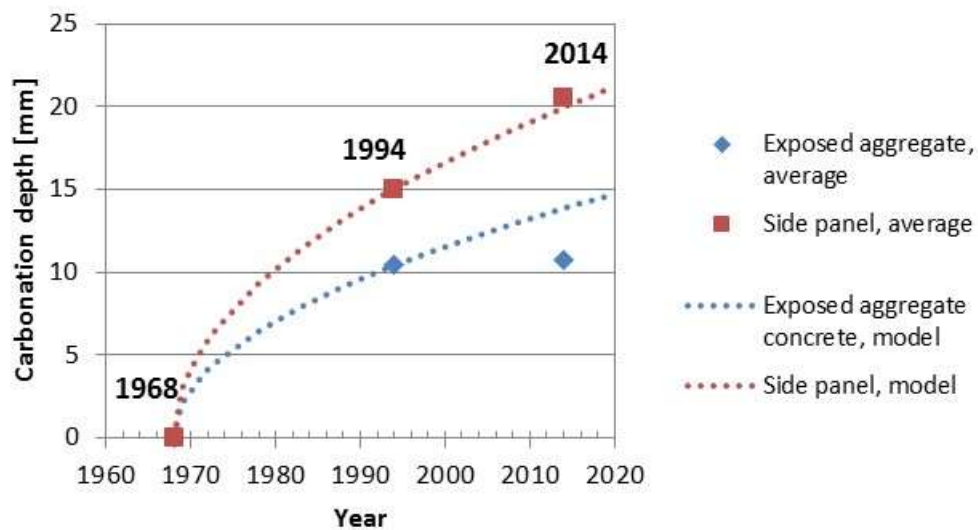
Figure 3 – Average carbonation of concrete in 1994 and 2014 and computational progress of carbonation based on the first condition investigation.

On the balcony side panels, the carbonation coefficient is approximately the same in both investigations. The standard deviation is also approximately the same, and carbonation curve follows Eq. (1) nicely, see Figure 3. On the other hand, in sandwich panels, the carbonation

coefficient is very different between 1994 and 2014. Results from 2014 investigation do not follow the equation based on the first condition investigation, see blue dots in Figure 3.

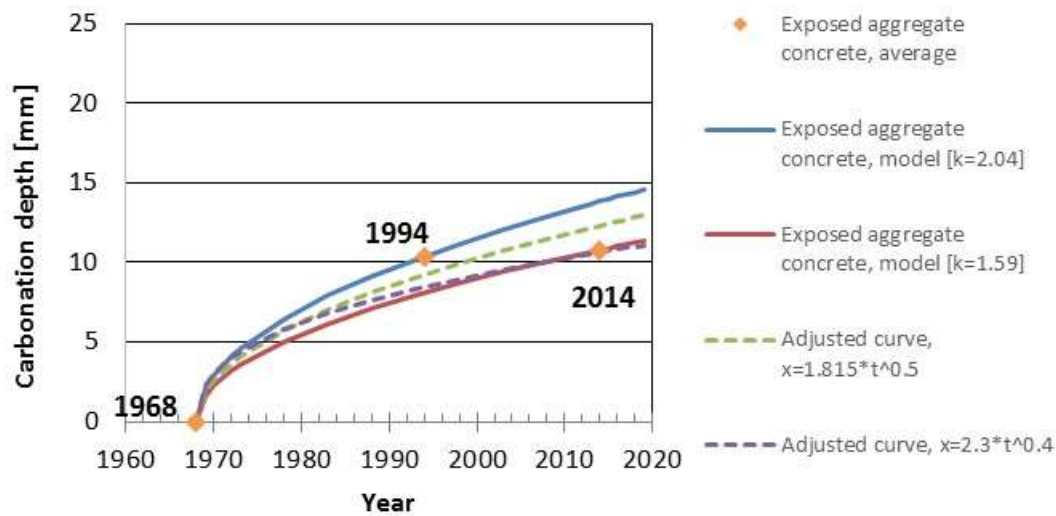
Figure 4 – Average carbonation of concrete in sandwich panels in 1994 and 2014 and computational progress of carbonation based on two different models.

In Figure 4 is presented different carbonation curves for sandwich panels to illustrate the progress of the carbonation.

In Figure 4 the progress of carbonation has been adjusted with square root model (Eq. (1)), too. Three different curves have been drawn: carbonation coefficient $k = 2.04$ (first condition investigation), $k = 1.59$ (second condition investigation) and $k = 1.815$ (average of both condition investigations). The fourth curve in the Figure is adjusted based on Eq. (3).

Eq. (1) gives too pessimistic values for carbonation in freeze-thaw damaged concrete as can be seen in Figure 4. For freeze-thaw damaged concrete the adjusted curve follows Eq. (3):
