Suspended timber ground floors: Heat loss reduction potential of insulation interventions

S. Pelsmakers^{a,*}, C.A. Elwell^b

^a Sheffield School of Architecture, University of Sheffield, Western Bank, Sheffield, S10 2TN, UK

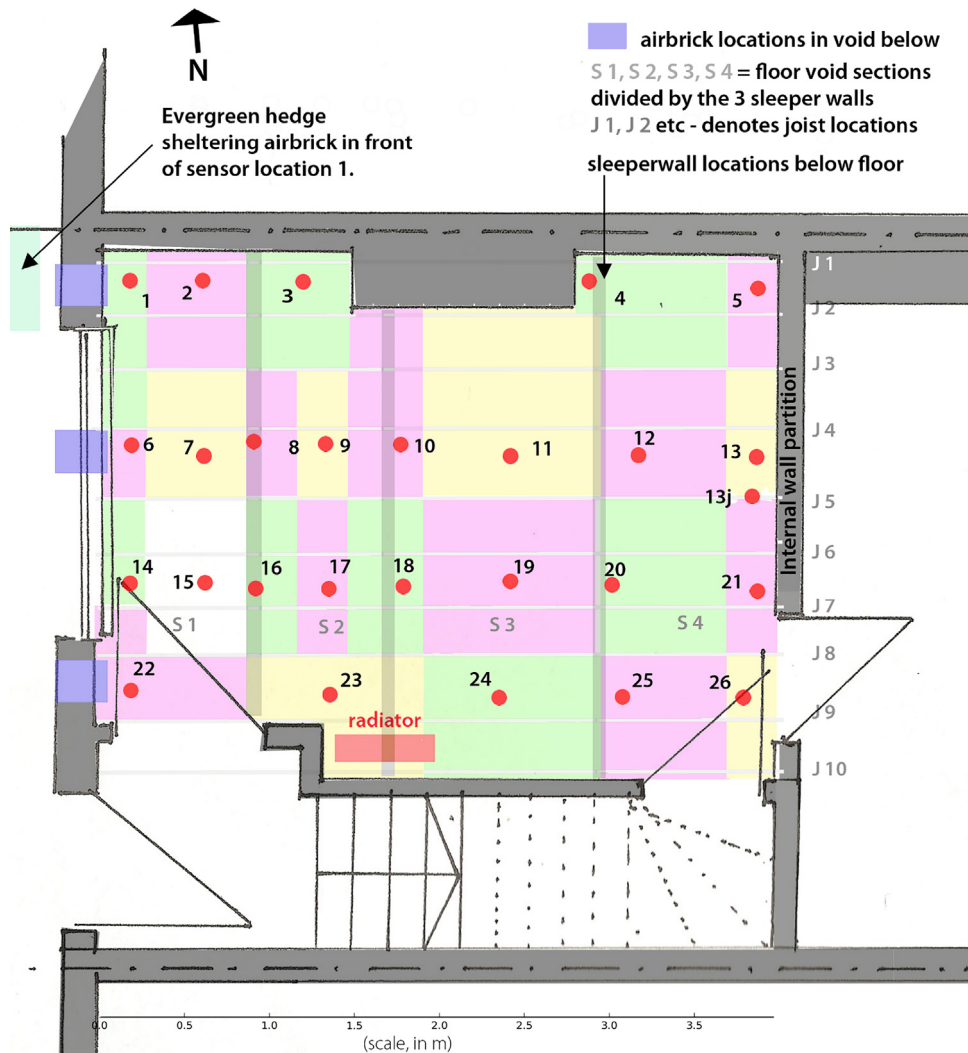
Fig. 1. Floor plan with heat flux sensor locations (red circles and numbered); airbrick locations (blue), and sleeper walls (grey). Approximate joist locations are marked with a faint grey line and annotated with J1, J2 etc. Location 13j is the only location measured on a joist. Portable radiant oil-filled electrical plug-in heaters are marked on the plan. Note that the colours have no meaning other than each colour distinguishes one representative area around a HF sensor from another. Representative areas were derived from infrared images. (For interpretation of the references to colour in this figure legend, the reader is referred to the web version of this article.)

An area weighted U-value (U_{wf}) was obtained by defining areas (as shown in Fig. 1) around each heat flux sensor for the uninsulated floor, for which its measured per unit area heat flux was considered the most representative available. This was achieved by detailed

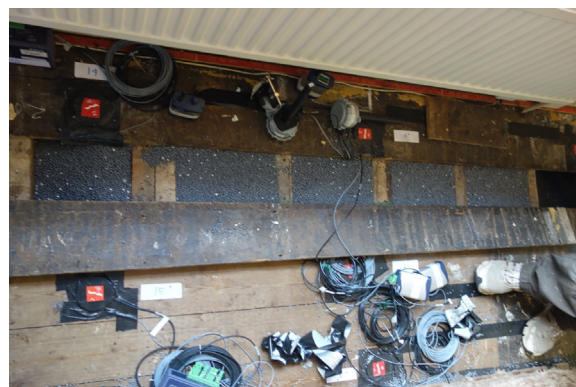
Fig. 2. The bead filled floor along the exposed perimeter wall.

Loose graphite coated EPS beads ($\lambda = 0.033 \text{ Wm}^{-1} \text{ K}^{-1}$ [50]) were blown into the full depth of the four floor void sections, allowing the insulation of floors without the disruption of lifting and re-fitting all of the floorboards. As the entire floor void depth is filled with EPS beads, and to avoid beads spilling out, airbricks were sealed with airtightness tape and covered with waterproof plastic boxes on the outside and bubble wrap on the inside. However this is yet to be proven appropriate, as airbricks are in place to regulate moisture in the void [51–53]; the long-term impact of sealing airbricks remains uncharacterised at present. Four floorboards – one in each section – were lifted to fill the entire 250 mm floor void under the joists and in between and up to the top of the 100 mm joist height, using the same equipment as cavity blown EPS beaded insulation, without the binding agent to allow for later removal of the beads by vacuuming them out. After mechanical filing, beads were manually filled and smoothed to the top of the joists – see Figs. 2 and 3.

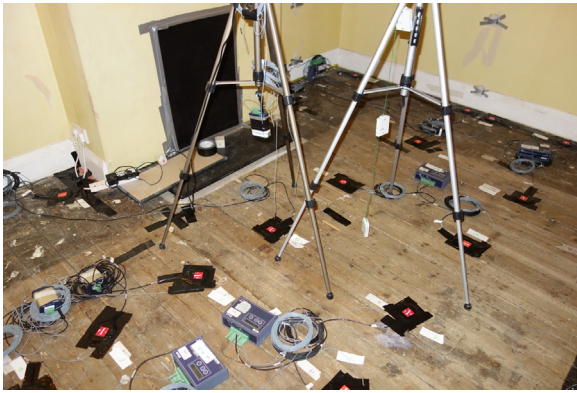
Fig. 3. Post-bead insulation with monitoring instruments in place.

After bead removal,² all instruments and floorboards (as illustrated in Fig. 3) were removed and 100 mm woodfibre insulation

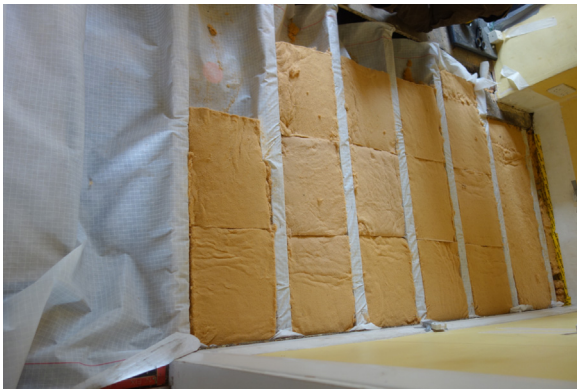
Fig. 4. Installation of woodfibre insulation in between the joists, held in a breather membrane over and under joists.

($\lambda=0.038 \text{ Wm}^{-1} \text{ K}^{-1}$ [54]) was installed between the joists (see Fig. 4), held by a tightly stretched and stapled breather membrane suspended over and under the joists with taping of overlapping joints. This is a typical insulation solution, but generally the insulation is a more flexible product such as mineral wool, which can be more easily inserted between unevenly spaced floor joists and often installed DIY [55,56] and held in place by netting. Reduced insulation had to be fitted where radiator pipes and services encroached in the space between joists, as was the case near sensor locations 23–26. Near the airbricks, the insulation was also reduced by chamfering the edge to allow airflow underneath (see Fig. 5). Insulation was fitted tightly between the joists to minimise any air gaps which could lead to increased convective heat loss [57]. The airflow between sleeper wall sections was likely significantly reduced due to the insulation being installed between joists, which were the largest openings between floor void sections prior to insulation (see Fig. 6).

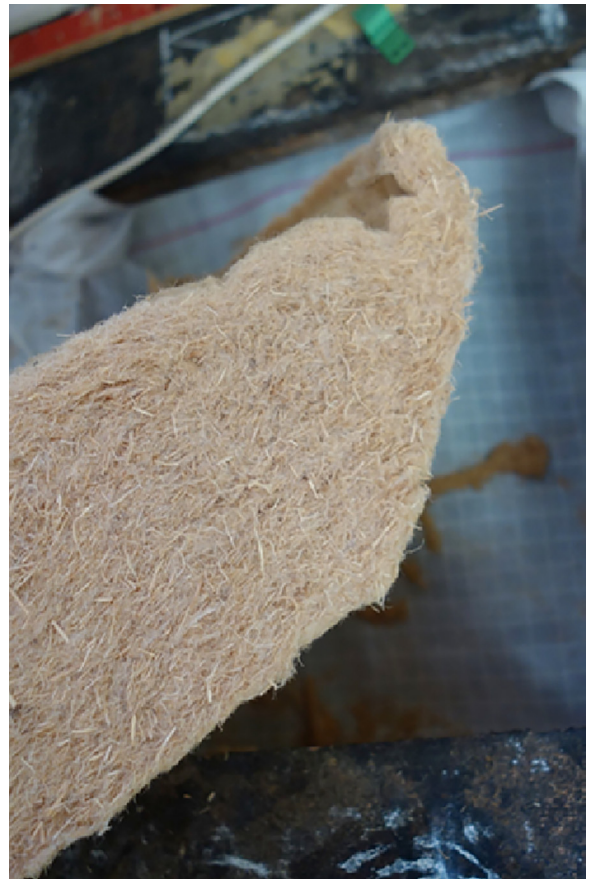
Fig. 5. Close-up of the chamfered woodfibre insulation to enable airbrick airflow.

Generally, U_p -values for the woodfibre insulated floor were between 58%–81% lower than the uninsulated values, depending on where measurements were taken (see Table 3). Use of the thermal camera, combined with the high-resolution measuring technique and post-measurement lifting of floorboards to visually assess the installation fit and quality, allowed for the identification of local installation issues, caused by insufficiently tight-fitting insulation in some areas. For example, insulation in locations 6 and 14 was ill-fitting against the perimeter foundation wall, in addition to reduced insulation from chamfered edges in location 6 (see Fig. 5), leading to reduced heat loss savings post-insulation – see Fig. 9 and

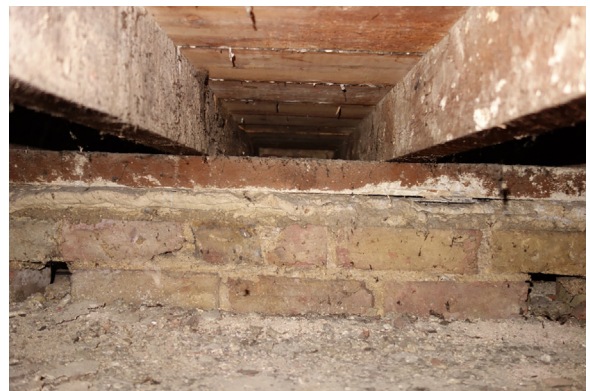
Fig. 6. A typical sleeper wall, showing also the openings between the joists, which were filled with insulation and hence leading to significantly reduced airflow between different floor sections.

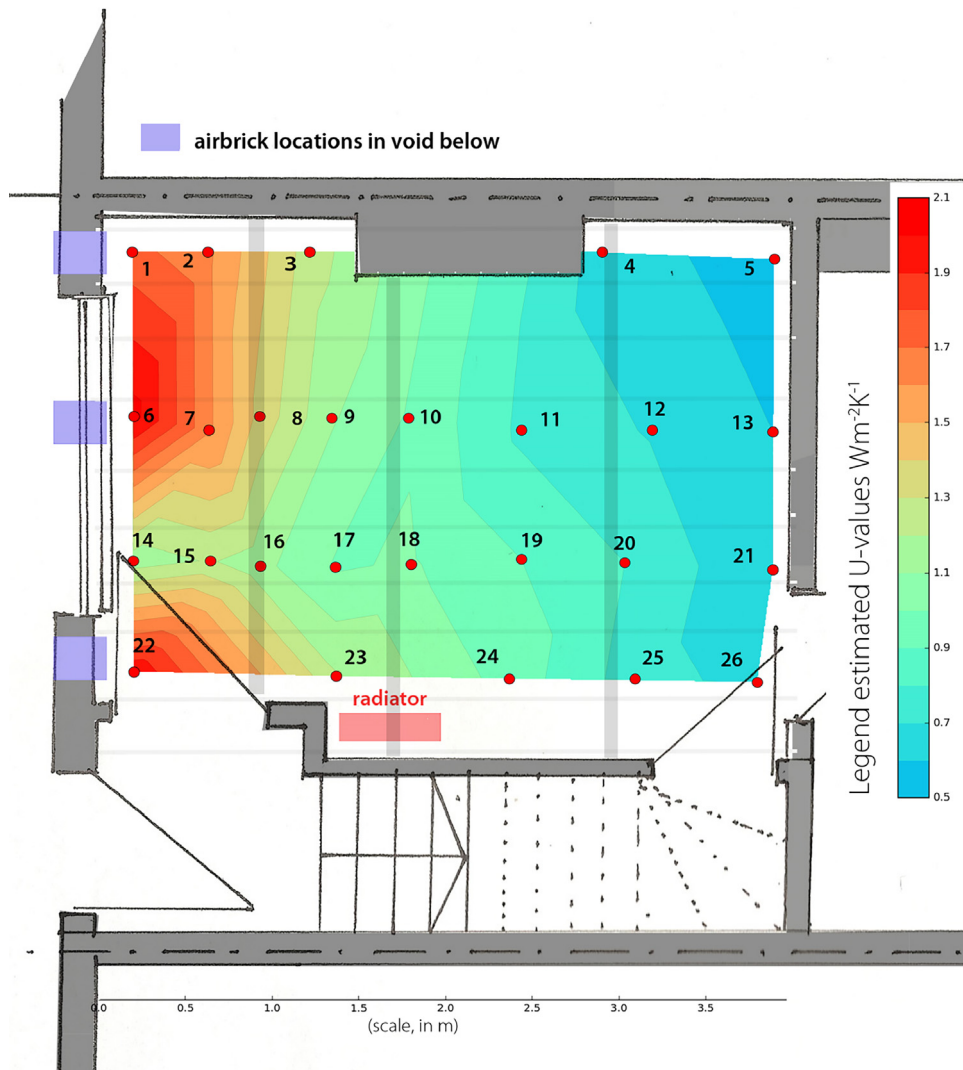
Fig. 7. Presents linearly interpolated U_p -values as a heat map between observed point U -value locations for the uninsulated floor; point locations are marked with a round dot and numbers; sleeper wall locations are indicated in light grey shade. Note that the map only shows interpolated values between points, with no values between the walls and the points (hence the white zone). Joist presence is not accounted for.

For the uninsulated floor, there is a clear association between the measured U_p -value and distance to the external perimeter walls [38,58], see Fig. 7. However, the relationship between the distance from the observed location to the exposed wall was significantly

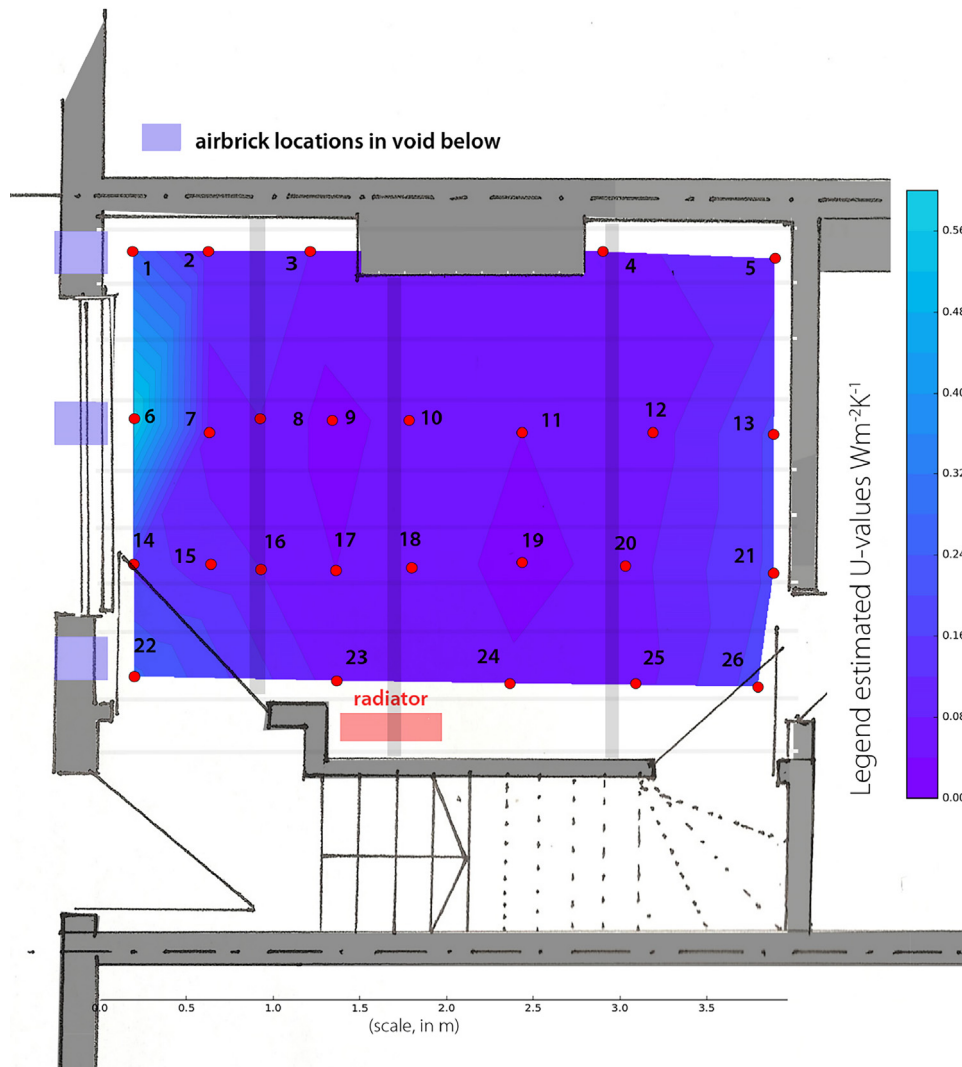
Fig. 8. Linearly interpolated U_p -values as a heat map between observed point U -value locations for the bead insulated floor, with the same scale used for the colour legend as in Fig. 7. An overall significantly reduced heat loss is observed post-insulation, with a reduced perimeter effect (though still present) and a more even spread of U_p -values across the floor.

reduced once insulated, though there were still increased U_p -values in the perimeter zone – see Figs. 8 and 9. U_p -values near the perimeter were considerably lower for the bead insulated floor compared to the uninsulated floor, explained by the sealed airbricks and large amount of insulation – see Fig. 8. However, as illustrated in Fig. 9, for the woodfibre insulated floor, a larger perimeter effect was still observed due to insulation installation quality issues, as described in section 4.3. Due to this, only small heat-flow reductions were observed in locations 6 and 14 near the exposed perimeter, while an increase in U_p -value was observed in location 21 further away from the perimeter and only a small reduction in location 3 (all were within the margins of error) – see Table 3 and section 4.3.

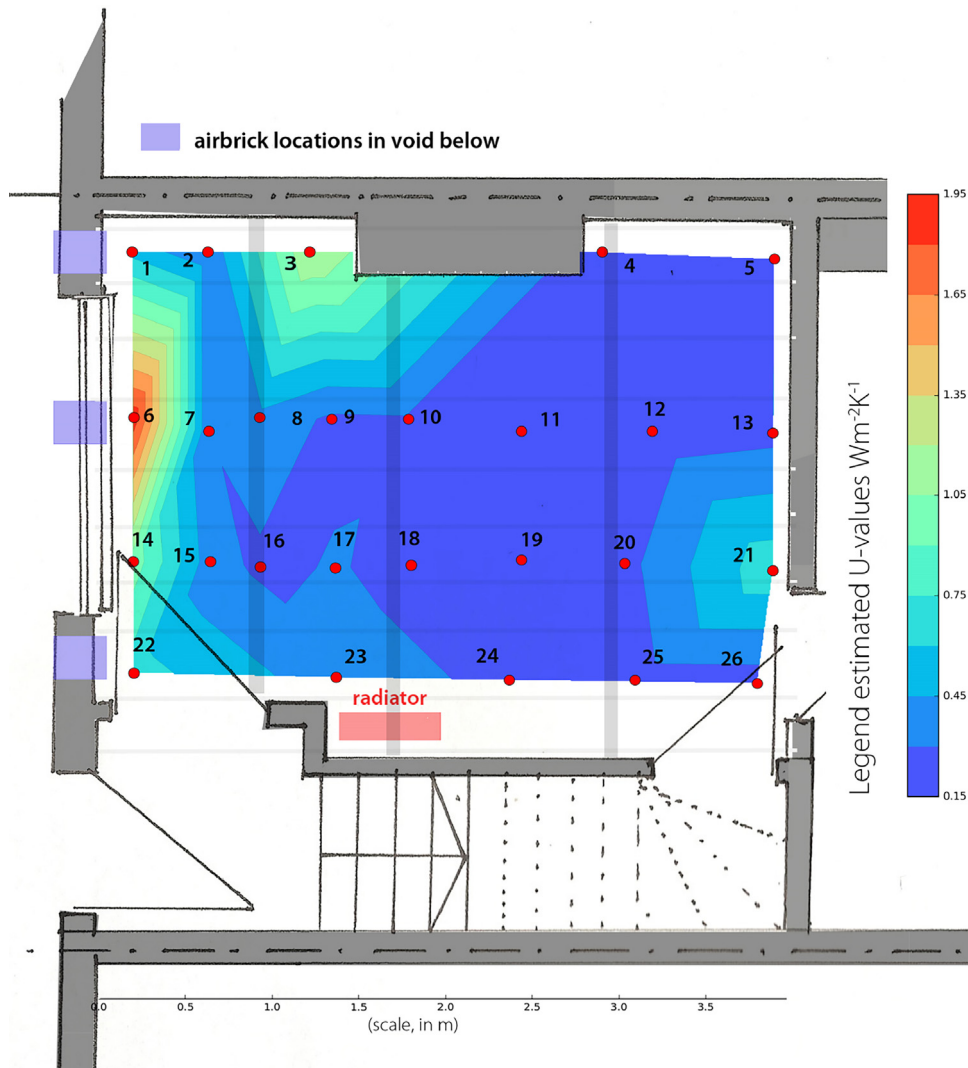
Fig. 9. Linearly interpolated U_p -values as a heat map between observed point U -value locations for the woodfibre insulated floor with the same scale used for the colour legend as in Figs. 7 and 8. An overall significantly reduced heat loss is observed post-insulation, though as expected not as much as the bead-insulated floor. There is still a significant perimeter effect and also a large spread of U_p -values across the floor.

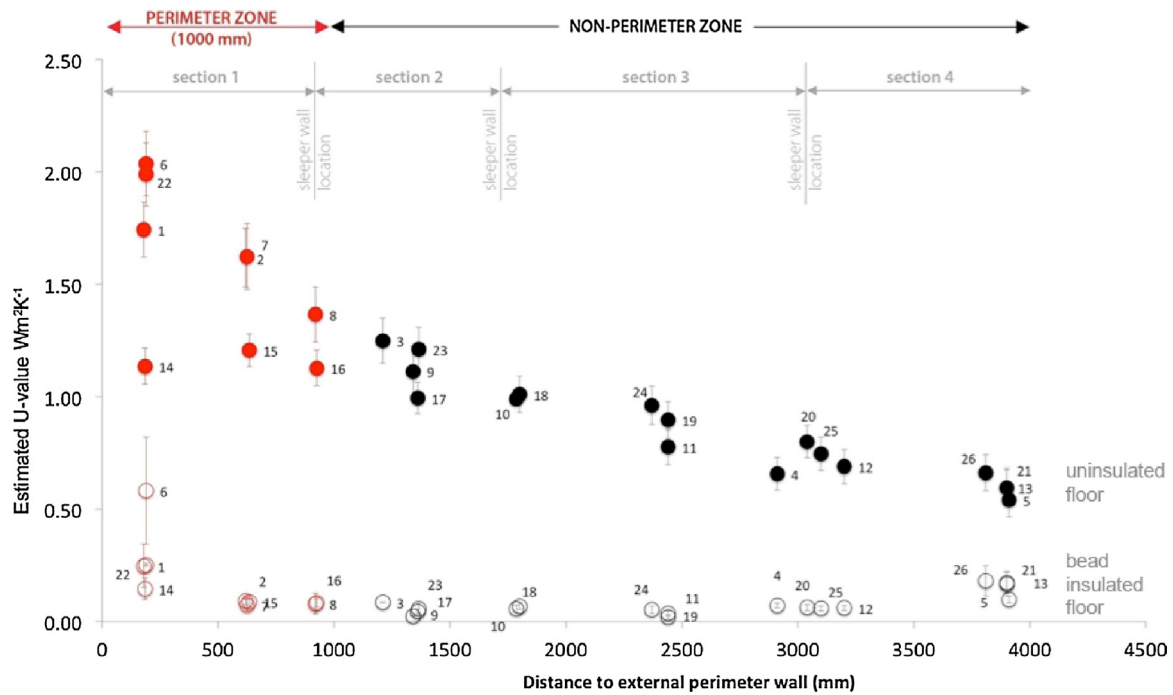
U_p -values (outline data points) as a function of distance to the exposed wall. Red data points are located in the 1000 mm perimeter zone; black-data points are $>1000 \text{ mm}$ away from the external perimeter wall. Error margins are as per Eq (3); pre/post insulated point U -values are outside the estimated margins of error. Significant U_p -value reductions are observed after insulation.

Fig. 10. Plots the uninsulated U_p -values (solid data points) compared to bead-insulated U_p -values (outline data points) as a function of distance to the exposed wall. Red data points are located in the 1000 mm perimeter zone; black-data points are > 1000 mm away from the external perimeter wall. Error margins are as per Eq. (3); pre/post insulated point U -values are outside the estimated margins of error. Significant U_p -value reductions are observed after insulation. (For interpretation of the references to colour in this figure legend, the reader is referred to the web version of this article.)

The increased U_p -values in the perimeter zone were statistically significant for both insulated floors (Mann–Whitney ($W = 127$, $n_1 = 9$; $n_2 = 17$, $P < 0.05$ (0.005, unpaired)) for the bead insulated floor and Mann–Whitney ($W = 130$, $n_1 = 9$; $n_2 = 17$, $P < 0.05$ (0.003, unpaired)) for the woodfibre insulated floor). For the bead insulated floor, the estimated mean of the perimeter U -values was $0.18 \pm 0.08 \text{ Wm}^{-2} \text{ K}^{-1}$ compared to $0.08 \pm 0.02 \text{ Wm}^{-2} \text{ K}^{-1}$ for locations $>1000 \text{ mm}$ away from the perimeter (after [58]). For the woodfibre insulated floor, the mean perimeter zone U -value was $0.64 \pm 0.11 \text{ Wm}^{-2} \text{ K}^{-1}$ compared to $0.33 \pm 0.06 \text{ Wm}^{-2} \text{ K}^{-1}$ in the non-perimeter zone. In both cases, locations near the airbricks (sealed for the bead intervention) were generally outside the margins of error of other estimated point U -values and the pre/post U_p -values were also generally outside the estimated margins of error (see Figs. 10 and 11).

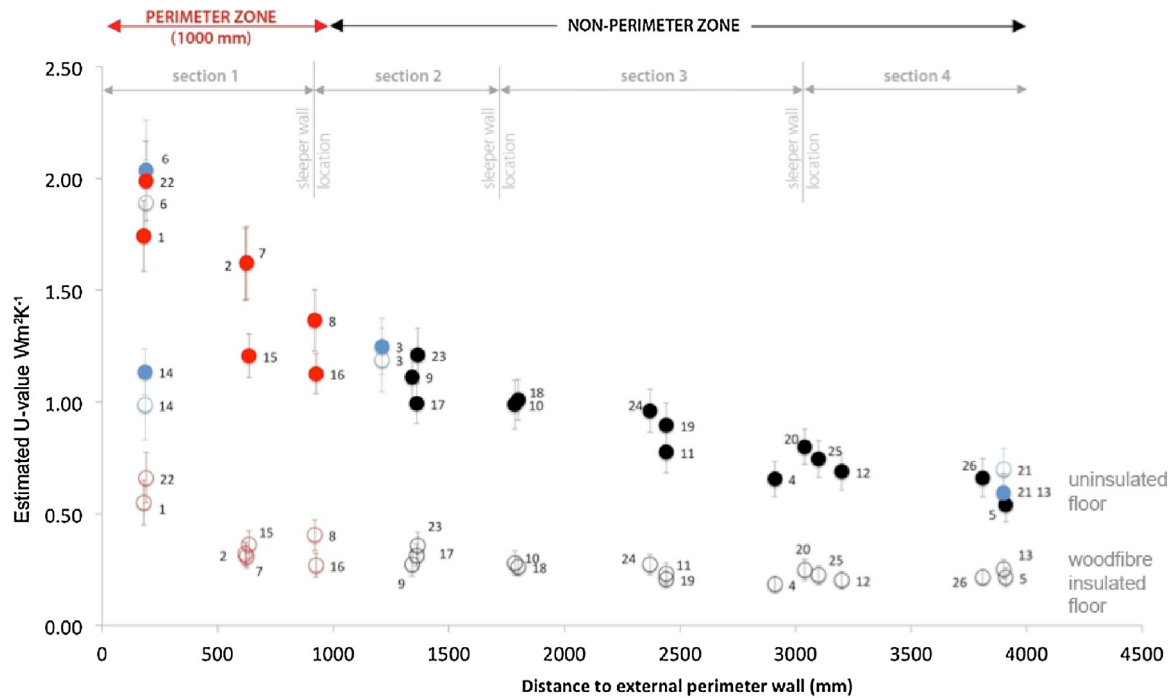
U_p -values (outline data points) as a function of distance to the exposed wall; significant U_p -value reductions are observed after insulation. Red data points are located in the 1000 mm perimeter zone; black-data points are >1000 mm away from the external perimeter wall. Error margins are as per Eq. (4); pre/post insulated point U -values are generally outside the estimated margins of error, although U_p -values in locations 3, 6, 14 and 21 (in blue) are within the margins of errors, likely due to installation quality issues – see 4.3.

Fig. 11. Plots the uninsulated U_p -values (solid data points) compared to woodfibre-insulated U_p -values (outline data points) as a function of distance to the exposed wall; significant U_p -value reductions are observed after insulation. Red data points are located in the 1000 mm perimeter zone; black-data points are > 1000 mm away from the external perimeter wall. Error margins are as per Eq. (4); pre/post insulated point U -values are generally outside the estimated margins of error, although U_p -values in locations 3, 6, 14 and 21 (in blue) are within the margins of errors, likely due to installation quality issues – see 4.3. (For interpretation of the references to colour in this figure legend, the reader is referred to the web version of this article.)

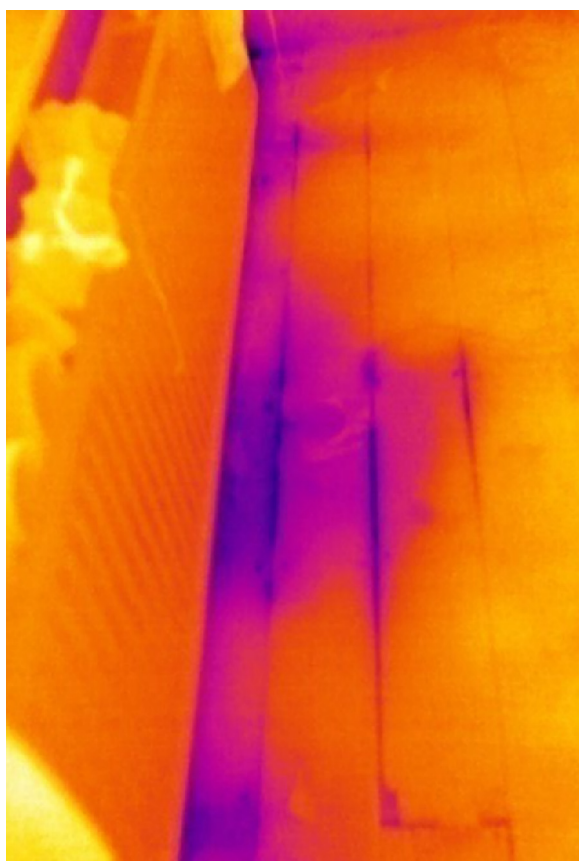
Fig. 12. Shows a thermal image of woodfibre insulated floor and the ineffective fitting of insulation in location 6 along the perimeter.

thermal image Fig. 12. Such installation issues are likely to have contributed to an increased perimeter effect; this might also have occurred in other non-observed locations. Similarly, installation issues were identified in the other outliers (see Table 3): ill-fitting insulation and gaps in floorboards and membrane in Location 3 and a 15–20 mm gap between a bent floorboard and the insulation below in location 21, a likely source of a thermal bypass.
