Open structural monitoring data from two extensively instrumented road sections – case Aurora

ABSTRACT: In 2017, the Finnish Transport Agency (FTA) launched an open testing ecosystem of intelligent transport and infrastructure solutions, known as Aurora. The Aurora test area consists of an approximately 10 km section of main highway E8 South from the village of Muonio, Finnish Lapland. Regarding road infrastructure, the core of the testing ecosystem consists of two extensively instrumented road sections, one of which is located on a stiff substructure area and the other on a softer substructure area. Commissioned by the FTA, the structural instrumentation of Aurora monitoring sections was accomplished jointly by Tampere University of Technology (TUT) and Roadscanners Ltd (RS). Instrumentations installed in these sections enable both continuous monitoring of structural condition and structural responses during vehicle overpasses. In addition, a nearby concrete slab bridge furnished with a Weigh-In-Motion (WIM) system enables monitoring of the vehicle masses. A unique feature of the monitoring systems described in more detail in this article is that all the monitoring results to be

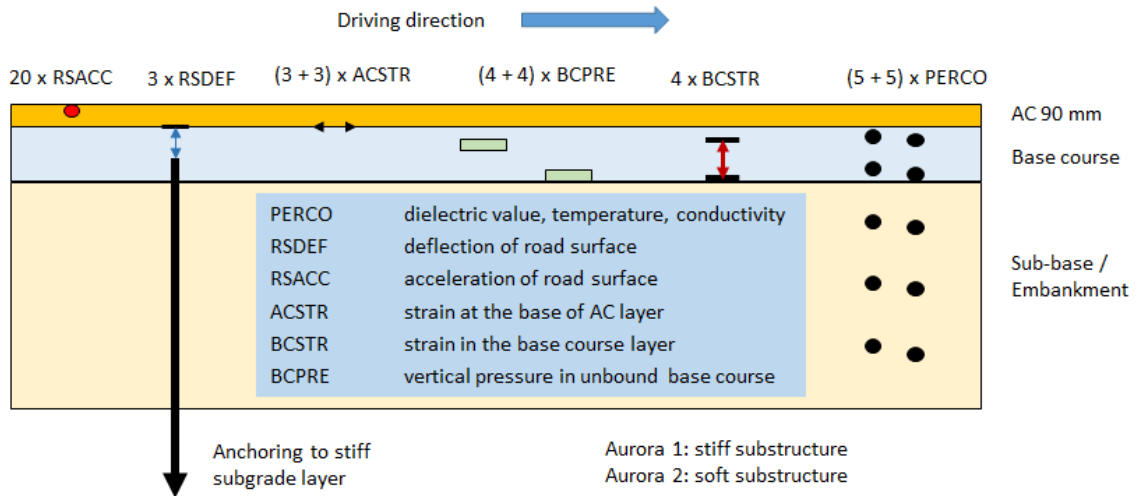
Figure 1. Schematic picture of structural instrumentations at Aurora 1 and 2 test sites.

Both the Aurora 1 and 2 test sites are furnished with almost identical structural instrumentation systems, a schematic picture of which is shown in Figure 1. The instrumentations consist of the following instrument types and the numbers of installed instruments given in parentheses for the Aurora 1 and Aurora 2 test sites, respectively:

- Displacement transducers monitoring the road surface deflection (0 + 3)
- Acceleration transducers monitoring also the road surface deflection (20 + 20)
- Horizontal strain transducers at the base of lower AC layer (5 + 6)
- Vertical pressure cells at two levels in the unbound base course layer (8 + 8)
- Vertical strain transducers in the unbound base course layer (4 + 4)

outer wheel path of the lane from North to South. The parallel instruments are installed at a spacing of 150 to 200 mm in cross-sectional direction of road to enable obtaining of a more complete picture of the 3D distribution of structural responses caused by vehicle loadings. The only exception is acceleration transducers that have been installed in two rows with an instrument to instrument spacing of only 100 mm.

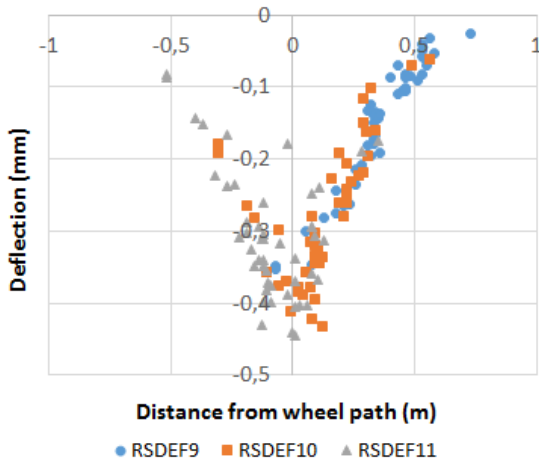
Figure 2. Road surface deflections measured with three parallel displacement transducers at Aurora 2 test site.

One frequent type of heavy vehicle traveling from North to South via highway E8 is a semitrailer truck transporting fish from Norway to Finland. These trucks typically weigh about 40 to 50 tons and have an 1 + 2 axle truck pulling a trailer with three axles. Figure 2 presents a summary of the measured road surface deflections at Aurora 2 test site caused by the steering axles of these "fish trucks" during a time period from the 19th of April to the 24th of April 2018. At that time the road structure had thawed up to the depth of about one meter (Figure 8).

When the recorded results are plotted as a function of the distance between the transducer in question and the location of outer wheel path of the vehicle, as has been made in Figure 2, it is obvious that all the parallel instruments have been producing quite nicely identical results. When analyzing the results shown in Figure 2 it is important to note that the actual weights of the steering axles of these trucks recorded at the WIM-station varied from 65 kN to 93 kN. Therefore, a certain amount of scatter in the results is inherent. In connection with specific loading tests carried out using a single truck that was passing over the site repeatedly, the scatter in the results was naturally smaller.

As Figure 2 indicates, the peak values of road surface deflection have been typically of the order of 0.4 mm and in the cross-sectional direction of road they have been decreasing down to about 0.1 mm at a distance of half a meter from the located position of the wheel path.

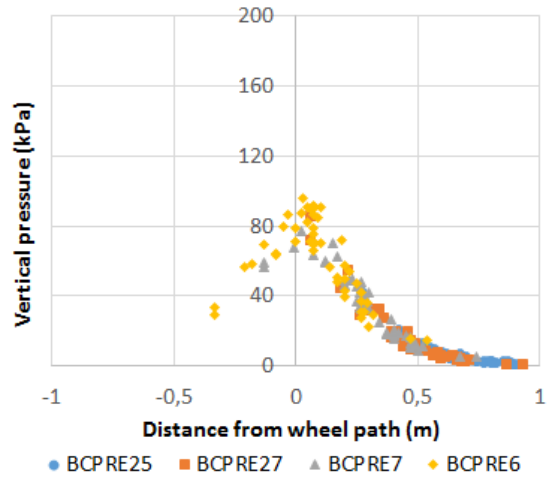
Figure 4. Vertical pressures measured with four parallel pressure cells at a depth of 280 mm at Aurora 2 test site.

vertical pressure at the depth of 280 mm in Figure 4, vertical compression of the unbound base course layer in Figure 5, horizontal strain at the base of AC layer in the longitudinal direction of road in Figure 6 and horizontal strain in the transversal direction of road in Figure 7.

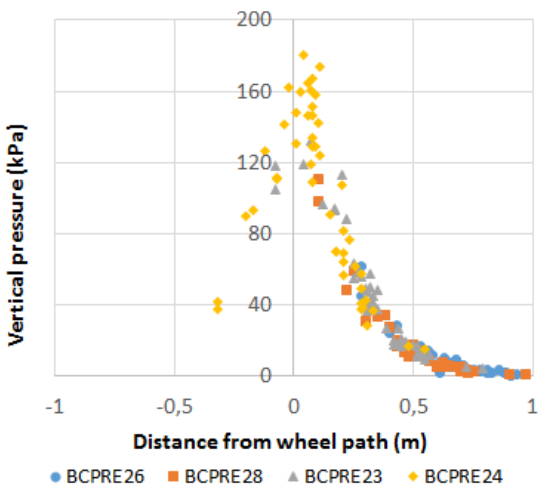
Figure 3. Vertical pressures measured with four parallel pressure cells at a depth of 180 mm at Aurora 2 test site.

Corresponding results recorded during the overpasses of the same group of vehicles as in Figure 2 is given for vertical pressure at the depth of 180 mm below the road surface in Figure 3,

The respective peak values determined for the vertical pressure in the unbound base course at a depth of 180 mm below the road surface are about 160 kPa (Figure 3). The relative scatter in the peak values of vertical pressure measured directly under the wheel contact area is, however,

now somewhat higher. In addition to the variation of actual axle/wheel loads that was already discussed above, the scatter is partly assumed to be due to the variation in tire inflation pressures between different vehicles, the effect of which could not be taken into account by any means in the analysis of measurement results. At least to some extent, this conclusion is supported by the vertical pressures measured 100 mm deeper inside of the structure (Figure 4). In these results the relative scatter is lower, which could logically be explained by the fact that load spreading is making the effect of actual tire inflation pressure less important at a greater depth.

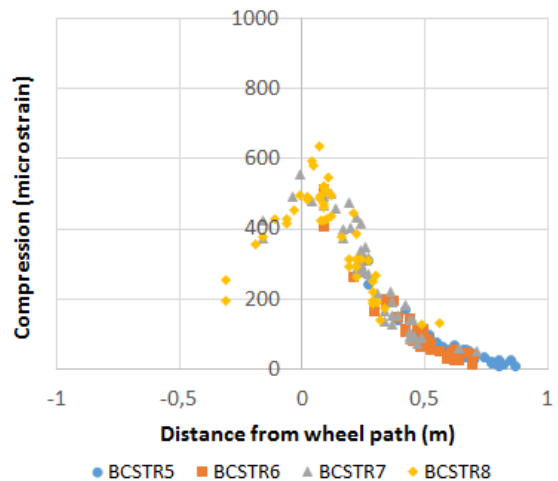
Figure 5. Vertical compression of unbound base course layer measured with four parallel strain transducers at Aurora 2 test site.

The measured peak values of vertical compression in the unbound base course layer are of the order of 500 microstrain (Figure 5). In terms of stiffness that corresponds to a value of resilient modulus of the order of 225 MPa if we assume the respective average value of vertical pressure on the distance of the measurement instrument to be somewhere in between the peak values shown in Figures 3 and 4, say 120 kPa. Considering the stress conditions prevailing under a 90 mm thick AC layer this order of stiffness can be considered very plausible.

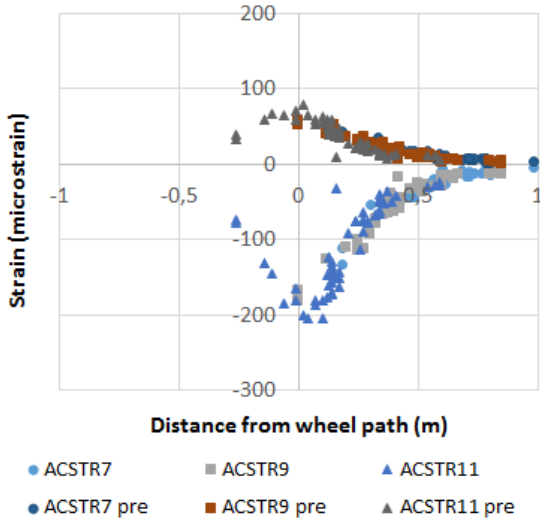
Figure 6. Horizontal strain at the base of AC layer in longitudinal direction measured with three parallel strain transducers at Aurora 2 test site.

The recorded peak values of tensile strain at the base of AC layer are in turn of the order of 200 microstrain both in the longitudinal direction (Figure 6) and in the transversal direction of road (Figure 7). The respective peak values of compressive strain both in front of wheel contact area (Figure 6) and on the side of it (Figure 7) are slightly above 50 microstrain.

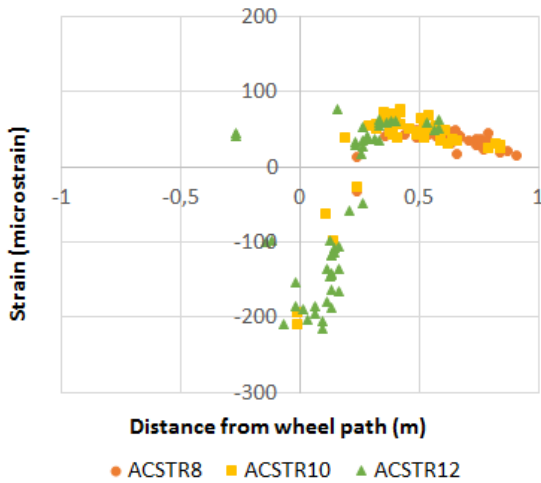
Figure 7. Horizontal strain at the base of AC layer in transversal direction measured with three parallel strain transducers at Aurora 2 test site.

Remarkable in Figure 7 is the sharp transition from peak tension to peak compression at the edge of tire contact area. If wheel path wander disappears together with the introduction of autonomous vehicles, this point is likely to be one of the critical ones with regard to the service life of road pavements.

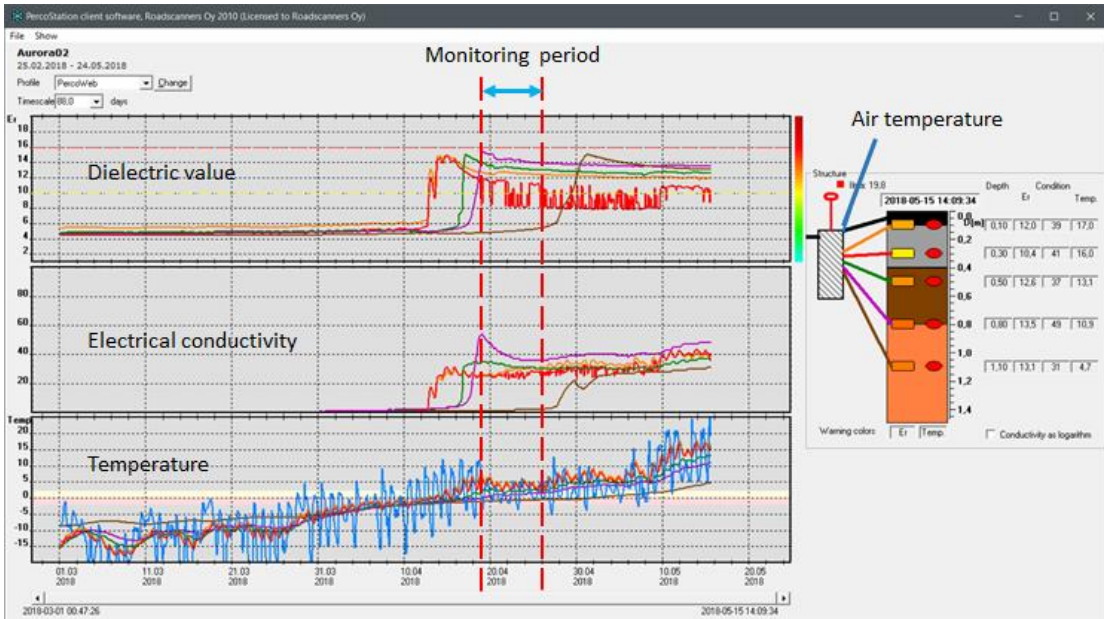
Figure 8. Dielectric values, electrical conductivities and temperatures measure at Aurora 2 test site in the spring 2018.

As an example of the results from structural condition monitoring dielectric values, electrical conductivities and temperatures recorded during the spring time of year 2018 at the Aurora 2 monitoring site are shown in Figure 8, in which also the time period corresponding to the structural response measurement results shown in Figures 2 to 7 has been indicated.

From the results of temperature measurements made at different depths below the road surface shown in the lower part of Figure 8, it can be observed that thawing of structural layers has started from the top of road at about the 13th of April and progressed up to the depth of 0.8 m in about a week. At the same time as thawing progresses both the dielectric values and electrical conductivities rise up rapidly alongside with the phase change of water from ice to free water. After reaching a peak value dielectric

values start to decrease, which indicates gradual drying of structural layers toward a normal summer time condition.
