Effect of de-icing salt as winter maintenance for corrosion of steel piles on bridges

V-M Uotinen¹, A Perälä², J Laurila³ and P Peura³

¹Finnish Transport Infrastructure Agency

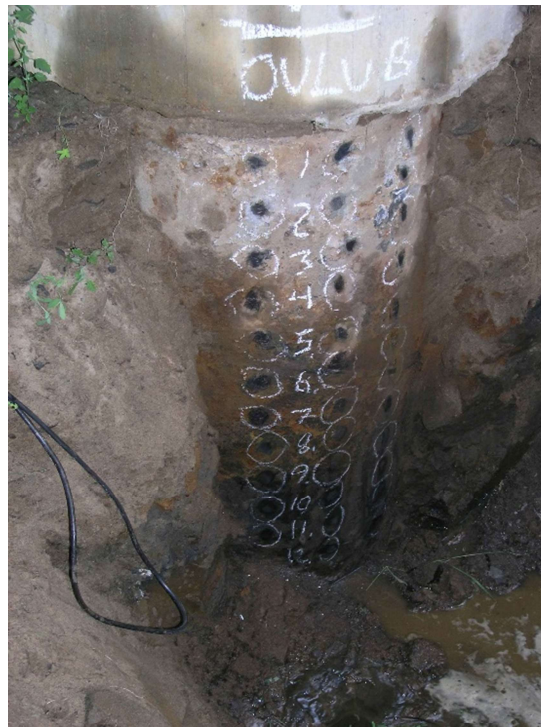
In Figure 1, it can be seen the points marked on the exposed pile surface. The thickness of the pile wall was measured from these points by using ultrasonic method. In this particular case on site O-1648 the distance between the measured rows was 90 mm and between the columns 150 mm.

Figure 1. Bridge O-1684. Pile is cleaned and measurement points are marked.
Steel pile is visible for 1.2 m below concrete column.

Bridge piles were exposed by making a sloped excavation around the pile, Figure 1. Typically head of the pile was in depth of 0.5 - 1.0 m. Groundwater flow into pit and stability of sloped excavation limited the excavation depths and piles could be exposed so that 0.5 - 1.5 m of the steel pile was visible. Special test piles were lifted up with vibrator.

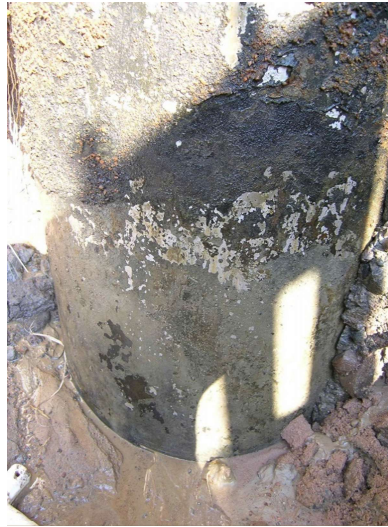
As a general result of the studies it can be concluded that the corrosion found from the piles is negligible. Highest corrosion levels were found from site Highway 3 noise barrier and from site T-2436. In Figure 3 is presented the pile surface exposed below ground in site T-2436. It can be seen that there is corrosion and corrosion pitting on the pile surface in the man-made fill layer. The surface inside the subsoil seen in the lower part of the Figure 3 has remained in uncorroded state and the original wall thickness of the pile can be measured from that area.

Figure 3. Excavation T-2436 and pile surface: on the upper part of the image can be seen corrosion on the pile surface in the man-made soil region, the surface inside the subsoil is remained in uncorroded state.

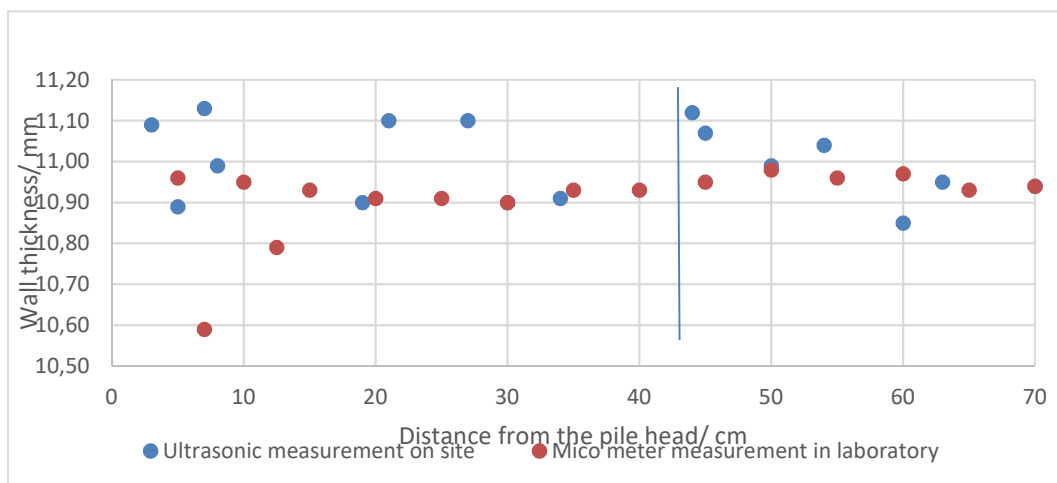
The results of the measurements on the site T-2436 are presented in the Figure 4 and 5. The wall thickness measured with micrometer from the pile inside subsoil was 10.95 mm and 10.99 mm measured with ultrasonic equipment respectively. The thickness measured from man-made fill layer area was with micrometer 10.87 mm and with ultrasonic equipment 11.00 mm. So, it can be seen that the measurements performed using a micrometer are more sensitive to pitting corrosion so that the measured average pile wall thickness is lower than when measured using ultrasonic equipment. The same phenomena can be seen also in the results of all pile wall thickness measurements, where the deviation between the measuring points measured using micrometer is much higher at the man-made fill layer area.

Figure 4. Example of the pile surface measurement T-2436 where the corrosion was found to be highest: Measurements with ultrasonic and with micrometer presented in same image. The original wall thickness is according to these measurements 10.90 - 10.95 mm measured from the subsoil region. The boundary between the man-made fill and subsoil is marked with blue vertical line.

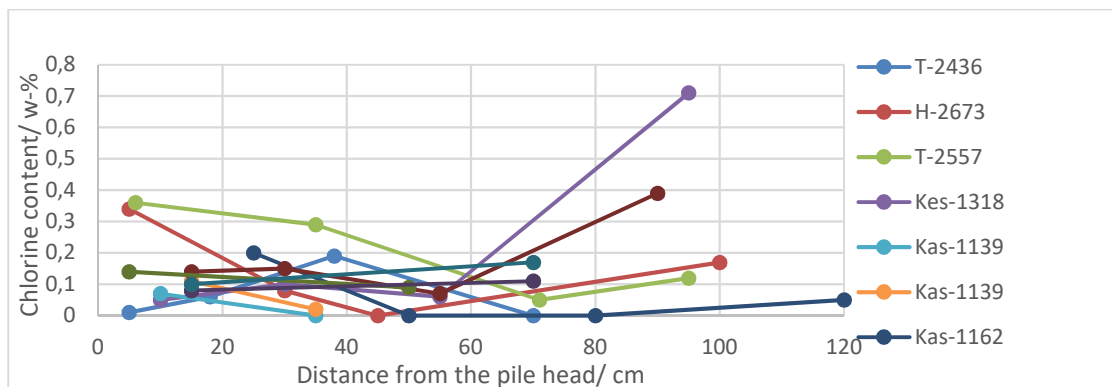
Samples were scratched off from the pile surface to analyse of the salt contents of the pile surface layers. The samples were glued on the sample holders and analyzed with Jeol IT 500 electron microscope equipped with EDX analyzer. When analyzing the results presented in Figure 6 it has to be seen that chlorine content above 0.1 % can be reliably measured.

According to the results presented in Figure 6, the chlorine content is relatively low on the pile surface layers. Nevertheless, chlorine is present in most of the cases and in Kes-1318, O-1558, O-1684, H-2673 and T-2557 the chlorine content is clearly elevated. Since chlorine is evidently present it must be taken into account when considering the corrosion rate of the bridge piles.

Figure 6. EDX-analyses of chlorine content measured from the samples scratched off from the pile surfaces.
