Cracking of the End Diaphragm of a Post-tensioned Beam Bridge

In concrete beam bridges, the end diaphragm at the end of the bridge is a common structural component that connects the main beams and transfers the beam loads to the bridge bearings. In integral bridges the end diaphragm also retains the soil of embankments due to the absence of abutments. Cracking of the front surface on the end diaphragm has been detected in post-tensioned

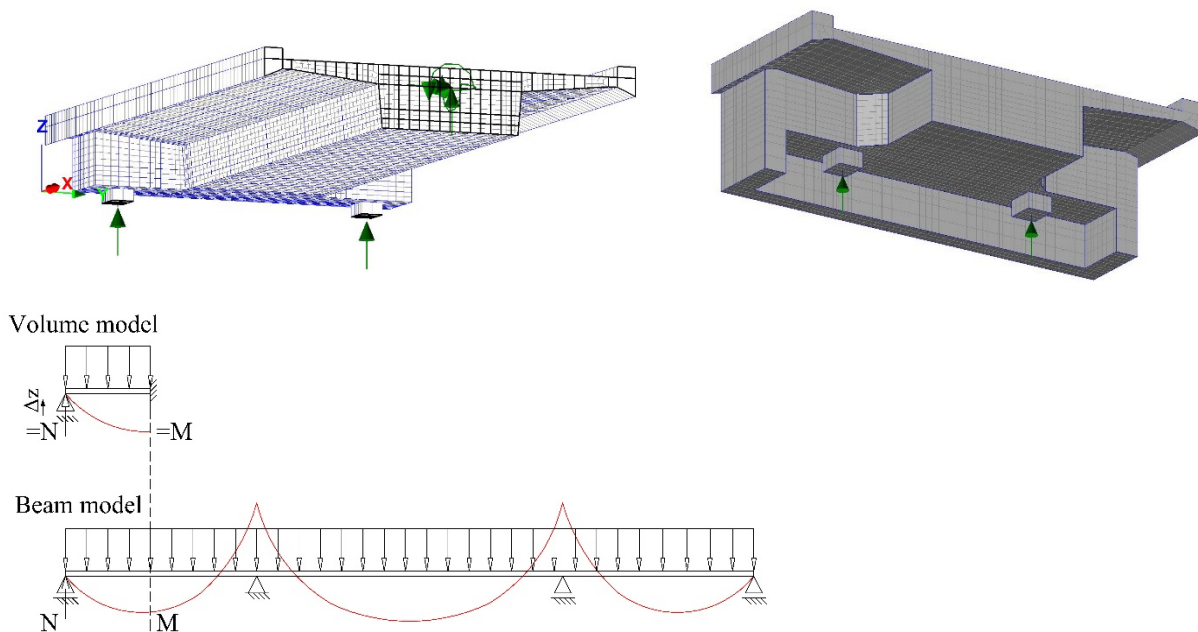
Only the end area of the bridge is modelled with solid elements; including the end diaphragm and approximately 11 metres of the main girder. This corresponds to 39% of the first span of the first case bridge and 42% of the span of the second case bridge. The main girder is intercepted in a rigid zone, where the rigid nodal support is attached. The bearings are modelled with the same material parameters as the bridge girder and the same size as the bearing plate. Rigid plates are attached under bearing. The stiff beam, with a length of 100 mm, is used to connect the rigid plate to the nodal support under the bearing. The nodal support at the lower end of the stiff beam is fixed in the Z-direction. The friction of the bearing is not included in the analysis. The solid model of the first case bridge is shown in Figure 4a.

Figure 4 - a) Solid model of the first case bridge b) Solid model of the second case bridge with smaller wedges (the full model is not shown) c) The schematic presentation of the volume model in relation to the beam model

The loads in the model are the self-weight of structures, post-tension force, traffic load and internal temperature gradient due to hydration of concrete and ambient air temperature fluctuations. The volumetric model is constructed by modelling rigid plates above bearings and pinned supports under plates, and a rigid plate at the location at which the bridge model is cut according to Fig. 4c. The application of loads is performed by using equivalent support

- the end diaphragm height was extended (downwards) by 815 mm
- the thickness was raised from the front side by 400 mm and 800 mm
- setting only one bearing in the middle of the end diaphragm
- two different sizes of wedges (400x400 mm², 640x800 mm², shape is shown in Figure 4b).

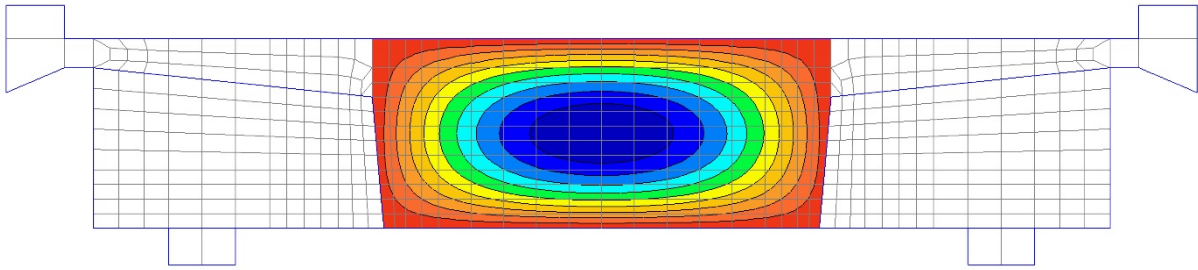
The temperature gradient is only modelled on the web of the girder (shown in Figure 5) for simplification. The hydration temperatures of the end diaphragm and the flanges of the main beam are neglected. The web is the most massive part of the girder and it was assumed to have an effect. In the middle of the girder the temperature difference is $-\Delta T$ °C (blue) and on the edge 0 °C (red). The used temperature gradient ΔT was 20.0 °C at the moment of tensioning due to hydration. The modelling temperature gradient is based on measurements of the Myllypuron risteysilta made by Tampere University of Technology [5] [6]. A creep effect is considered by reducing the temperature gradient by a factor $k = \frac{1}{1+0.85\cdot\varphi} = \frac{1}{1+0.85\cdot 0.39} = 0.75$. The resulting value on the gradient in model is 15.0 °C.

Figure 5 – Modelling of the temperature gradient

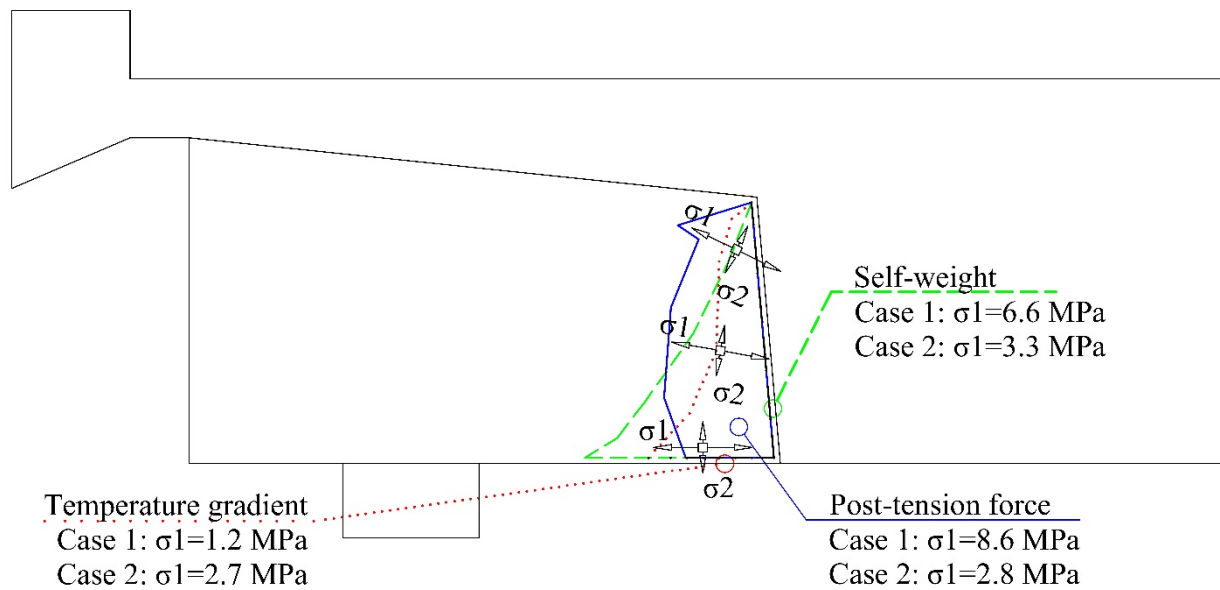
As the result of FE analysis, it was found that a crack does not open from a single loading but a combination of them. The magnitude of principal tensile stress is quite the same due to the self-weight, post-tension force, traffic load and temperature gradient of the main girder. Under different types of loads, the stress field is different and the maximum stress is not found at the same point. The schematic stress field at the front surface of the end diaphragm and the location of maximum stresses due to different load cases is shown in Figure 6.

Figure 6 – Schematic stress field due to different load cases and maximum tensile stress values with location, corresponding colours and line types in leader(lines) and stress fields

After post-tensioning, the forces added to the structure were self-weight, post-tension force and temperature difference due to hydration temperature. After post-tensioning, the maximum observed principle tensile stress (σ_1 in Fig. 6) in the model is 10.7 MPa on the first case bridge and 7.6 MPa on the second. This shows that it is most likely that the cracking occurs after post-tensioning because a tensile strength $f_{ctk,0.95}$ of the C35/45 concrete is 4.2 MPa [7]. It should also be noted that concrete has not reached its full strength before post-tensioning.

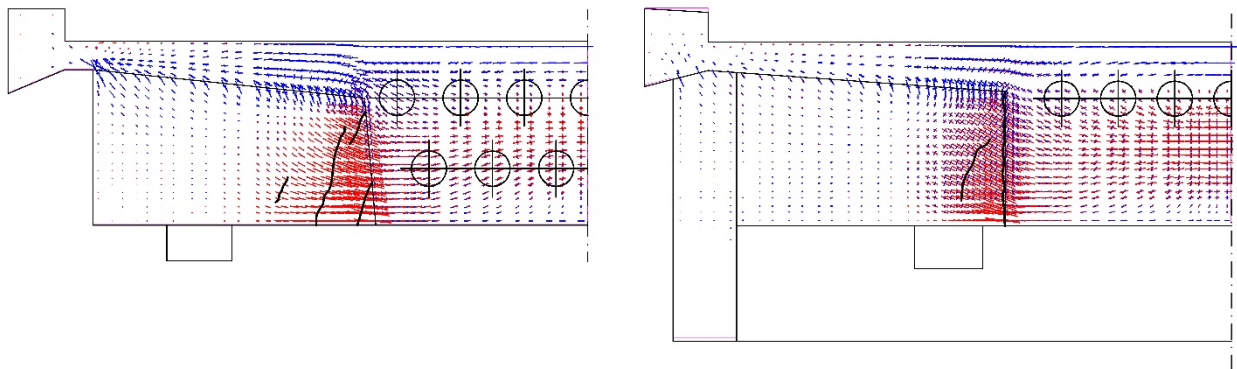
The cracks in concrete are assumed to form in a perpendicular direction to the principal tension stress [8]. In Figure 7 the vectors of principal stresses are shown (blue: compression, red: tension) in the front of the end diaphragm (case 1) after post-tensioning. The perpendicular direction of principal tensile stress matches the observed cracks in the real structure.

In the corner area, the direction of principal tension stresses is almost the same in vertical loads, post-tension force and temperature difference. From the direction of principal stresses, it can be noted that the majority of the tension stress occurs horizontally in the lower part of the end diaphragm. In the upper part of the end diaphragm, the direction inclines and so do the cracks. At the upper part of diaphragm, the horizontal stress component becomes smaller and is not so dominant in comparison to other components. In addition, the highest tensile stresses are detected to be in the same area as the observed cracking in the real structure.

Figure 7 – Direction of cracking compared to principal tensile stress direction (left: first case bridge, right: second case bridge)

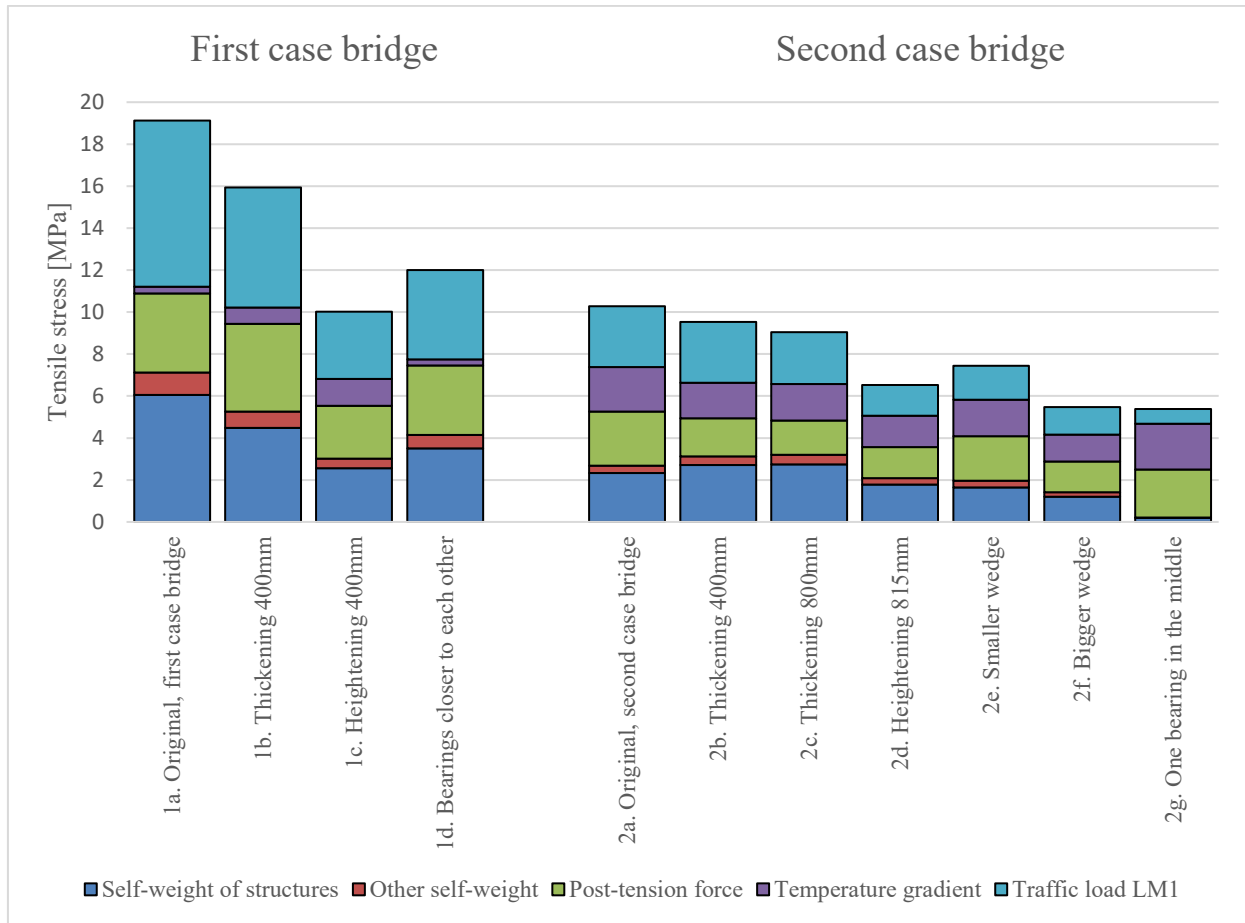
Because the maximum stresses do not occur at the same location in each load case and do not have same principal direction, they cannot be summed directly. In Figure 8, the principal stresses are shown in the location in which the highest tensile stresses occur after combining all loads. Because the principal stresses are not in same direction, each component is calculated with a weighting so that the resulting stress is correct in the chart. The result is not the same at all points because the contribution of different loads on the total effect is different.

Figure 8 – Combination of stresses on the location with highest total tensile stress

It is significant that making the end diaphragm thicker does not have a great influence on the highest tensile stress. The end diaphragm is not a normal beam loaded with a constant load. Making the end diaphragm thicker also raises the stiffness and consequently the total influence on tensile stress is minor. The highest tensile stresses after post-tensioning on the first case bridge reduced by 11% by increasing the end diaphragm thickness by 400mm. On the second case bridge the reduction is 7%. Increasing the thickness of the end diaphragm does not have an influence on the stress pattern and the highest tensile stress gathers in the same area as in the original structure.

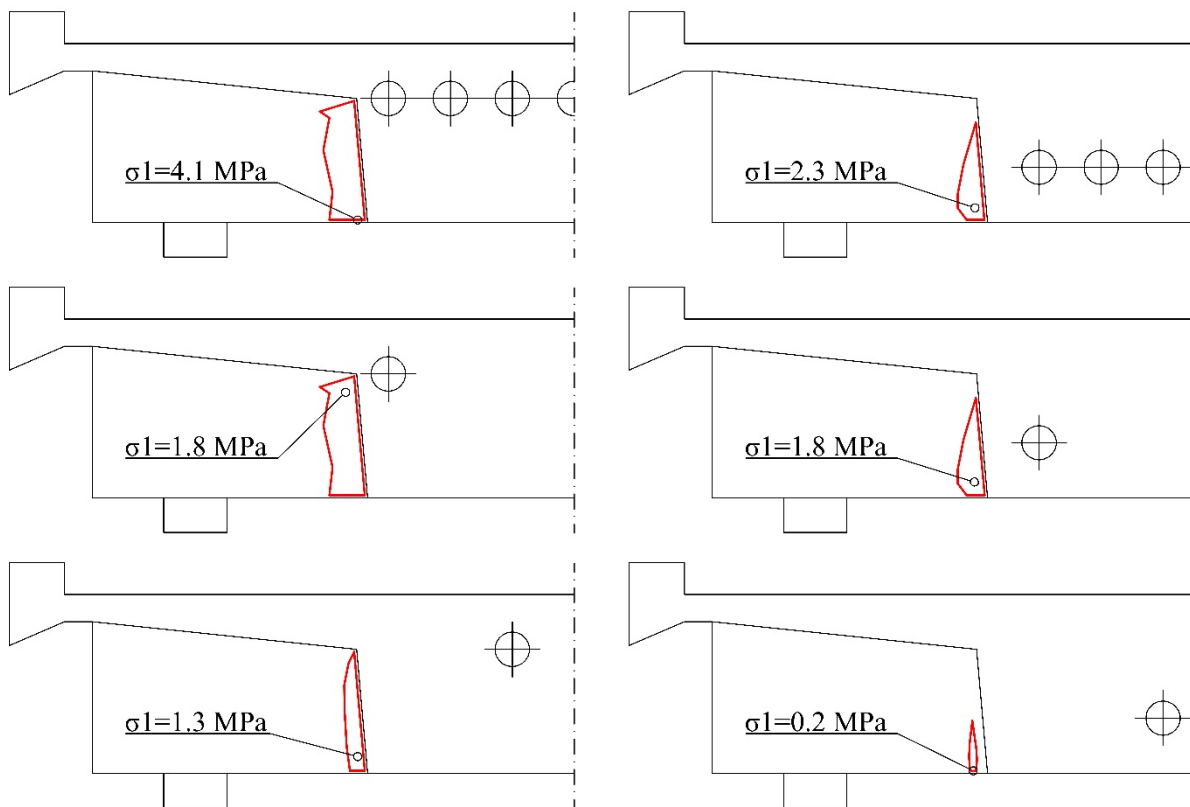
In the analysis, it was noted that the position of the post-tension anchors has an effect on the stress values. The upper post-tension anchors cause tension stresses to the entire height of the end diaphragm. The lower anchors cause more tensile stress in the bottom area of the end diaphragm. The schematic tensile stress pattern is shown in Figure 10. Anchors located on the edge of the main girder causes wider tensile stresses in a horizontal direction than those located more closely to the centre of the girder. The anchors on the edge also cause higher tensile stresses than the inner ones.

Figure 10 - Schematic tensile pattern by location of anchors, first case bridge

Compression due to post-tension force spreads out to the stresses in the end diaphragm at an angle of about 45° and becomes narrower when transmitting towards the web of the girder. This presumably causes bursting stresses to the front surface of the end diaphragm, which is why the outer anchors cause higher tensile stresses. On the inner anchors, post-tension force cannot spread to the end diaphragm. Due to the post-tension force, the flanges of the girder also try to bend the end diaphragm.
