JAAKKO GRÖNLUND  
ENDURANCE TEST OF HYDRAULIC PISTON AND ROD SEALS

Master of Science Thesis

**JAAKKO GRÖNLUND:** Endurance Test Of Hydraulic Piston And Rod Seals

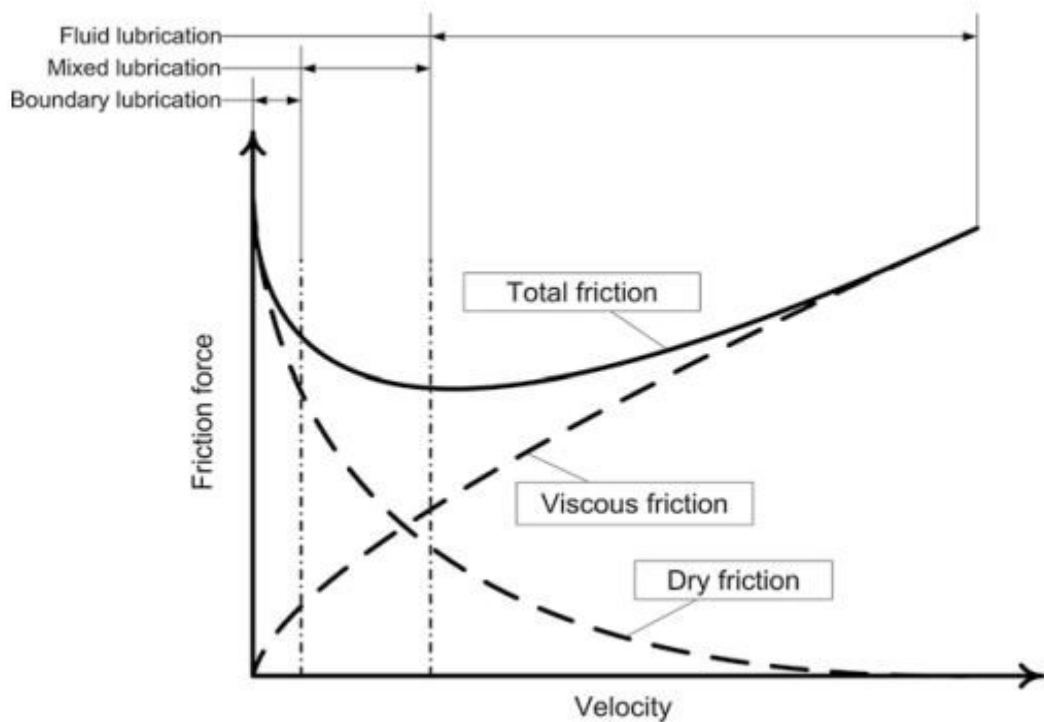
**Picture 4** Friction forces relation to velocity. (Koskinen & Aaltonen 2013, p. 1713)

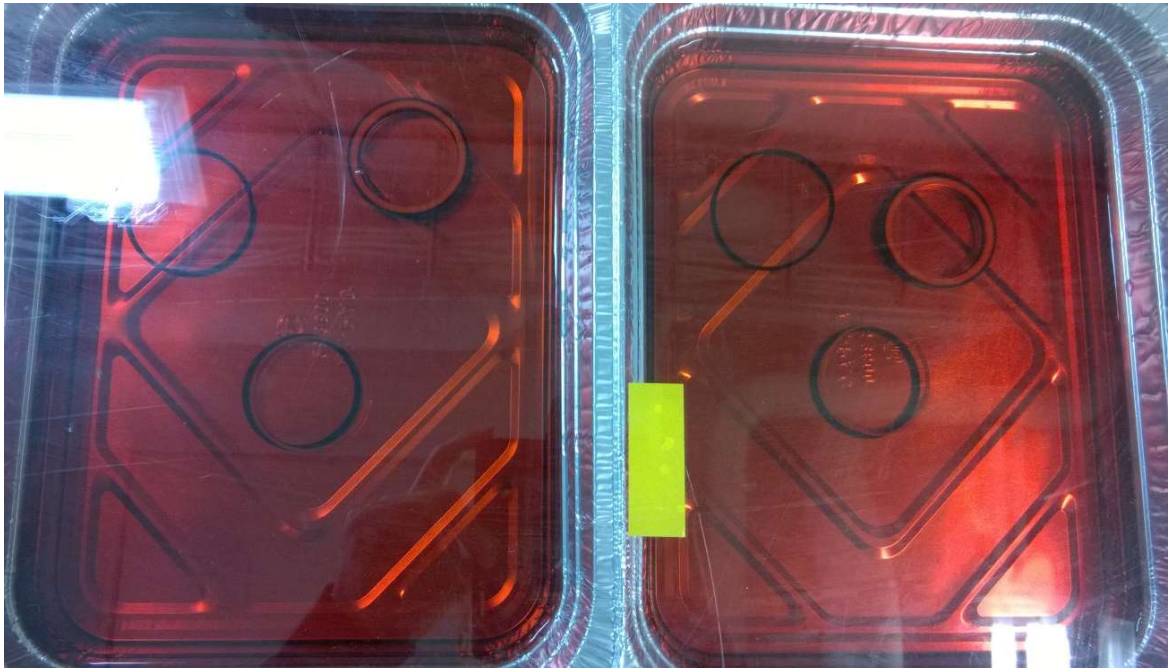
*Picture 5* Setup of absorption test in room temperature

The test equipment used in room temperature test can be seen in picture 5.

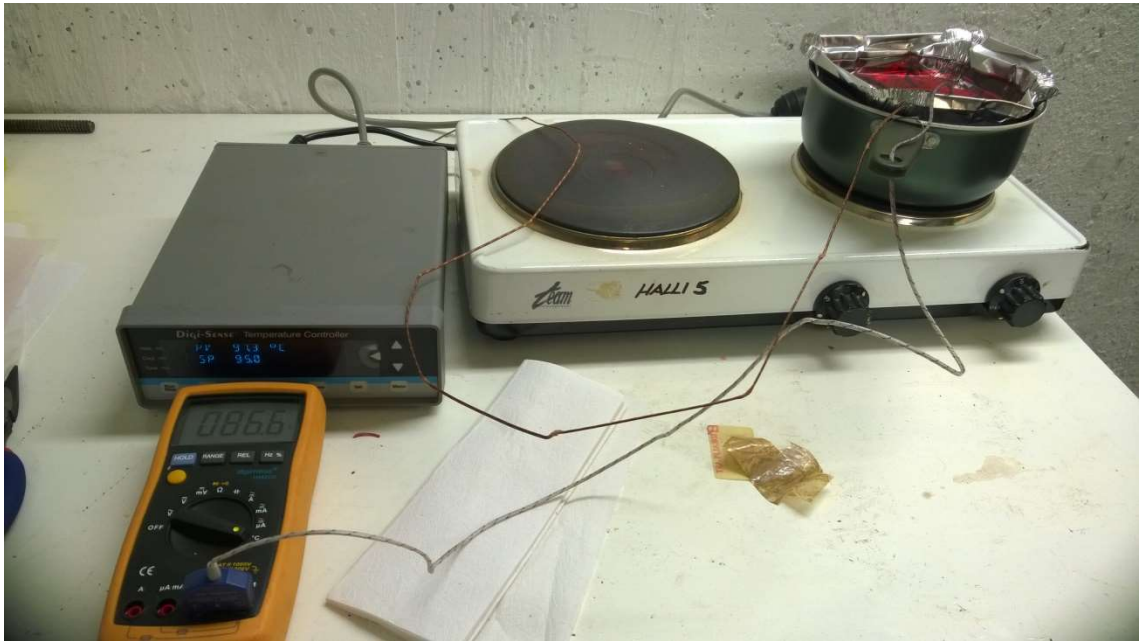
**Picture 6** Test setup of elevated temperature test.

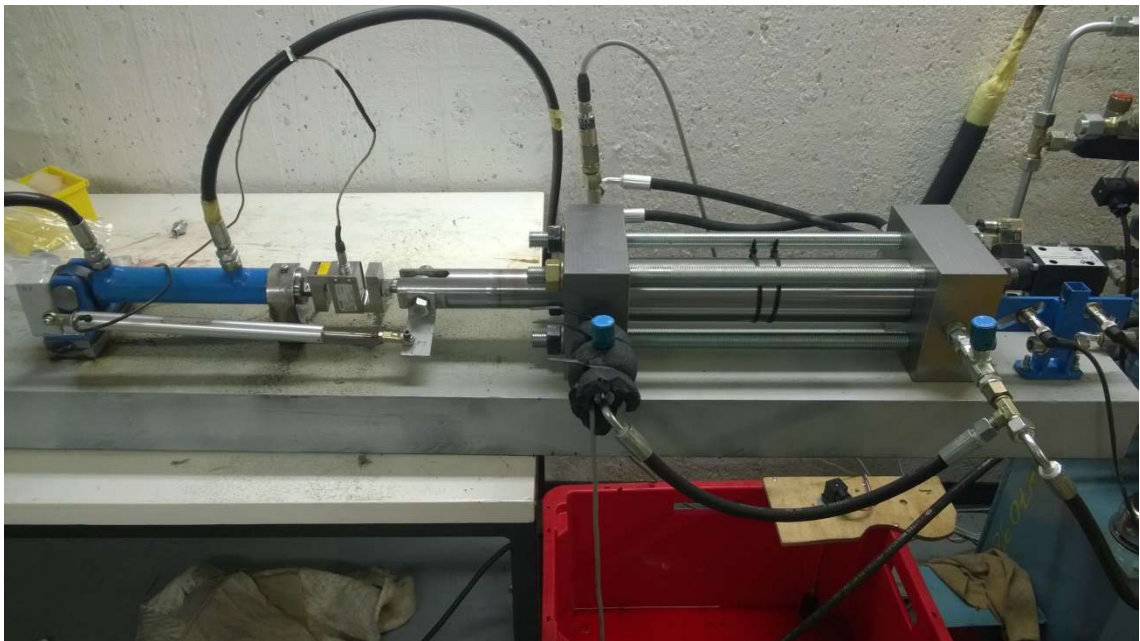
Test system consists of a test cylinder, driving cylinder, hydraulic power unit, measurement system and control logic.

**Picture 9** Test system.

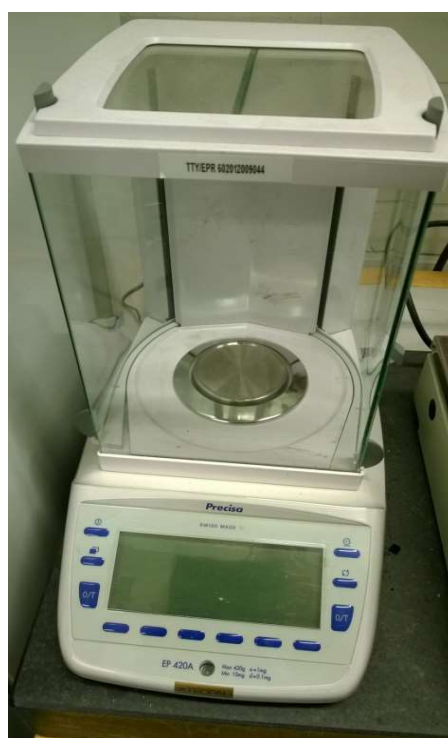
Before and after immersing the seals in the hydraulic fluid the seals were weighed using a Precisa EP 420A analytical balance. Readability of the balance was 0.1 mg.

*Picture 12* Precisa EP 420A analytical balance.

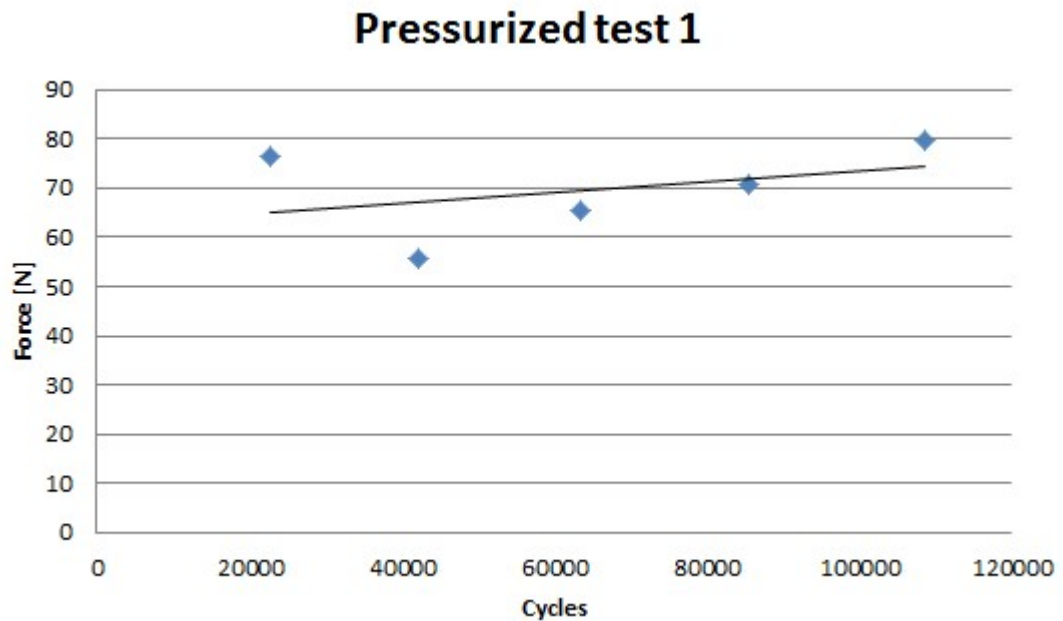
**Picture 17** Behavior of force at pressurized state during the endurance test 1

That may be caused because the seal has worn and that decreases the precompression of the seal. After 40000 cycles the friction starts to increase. When seal wears more it may start to affect on the hydrodynamic lubrication which results in rise of friction. Hydrodynamic lubricating film is dependent on the seal design, seal surface and the counter surface. (Koskinen & Aaltonen 2013, p. 1713)

When comparing the friction behavior from pictures 17 and 18 to picture 24 and 25 it can be assumed that the seals behaved in a similar way on the endurance tests but the seals of test 1 wore out much faster. From the figures of pressured state it can be assumed that the seals of manufacturer 2 reached the same amount of wearing at 120000 cycles as the seals of manufacturer 1 reached already at 40000 cycles thus suggesting a difference in material quality. From the figures it can be seen that until these cycle amounts the amount of friction keeps decreasing and after that the friction starts to increase. The increase of friction can be assumed to be caused by the changing of hydrodynamic lubrication because of the wearing of the seals. The frictions behavior of depressurized state show decreasing friction on seals of the both manufacturers. In depressurized state the hydrodynamic friction is not present because it depends on the pressure. The decreasing of friction can be explained by the decreasing precompression when the seal wears. Similar decreasing of friction during seal endurance test is observed by Bisztray-Balku (1999).

Sui et al. (1999) observed that during the phase of running-in wear leads to a rapid decrease of contact stress. After a period of high wear rate the decreasing of the radial load is almost linear. This behavior of radial load explains the friction behavior shown in picture 24 until cycle amount of 120000. The wearing out of the seals in endurance test one is so fast that this behavior is not clearly visible in picture 17.

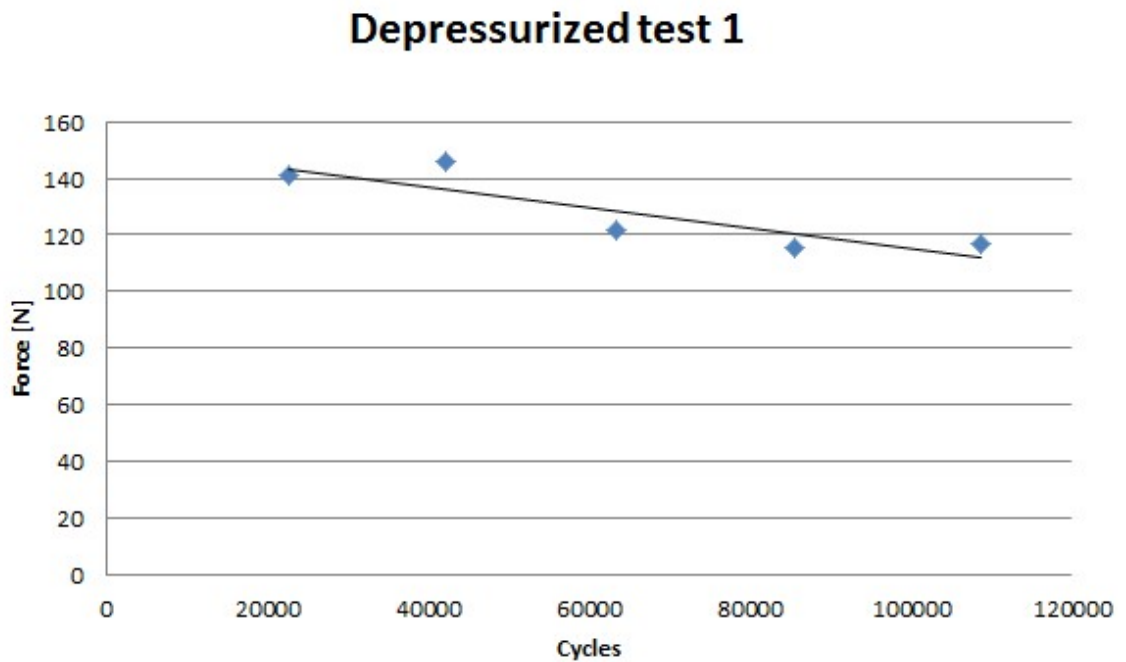
**Picture 18** Behavior of force at depressurized state during the endurance test 2

The data points are averages of 50 measurement points. Points are selected so that the movement speed and force were nearly constant for the 0.1 second time that 50 measurement points show. Test cylinder is depressurized when cylinder moves to a positive direction. The position from where the movement speed and force are constant is 2.2 cm. The regression line in picture 18 shows that the amount of friction decreases during the endurance test while the system is depressurized. Wearing of the seal decreases the pre-compression and that may be the explanation to the decrease of the friction

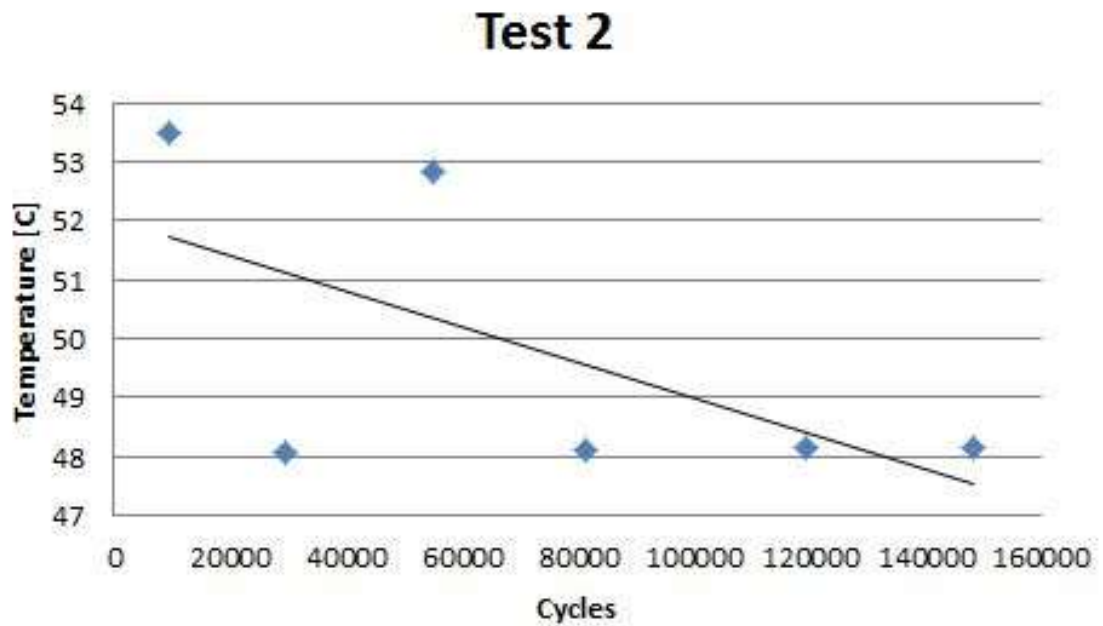
*Picture 21* Temperature on endurance test 2.

Picture 21 shows the temperature of the system during the other plots of endurance test 2. There is a clear difference between the later cycles of the temperatures between the endurance tests 2 and 1. During the endurance test 2 the system did not warm more than is shown in picture 21. The difference was approximately 16 degrees Celsius. This difference may be caused by the difference in cycle time that was caused by the change of the induction transducers placement. The regression line in picture 21 shows that the maximum temperature decreases during the test. The heating of system is due to energy loss in the system. This decreasing of temperature may back the observation that the leakage does not increase and the friction decreases. That does mean that the energy loss in the system decreases.

The fluid leakage was observed during the endurance test. Test temperature decreases during the endurance test 2 by 5 degrees Celsius. The decrease of temperature is shown in picture 21. The effect of temperature change to the viscosity of the hydraulic fluid needs to be found out. The change of viscosity may effect on the leakage flow.

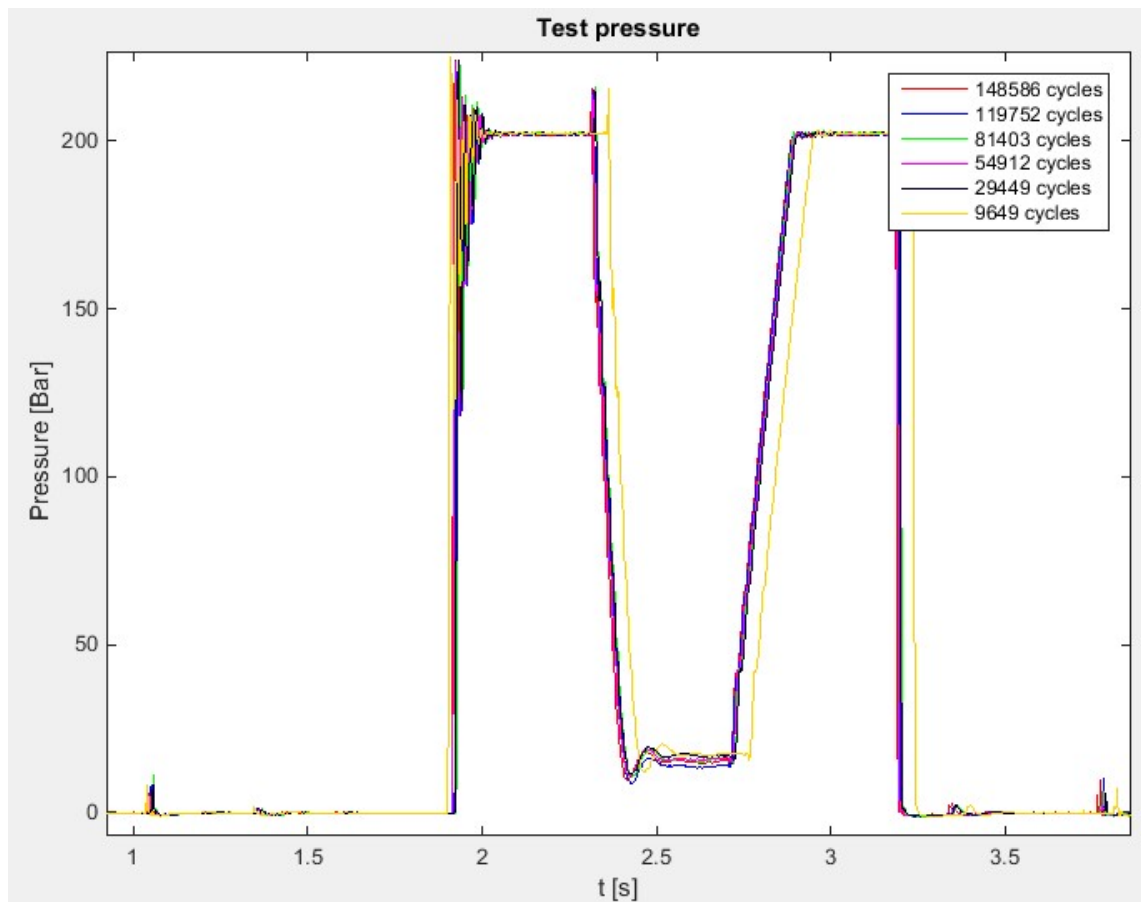
*Picture 22* Test pressure on test 2.

There is no change on supply pressure cycle during the endurance test 1 so it does not effect on test results. The minimum pressure while the cylinder moved to negative direction was 15 bar. When the cylinder moved to positive direction the minimum pressure was 58 bar. The maximum pressure was 202 bar. Pressure spikes were 208 bar. The only difference between the supply pressures in tests 1 and 2 was 7 bar on the minimum pressure on negative direction and a 3 bar difference on pressure spikes.

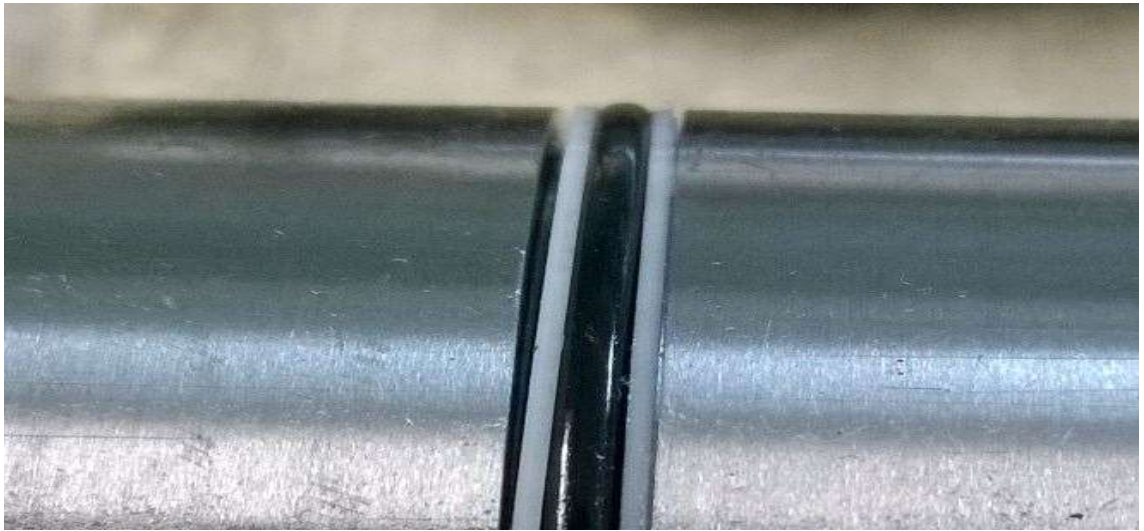
**Picture 28** Piston seal 1 from endurance test 1.

Picture 28 shows the piston seal 1 from manufacturer 1. In This seal shows no visible abrasion as on the seal 2 and the seal has kept its round form. Seal one lost only 1.5 % of its mass and thus there was a clear difference when compared to the seal 2. Seal 1 lost a 5.2 % mass from the Teflon rings. The mass loss is nearly double compared to the loss on seal 1. It is not clear how the Teflon rings have lost so much mass.

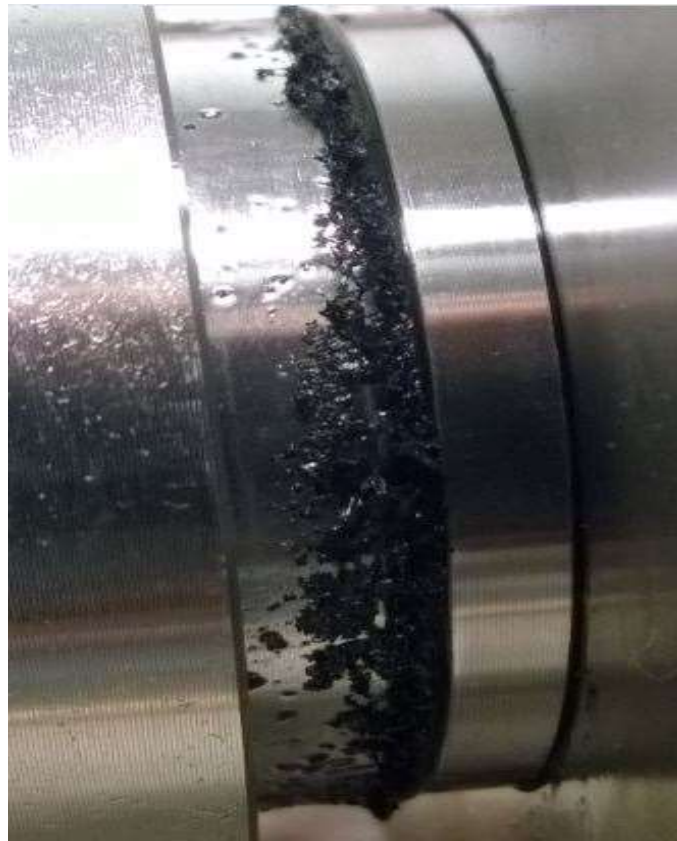
**Picture 29** O-ring 2 from endurance test 1.

Picture 29 shows the O-ring 2 of manufacturer 1 after the endurance test. There is a considerable amount of wearing visible on the seal. This type of wearing is not normal for a static seal. The wearing may be caused by the seal pushing into the clearance between the cylinder pipe and cylinder end. The seal lost 5.9 % of its mass and it can clearly be seen that it is due to abrasion. Next to the seal is a lot of rubber crumb which is shown in picture 29.

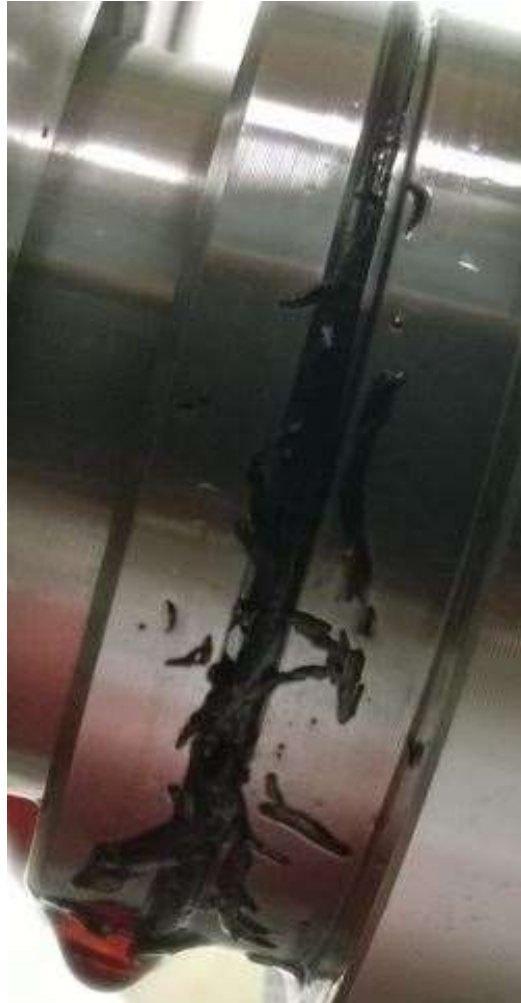
**Picture 30** O-ring 1 from endurance test 1.

Picture 30 shows the O-ring 1 of manufacturer 1 after the endurance test. Rubber flakes have ripped from the seal. This demonstrates how the seal lost nearly 3.7 % of its mass. This wearing behavior is not normal for seals as in the O-ring 2. The same explanations for the abnormal wearing apply for seal 1 as the seal 2. The abrasion of seal 1 and seal 2 differ from each other. The way the rubber has worn from the seal is different. The O-ring 1 has lost less mass compared to O-ring 2.

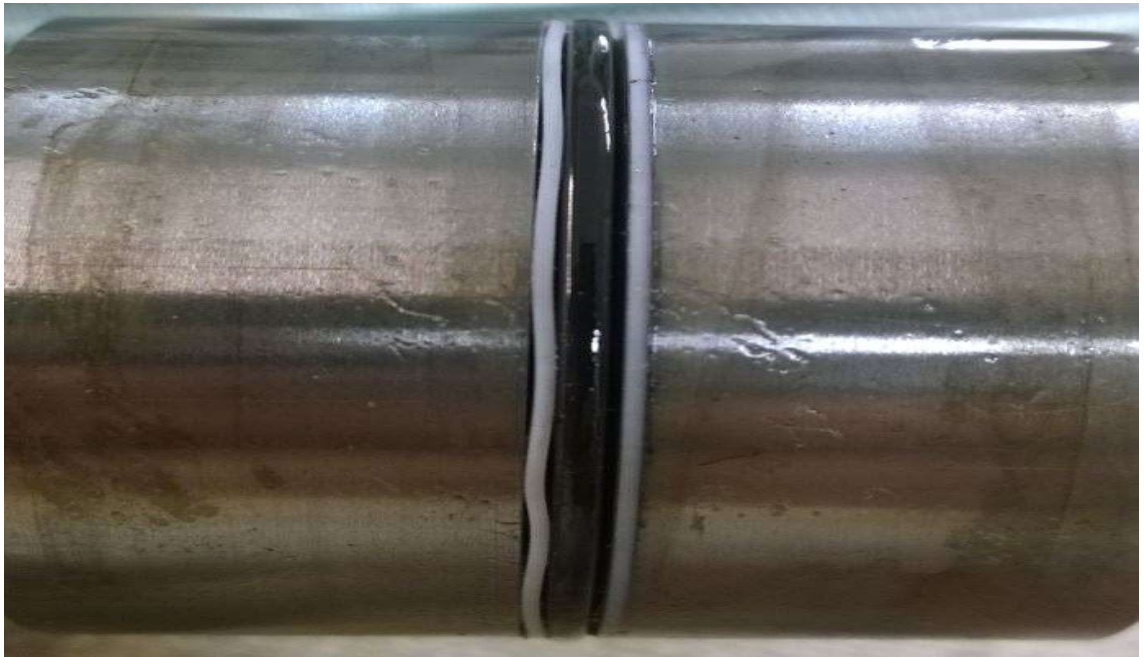
**Picture 31** Piston seal 1 from endurance test 2.

Picture 31 shows the piston seal 1 of manufacturer 2 after the endurance test. On the seal is visible abrasion because the seal has worn nearly flat. The seal has lost 2.9 % of its mass which is less than half of what the manufacturer 1's seal lost. Teflon rings have lost 2 % of their mass. The mass loss is smaller than on the endurance test 1. Picture 31 shows that the left Teflon ring has been elongated. The wavelike form of the Teflon ring shows the elongation.

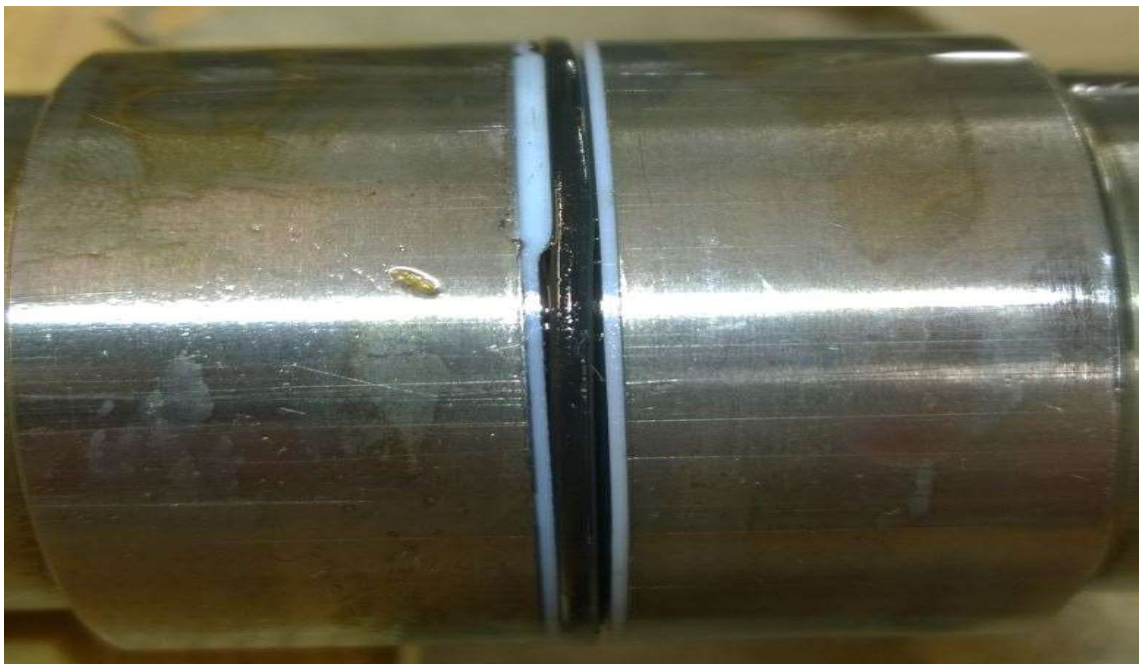
**Picture 32** Piston seal 2 from manufacturer 2.

Picture 32 shows the piston seal 2 from manufacturer 2 after the endurance test. Seal 2 has clearly more roundness left than seal 1. Weighting results show that this seal lost 1.5 % of its mass which is the same amount as the seal of manufacturer 1. Teflon rings lost 1.7 % of their mass. This is less than the seal of manufacturer 1 lost. There is also a visible deformation on the Teflon ring. The ring has turned 90 degrees around its axis on the part where it does lay against the cylinder pipe.

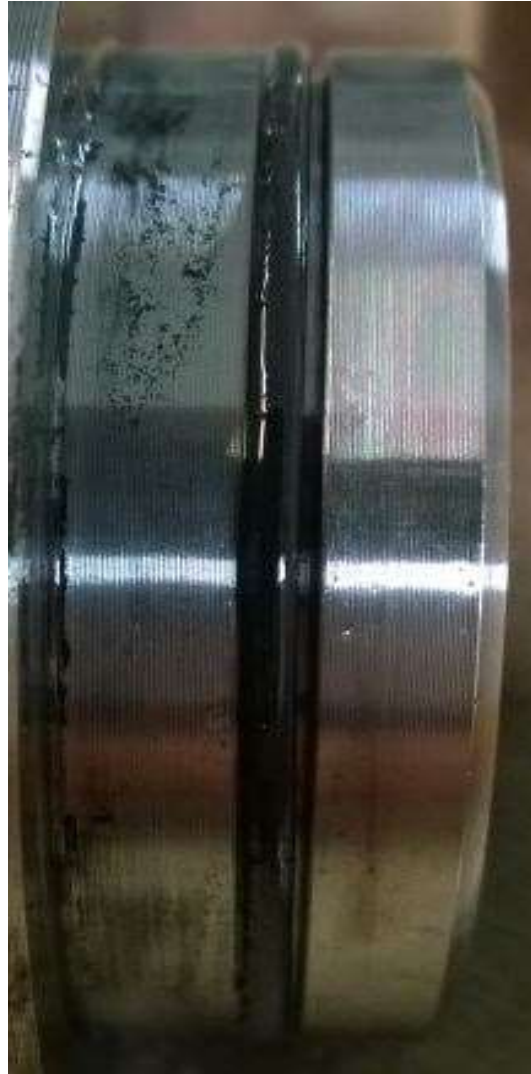
**Picture 33** O-ring 2 from endurance test 2.

Picture 33 shows the O-ring 1 of manufacturer 2 after endurance test. There is very little visible abrasion on O-ring 1. The O-ring has kept its original round form. This observation is confirmed by the weighting result which shows a 0.54 % mass loss. There is a clear difference when compared to the 5.9% mass loss of the manufacturer 1 O-rings.

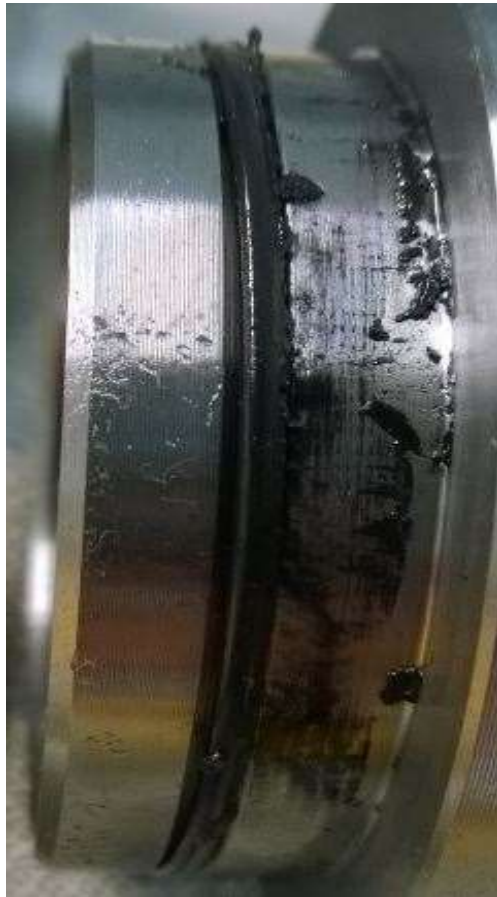
**Picture 34** O-ring 1 from endurance test 2.

Picture 34 shows the O-ring 2 of manufacturer 2 after endurance test. Some rubber crumbs are visible due to abrasion. The mass loss of the O-ring is 0.9 % which is much less than that of the O-rings of manufacturer 1.

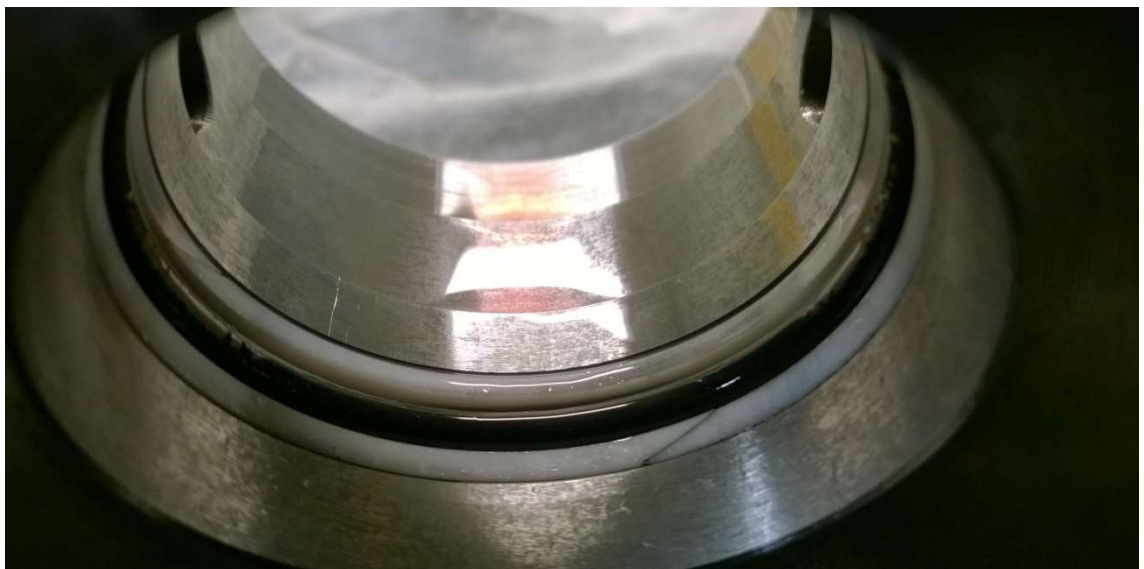
**Picture 35** Rod seal 1 from endurance test 1.

Picture 35 shows rod seal 1 from endurance test 1. The seal has lost 0.6% mass from support rings and 1.91% mass from elastomer. There is a little visible abrasion on the elastomer part because it is not as round as a new one. The mass loss from the elastomer is quite significant.

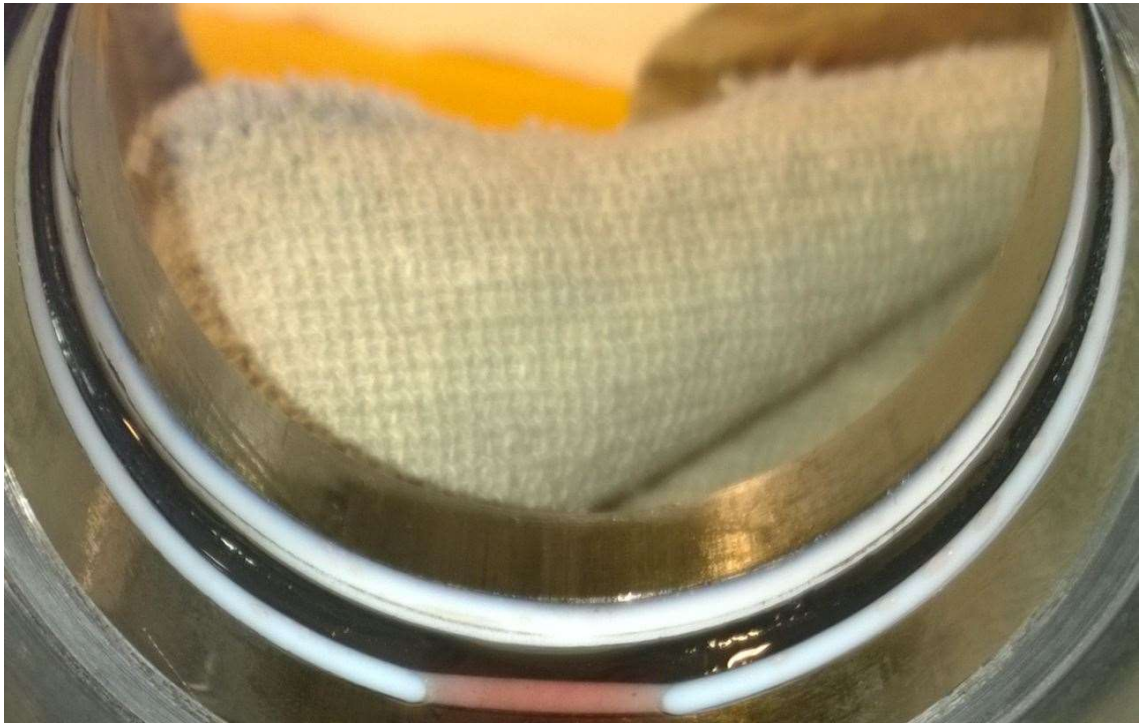
*Picture 38* Rod seal 2 from endurance test 2.

Picture 38 shows the rod seal 2 from endurance test 2. The seal has lost 5.6% mass from support rings and 0.15% mass from the elastomer. There is no visible abrasion on the elastomer part. The mass loss from the support rings is very significant. Visual inspection shows that the surfaces of the support rings are smooth so the wearing seems normal.
