Typical moisture failures of the slab-on-ground structures in Finland

Abstract: This paper includes a summary of several case studies on moisture damaged slab-on-ground structures. The object of the paper is to suggest a classification of the causes for moisture damages and introduce the typical moisture failure of the slab-on-ground structures in Finland. The common causes for moisture damages in the slab-on-ground structure can be classified into four categories: design, construction, repair and maintenance. According to the studied moisture damage cases the most common cause is design fault. Usually the slab-on-ground structure is unfit in the light of present knowledge. The most common design faults are lack of capillary breaking drainage layer under the slab, lack of thermal insulation and incorrect placement of the vapor barrier.

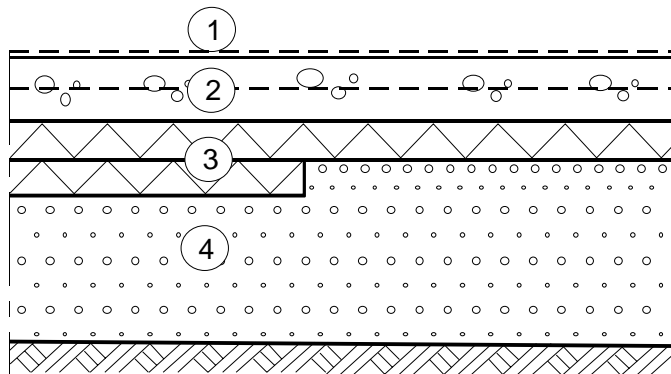
1 Floor covering material. If the floor covering is water vapor tight the excess water from cast concrete must have been dried out before installing floor covering.

2 Concrete slab, about 80 mm
