1 NEED TO REPAIR MOISTURE- AND MOULD DAMAGE IN DIFFERENT STRUCTURES IN FINNISH PUBLIC

- 2 BUILDINGS
- 3 Petri J. Annila¹, Jukka Lahdensivu², Jommi Suonketo², Matti Pentti², Juha Vinha²
- 4 ¹ Corresponding author: <u>petri.annila@tut.fi</u>, Tampere University of Technology, P.O.B. 600, FI-33101
- 5 Tampere
- 6 ² Tampere University of Technology, P.O.B. 600, FI-33101
- 7

- 18 Moisture- and mould damage and resulting impurities are related to complex indoor air quality problems.
- 19 This study focuses on the need to repair moisture- and mould damage in different structures. The research
- 20 material consists of 168 Finnish public buildings. Based on research material, the highest need for repair is
- 21 in timber-framed ground floor with crawl-in space, slab-on-ground structures, external walls in concrete-
- framed buildings and walls in contact with soil. A need to repair these structures exists in 56-85% of the
- 23 examined buildings. The study reveals that buildings are multi-problematic: on average 3.1 main category
- 24 structures were damaged in every studied building.
- 25
- 26 KEYWORDS:
- 27 Moisture damage, mould damage, moisture performance assessment, condition inves

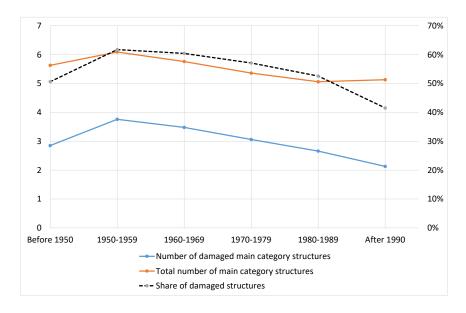
The results indicate that the buildings examined had suffered multiple damage, meaning that the need to repair moisture- and mould damage was found in many different structures, as presented in Figure 1. According to the structural classification, damage was found in all seven different main category structures, as presented in Table 5. Figure 1 also illustrates the average number of main category structures and share of damaged structures in different age groups.

207 Figure 1. Number of damaged structures and total number of structures.

208 The number of damaged main category structures in the entire body of research was 3.1 damaged 209 structures per building. The value is highest in buildings from the 1950s, with on average 3.8 different 210 structures being moisture- or mould-damaged. The share of damaged structures was 62% of the total 211 number of structures in these buildings. After the 1950s, the trend of number of damaged structures and 212 trend of total number of structures decreases. Moreover, when the share of damaged structures of the 213 total number of structures is evaluated, the trend also decreases in buildings built after the 1950s. It seems 214 that newer buildings are simpler than older buildings and one reason for this is that newer buildings are more often built without a basement. They are also more rectangular in shape and simpler in terms of 215 216 architecture. Basically this means massive single-material structures or at least fewer different materials. Figure 1 clearly demonstrates that in newer buildings the need for repair of moisture- and mould damage is 217 218 rarer than in older buildings.

The trend of the number of moisture- and mould-damaged structures is almost linear, if we ignore the oldest building group *'before 1950'* and draw linear regression into Figure 1. As mentioned before, the group *'before 1950'* is quite a heterogeneous group of buildings and it is probable that the most damaged buildings are not in use anymore. This may be why this group differs from other groups as presented in Figure 1. The direction of the trend is as supposed: the need for repair is greater in older buildings, also in terms of moisture and mould damage.
