Water content variation of railway track sub-ballast layer in seasonal frost area: A case study from Finland

Juha Latvala ^{*},¹, Pauli Kolisoja ¹, Heikki Luomala ¹

Research Centre Terra, Tampere University, Finland

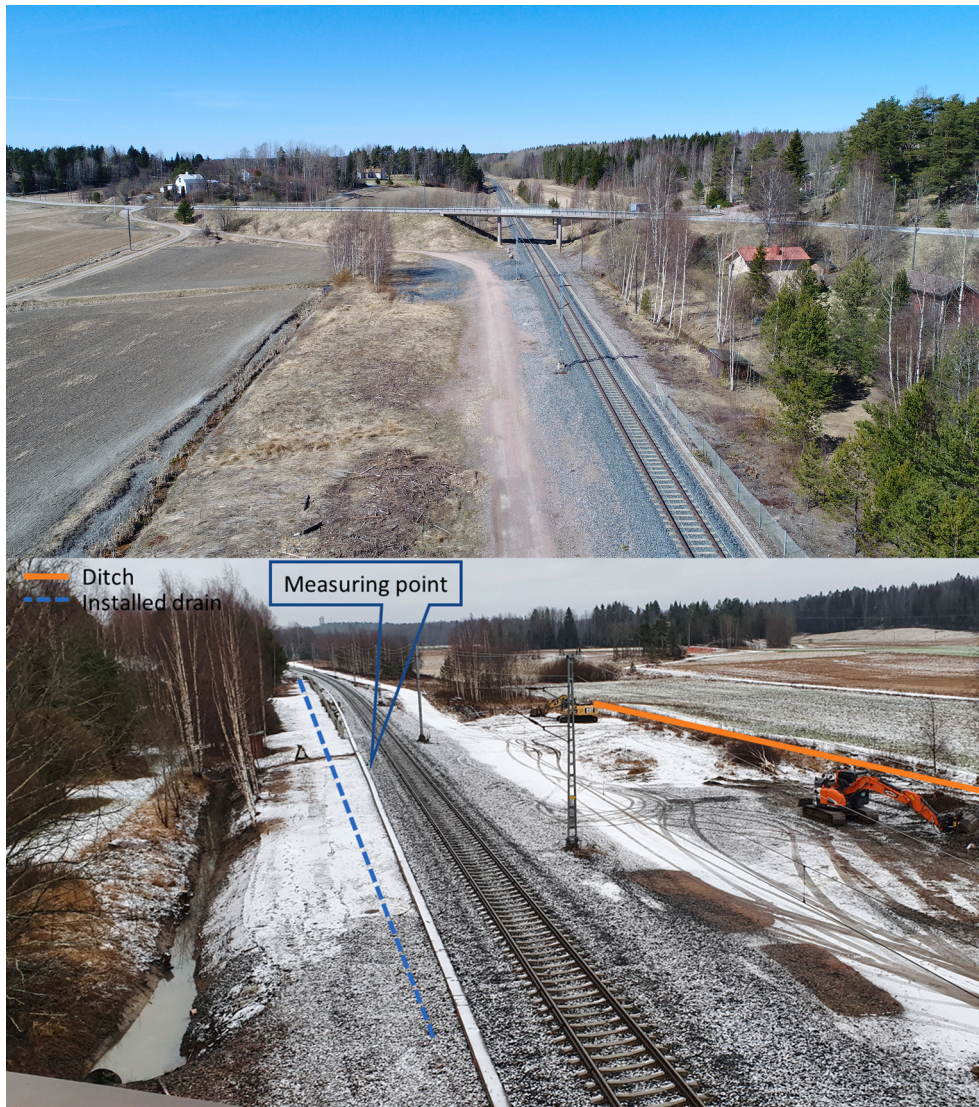
Fig. 2. The areal picture of Km 44 before and after the drainage improvement from opposite perspectives. The track is on flat terrain, and the drainage was not working properly. Photos taken on May 04, 2017, and January 29, 2020.

The monitoring site at Km 44 is located in a flat area where the track is about the height of a ballast layer higher than the surrounding terrain. This is shown in an overview of the area before and after drainage improvement, taken on July 04, 2017, and January 29, 2020 (Fig. 2). The subsoil under the track is clay with a thickness of about 16–18 m.

During sensor installation, the ballast layer thickness was found to be much thicker than normal 0,55 m and the ballast particles were found up to the depth of 1 m mixed with sub-ballast material. The track has presumably sunk into the clay layer over time due to consolidation settlement. The prevailing drainage condition of the site was challenging, as the site is located on a flat area, and the surrounding terrain partly slopes in the direction of the track. There was a short ditch on one side of the track near the measuring point, and on the other side, a small ditch at the edge of the field, which was already quite far away. The water level in the ditches was high during all inspection visits, indicating that the water was not getting out of the track area. At the turn of 2019 until 2020, drainage improvement was conducted at the site by installing a drain on the side of the measuring station to the depth of –1,85 m. After that, the area was shaped, and the ditches were deepened. Simultaneously, the water drainage path outside the track area was also improved.

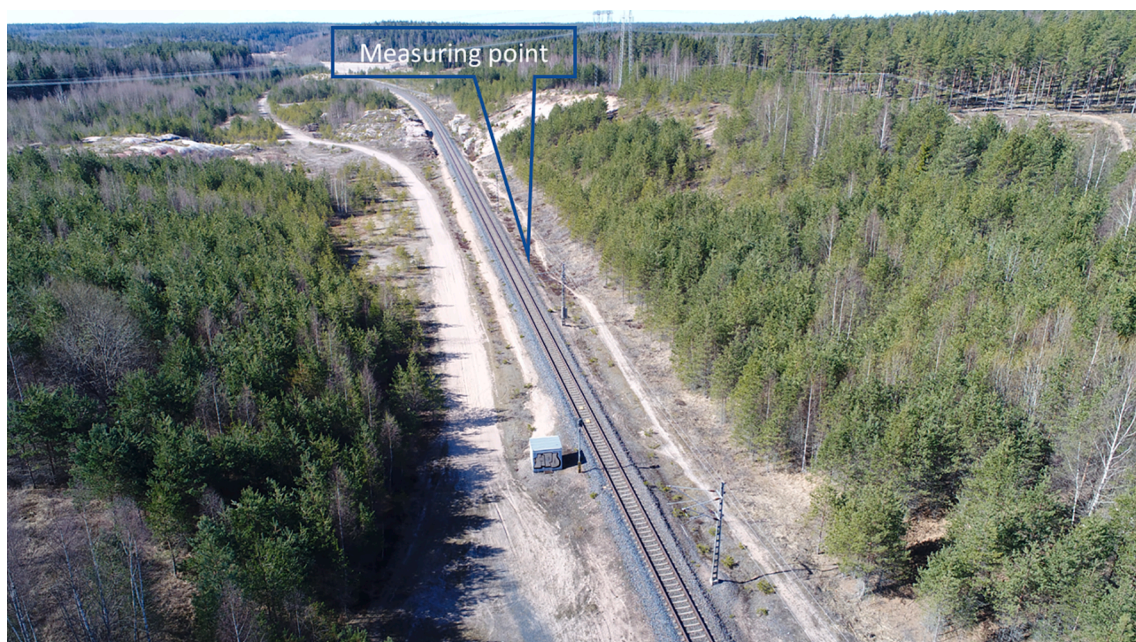
Fig. 4. The southwest areal picture of Km 137. The site is located near the sand esker that slopes in the direction of the track. Photo taken on May 04, 2017.

Km 137 is significantly different from the other two sites, as it is located next to a sand esker (Fig. 4). The surface of the ground is very dry. Sites like this are suspected to have some underground water flow due to the height differences and the esker. Consequently, the site was selected as one monitoring site. The thickness of the sand layer in the direction of the track varies. At the monitoring station, the sounding rods penetrated 3.9–4.0 m deep. After that, there was a hard bottom, probably a bedrock. Near the measuring station, 100–200 m away, there is a rock cut and a tunnel through the rock at the same distance on the other side. Therefore, the subsoil conditions vary rapidly at this site.

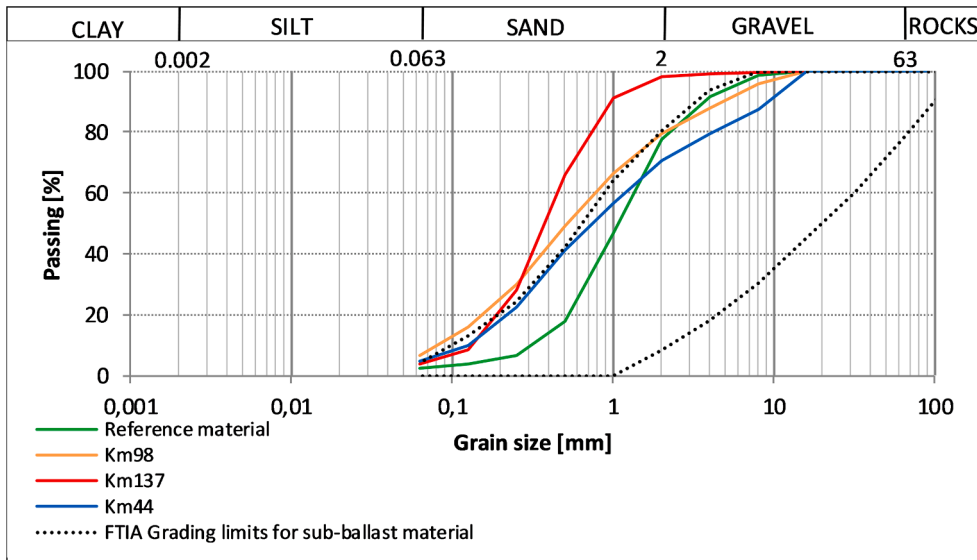
Fig. 6. The measured grain size distributions of the test materials. Dashed lines describe the grading limits of the Finnish Transport Infrastructure Agency for sub-ballast material.

have been examined in the laboratory. One additional good-quality reference material was also included in the laboratory tests, which fulfilled the Finnish Transport Infrastructure Agency (FTIA) requirements for the sub-ballast layer at the time of the study. Fig. 6 shows the grain size distribution curves of the materials, and Table 1 shows the typical geotechnical parameters. Only one of the samples, the one taken from Km 44, fulfilled the granularity requirements. All the samples taken from the field differed from the reference material, mainly on the finer end of the grading curve. The Km 137 material was mostly out of the FTIA grading limits due to its small average particle size, and as a uniformly-grained material, it was poorly compactable.

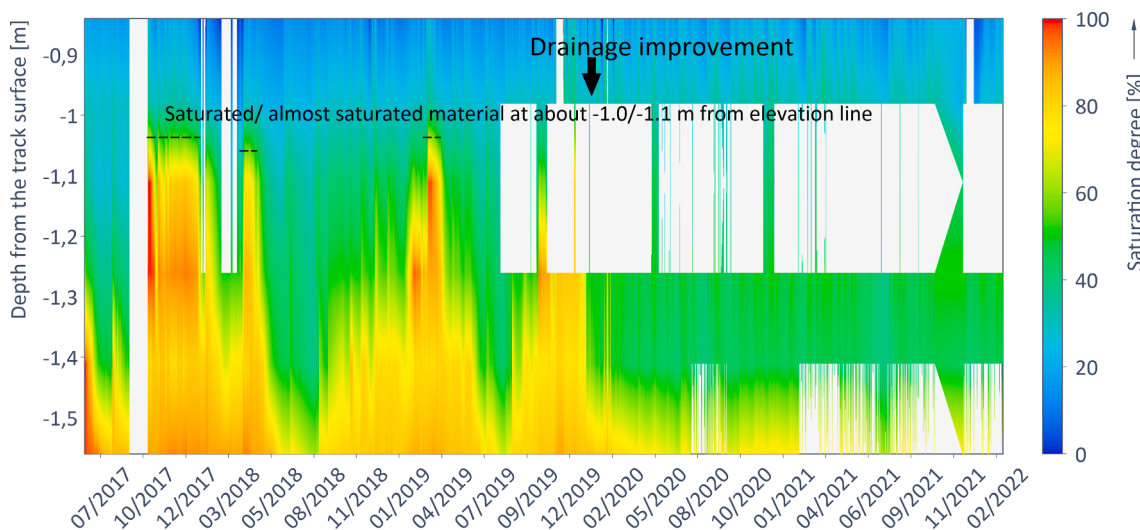
Fig. 8. The saturation degree of Km 44 sub-ballast layer. White boxes are due to intermittent malfunctions of two sensors.

Fig. 8 shows the long-term water contents of the monitoring site, Km 44. During the measurement history, before the drainage improvement at the turn of 2019 until 2020, the site experienced several periods of

high water content. The saturated zone extended to a depth of $-1,0$ m from the track elevation line (zero level). These high water level moments appeared in autumn and summertime. In July 2017 and May 2018, the saturation ratio was at its lowest when the saturation ratio of the sub-ballast was approximately 50 % in the deeper structure and less than 20 % near the surface. After the drainage improvement, high water contents were no longer measured, and the saturation degree remained below 60 %. In the lowest sensor located -1.56 m below the elevation line, there have been momentary indications of 70 %–80 % saturation degrees. Based on these measurements, the groundwater level is most likely located under the lowest sensors after the drainage improvement.

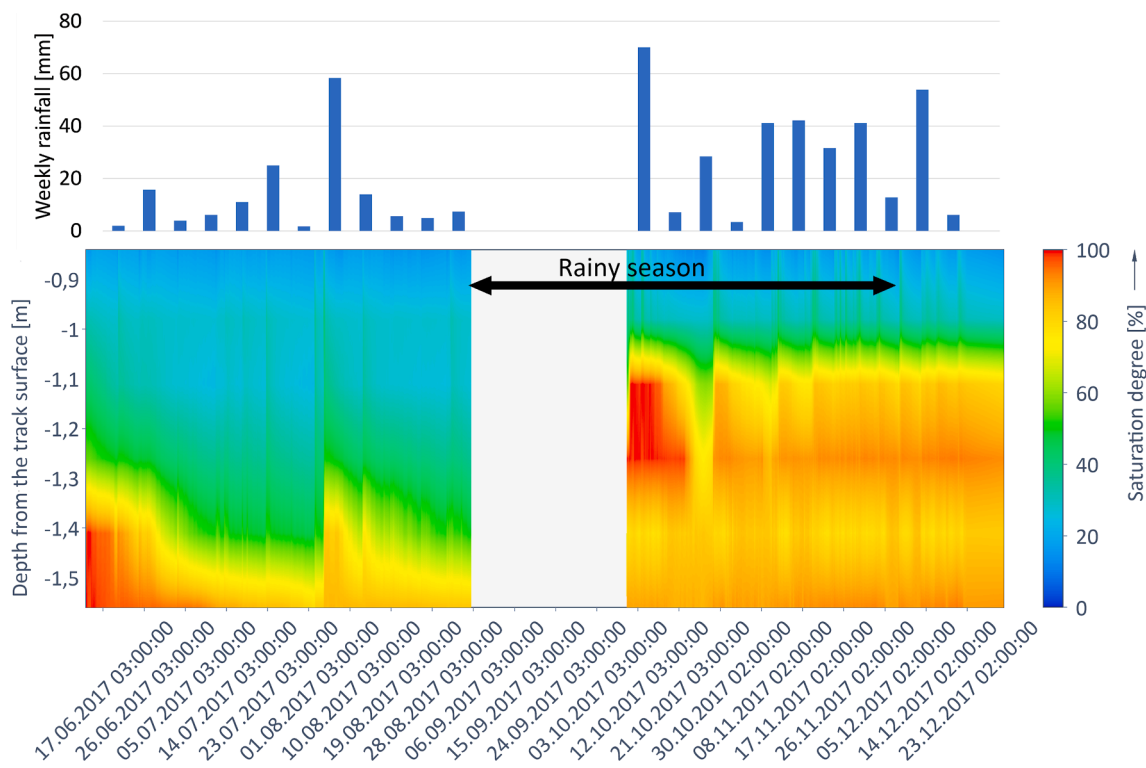
Fig. 11. Saturation degrees of Km 44 sub-ballast layer with weekly rainfalls during the summer and autumn of 2017. White area is due to total malfunction of measurement station.

In addition to the long-term seasonal water content fluctuations, short-term phenomena were also analyzed. Fig. 11 shows an example from the autumn of 2017 at Km 44, which was very rainy from September to the end of year 2017. The precipitation measured at Km 44 was 106 mm in October and almost 140 mm in November. This rainy

season affected the water content of the upper part of the structure such that water content quickly increased from 20 to 30 % to a 50–60 % saturation degree and the practically saturated zone rose from the – 1.5 m level to the – 1.05 m level. This was due to the areal water level rather than water retained in the upper part of the structure from rains. A similar analysis was carried out for Km 98 in the autumn of 2019, and Fig. 12 shows the results. In the upper part of the sub-ballast layer, about 70 % saturation degrees have been measured to be caused by rain. Still, deeper in the sub-ballast, the surrounding water level has probably risen, which is visible in the deepest sensors’ readings. The structure of Km 98 retains water better than Km 44.

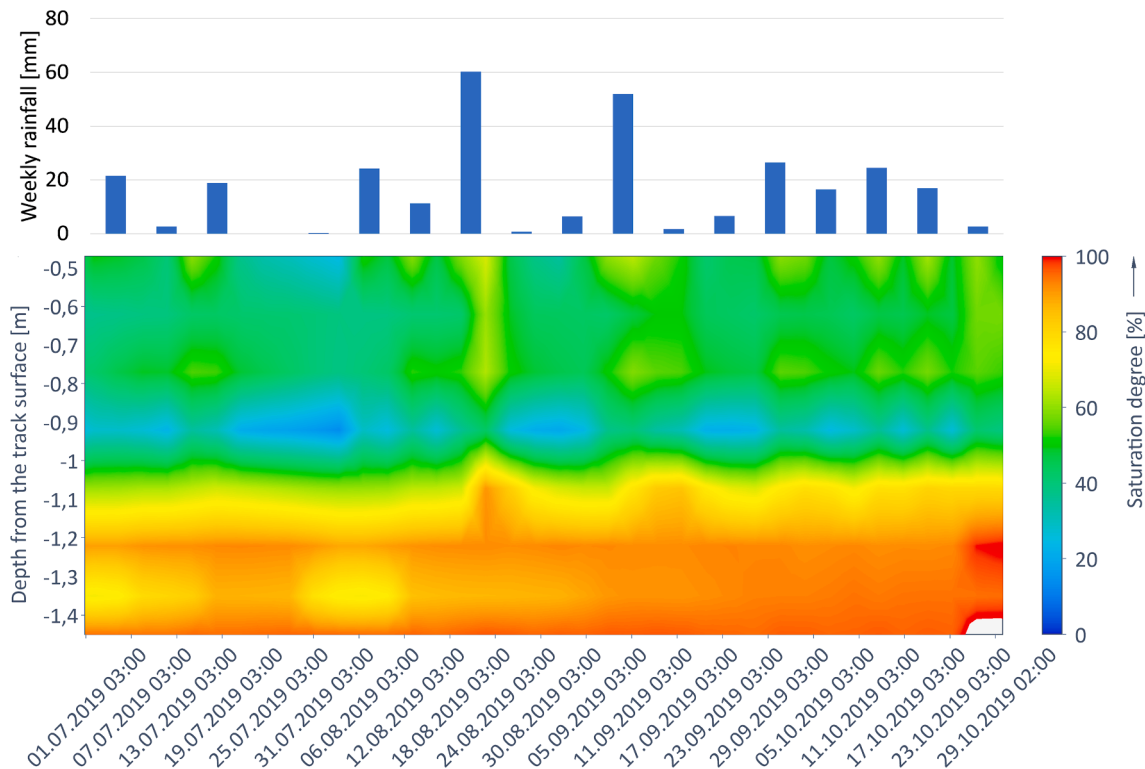
Fig. 12. Saturation degrees of Km 98 sub-ballast layer with weekly rainfalls during the rainy season of 2019.

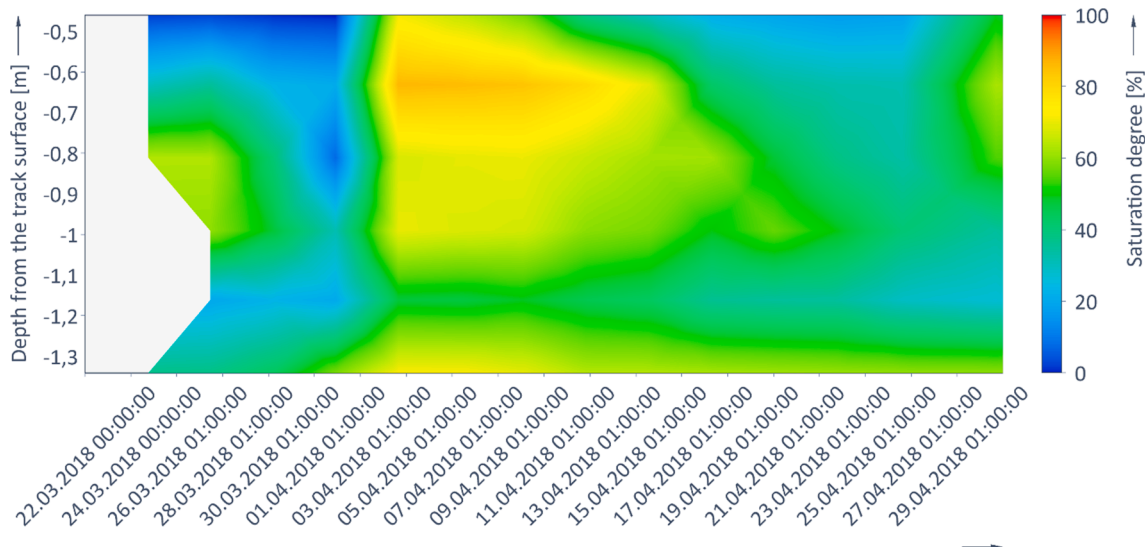
Fig. 13. Saturation degrees on Km 137 sub-ballast layer during the frost thawing period of 2018.

Regarding Km 137, the short-term review focused on frost thawing,

and Fig. 13 shows the respective measurement results. The white area at the beginning of the period was filtered out because the sensors could not measure the amount of frozen water correctly. In the spring of 2018, frost melting caused a period of approximately 80 % saturation, especially below the ballast layer, lasting for about 10 days. The water content of the rest of the sub-ballast has also increased significantly. The highest moisture contents are thus measured at the level where the increase of stresses caused by overpassing train loads is still moderately high.
